**Austen Quarry  
Stage 2 Extension Project**

**Aquatic Ecology  
Assessment**

**Cardno (NSW/ACT) Pty Ltd**

**September 2014**

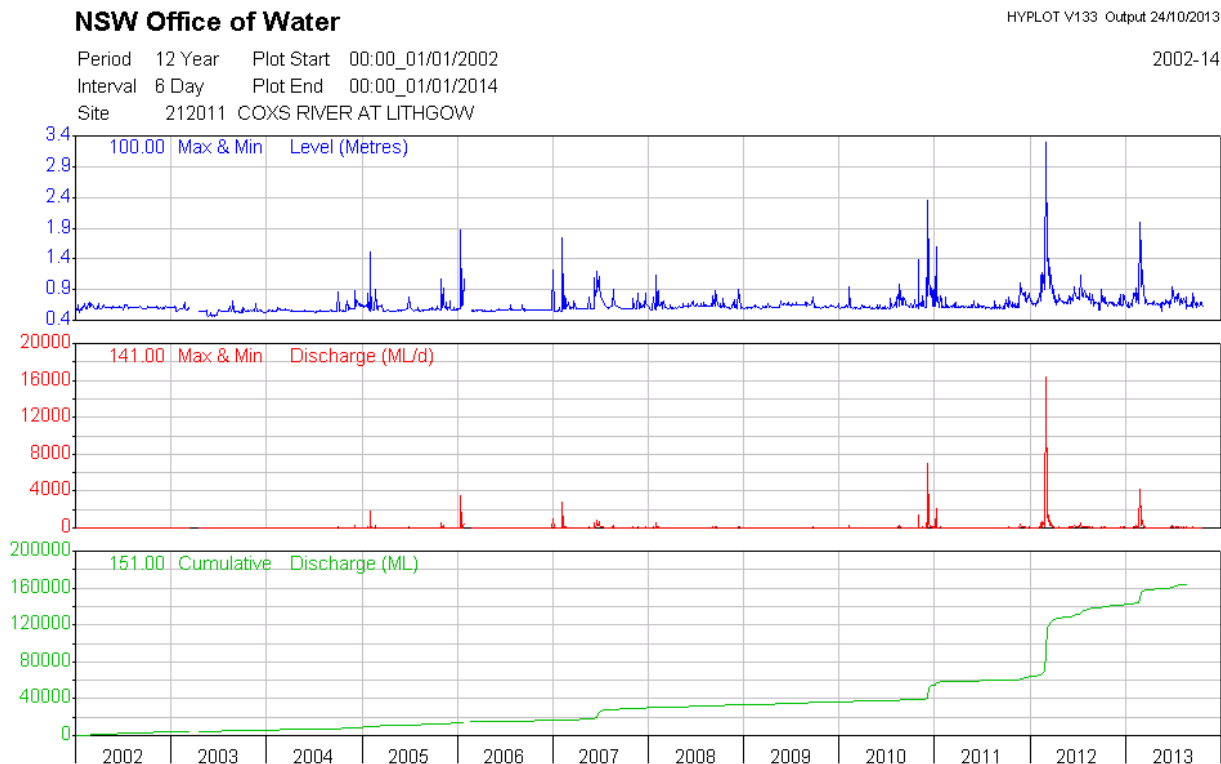
**Figure 3-2 Hydrological data for the Coxs River at Lithgow for 2002-2013**

The flow regime of the section of the Coxs River of interest has been impacted by land clearing, regional climatic variations; and the construction and operation of Lyell Dam (Young *et al.* 2000). Hydrological data were sourced from the NSW Water Information website administered by the NSW Office of Water (2013) for the gauging station on the Coxs River at Lithgow (Station No. 212011), which is located between Lake Lyell and the McKanes Falls Road Bridge. Water level, daily discharge (flow) and cumulative discharge data for the period 2002-2013 are depicted in **Figure 3-2**.

The most prominent feature of the hydrological data depicted in **Figure 3-2** is the large increase in discharge after late 2010, compared with preceding years, associated with several large flood events. The substantial increase in discharge is likely to have influenced the aquatic environment and biota, particularly in the weeks and months after these events.

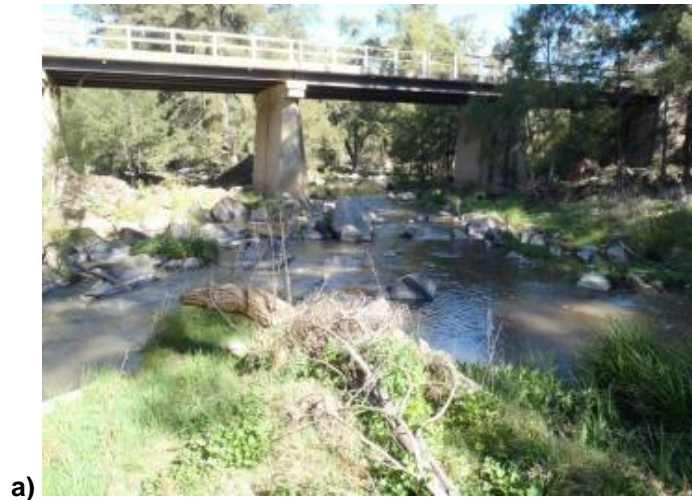
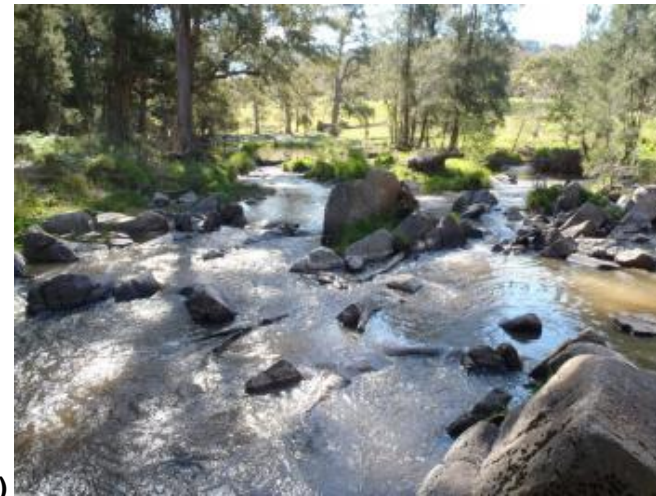
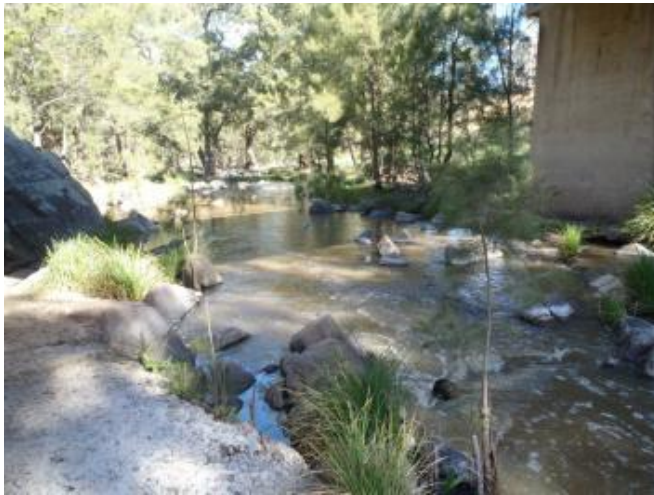
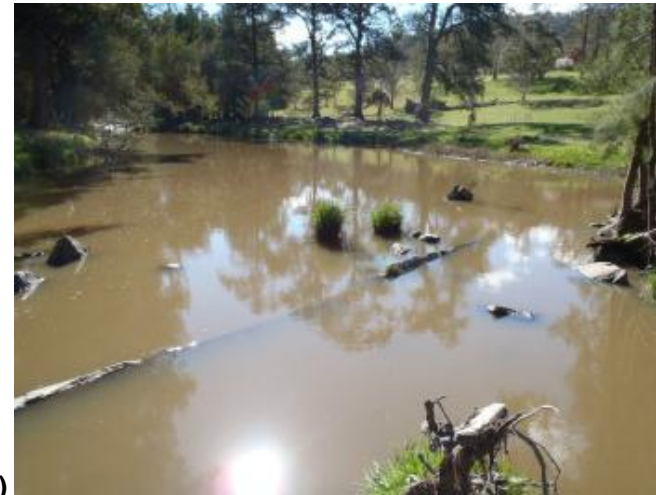
**Plate 1 Coxs River at Glenroy Bridge (Site 5), 18 September 2013: a) looking downstream from the middle of the site at bridge and riffle habitat; b) looking upstream from the middle of the site at riffle habitat; c) looking downstream from the bottom of the site at riffle and pool habitat; and, d) looking upstream from near the top of the site at pool habitat and the Glenroy Cottages camping ground.**

Riparian vegetation consisted of a sparse to moderate canopy of tall to sapling sized river she-oak (*Casuarina cunninghamiana*), sparse shrubs including *Acacia* sp. and extensive groundcover of various grasses and weeds. A sedge (*Carex* sp.) was the dominant emergent aquatic macrophyte along the littoral fringe, with a small stand of cumbungi (*Typha* sp.) also observed on the edge of the large pool. No submerged macrophytes were observed in 2013, probably due to the poor water clarity, although a sparse cover of a number of species has been reported along this stretch of the river (OEH 2010). This site was given RCE scores between 39 and 42 on visits between 2005 and 2007, indicating good quality aquatic habitat, and a score of 41 during the 2013 visit.

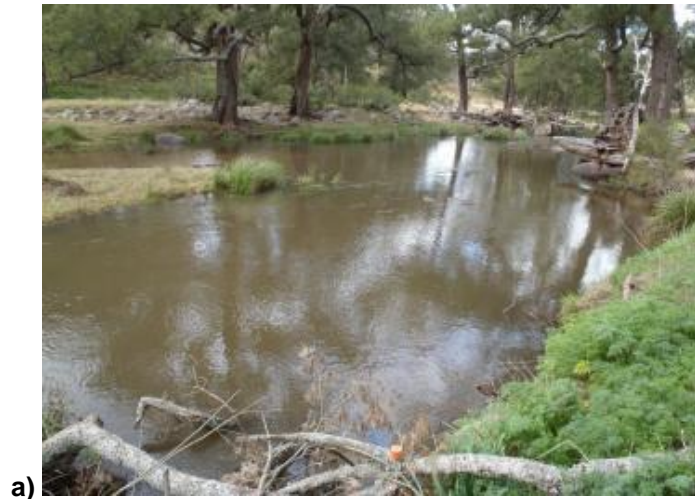
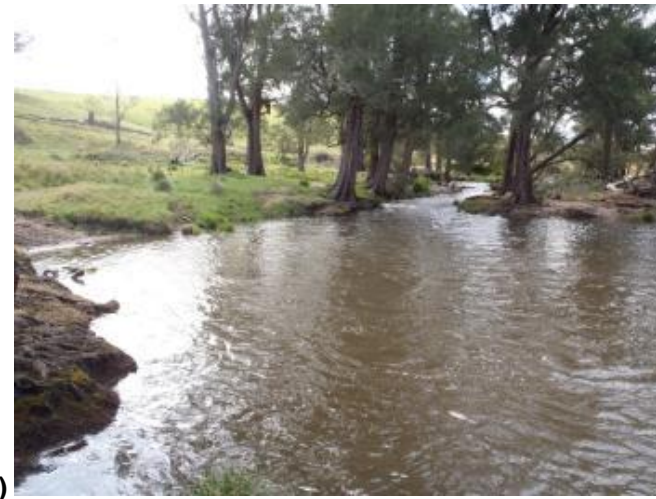
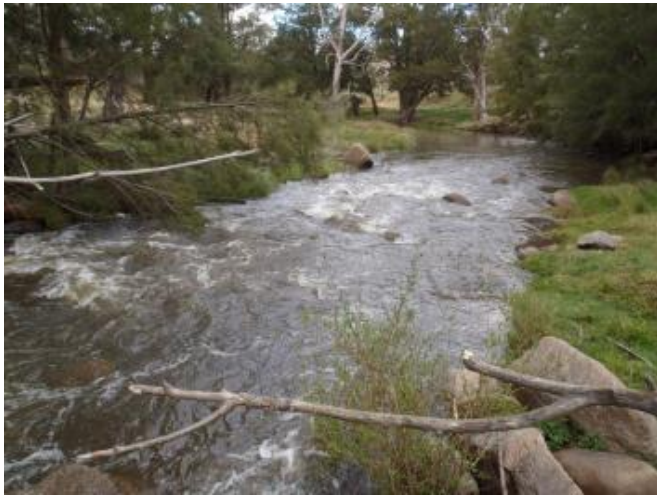
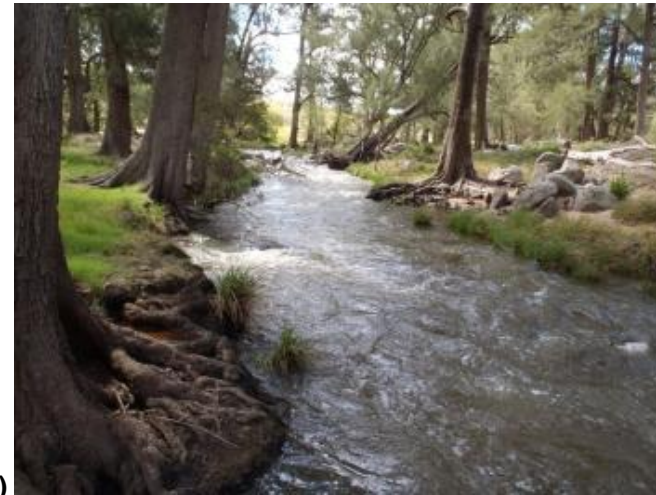
**Plate 2 Coxs River at the Quarry Control (Site 7), 17 September 2013: a) looking downstream from the middle of the site at pool habitat; b) looking upstream from the middle of the site at pool habitat; c) looking downstream from the bottom of the site at riffle habitat; and, d) looking upstream from the top of the site at riffle habitat.**

This site was located at a ford on the river within farming land, approximately one kilometre northwest of the secondary processing area (**Plate 2**). A large, slow flowing pool was present at the ford around the middle of the site and riffle habitat was present at its upstream and downstream boundaries. The pool was approximately 70 metres long, 25 metres wide and had a maximum depth of one metre. The riffle habitat upstream and downstream was approximately 5 metres wide and 30 to 50 centimetres deep with moderate to rapid flow. The substratum in the riffle habitat was predominantly large rounded bedrock, boulder and cobble, while sand and silt were more dominant in the edge and pool.

Riparian vegetation consisted of a moderate canopy of tall *Casuarina cunninghamiana*, few shrubs and extensive grass and weed groundcover. Moss and various emergent macrophytes were present along the banks, with *Carex* sp. dominant. The submerged aquatic macrophyte *Potamogeton* sp. was found in the sample net but not observed due to poor water visibility. Common Eastern Froglets (*Crinia signifera*) were audible during the 2013 visit. This site received an RCE score of between 35 to 44 on visits between 2005 and 2007, indicating good to excellent quality aquatic habitat, and a score of 41 during the 2013 visit.

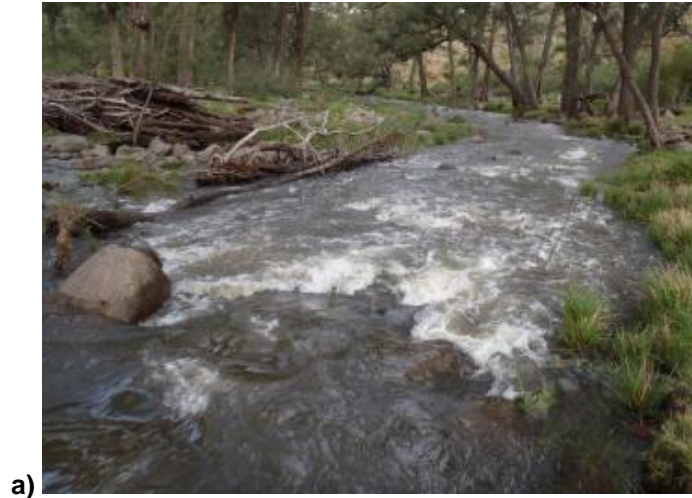
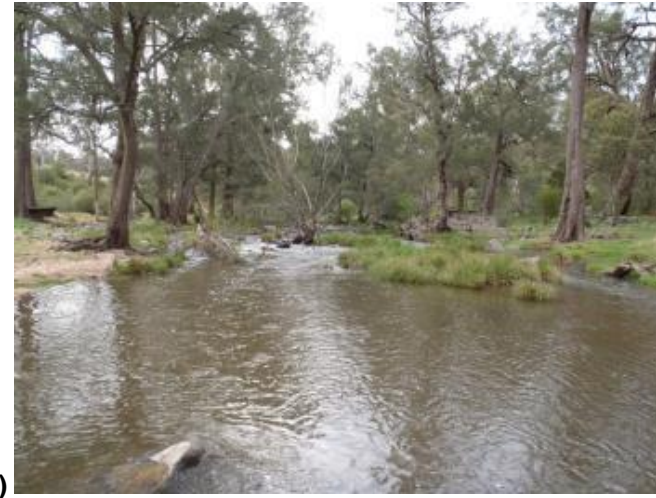
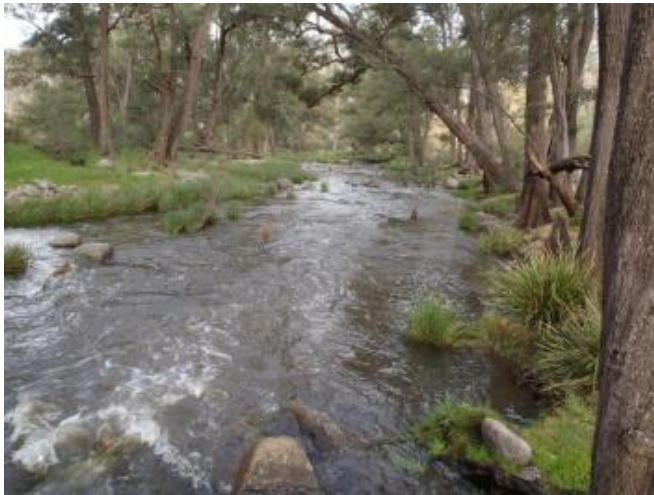
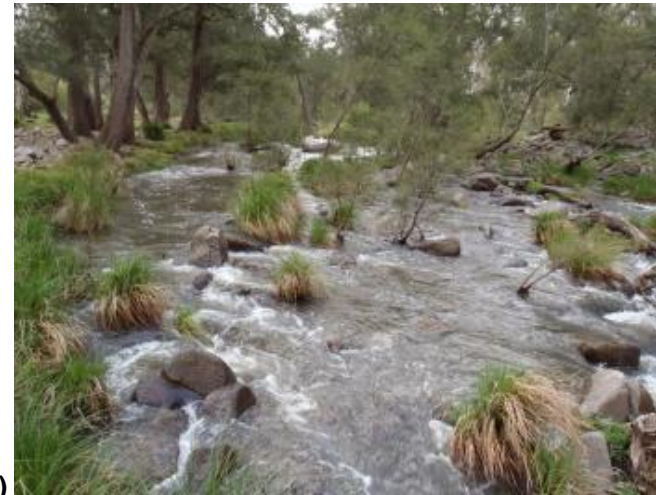
**Plate 3 Coxs River at the Quarry Treatment (Site 1), 17 September 2013: a) looking downstream from the middle of the site at riffle habitat; b) looking upstream from the middle of the site at pool habitat; c) looking downstream from the bottom of the site at riffle habitat; and, d) looking upstream from the top of the site at riffle habitat.**

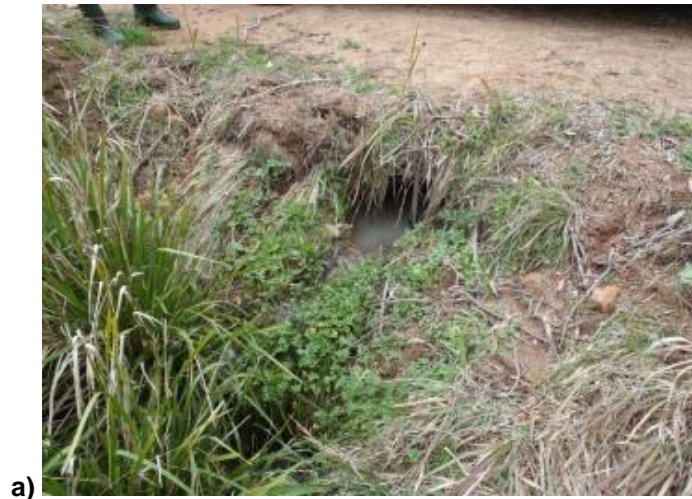
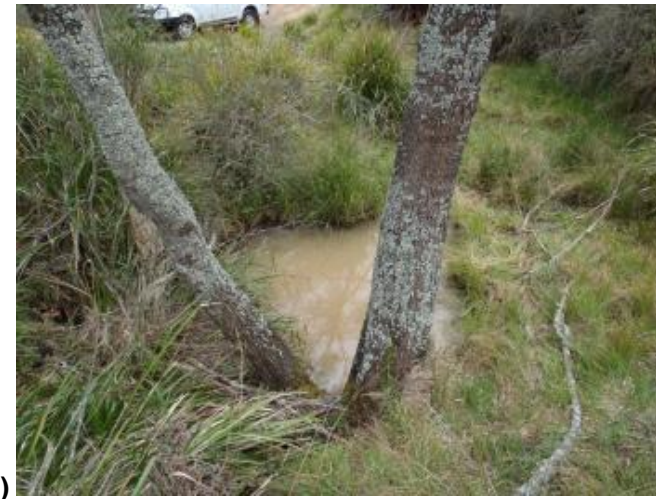
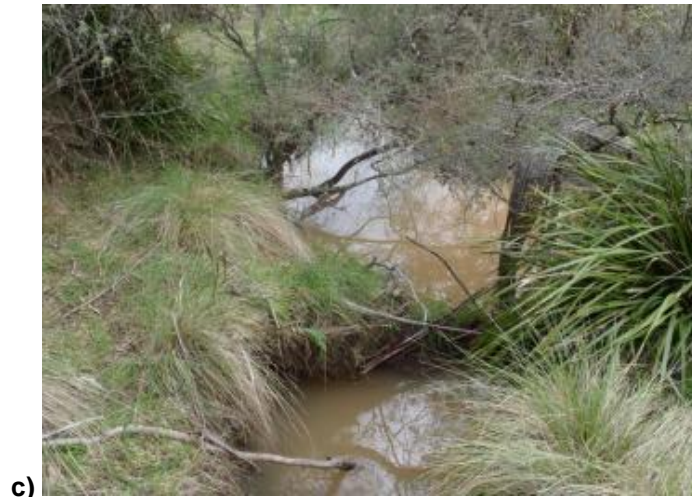
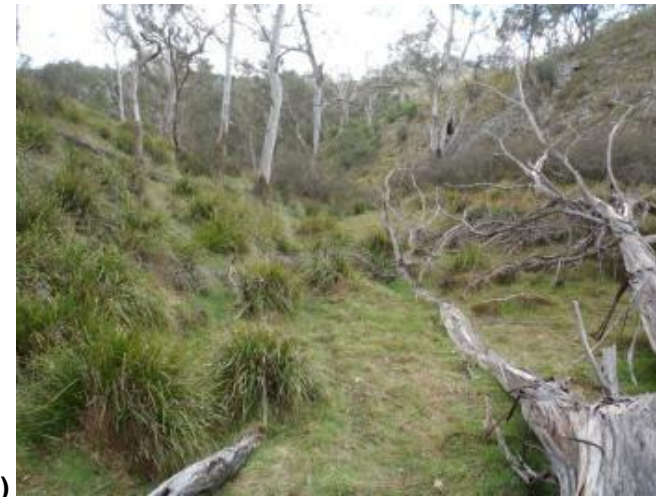
**Plate 4 Unnamed Tributary within the North Catchment (Site NC1), 17 September 2013: a) looking at trickle flow through the small pipe culvert under the four wheel drive access road; b) looking downstream at small pool directly upstream of the four wheel drive access road; c) looking upstream at small pools along the drainage line; and, d) looking upstream along the dry surface of the drainage line.**

This site was located on a small, unnamed, 2<sup>nd</sup> order drainage on the eastern side of the Coxs River North catchment, upstream of the 4WD access track and approximately 100 metres upstream of the confluence with the Coxs River (**Plate 4**). A small pipe culvert was in place at the 4WD crossing. This site had not been visited during monitoring events. The drainage consisted of a series of small pools (approximately 1-2 metre diameter, less than 1 metre deep) that were semi-connected by a trickle of flow at the time of sampling. The flow was almost certainly ephemeral considering the size of the catchment, although the pools may have persisted for some time during dry weather. Approximately 50 metres upstream of the road sub-surface interflow was apparently occurring, as surface flow was not observed. The substratum in the pools appeared to be fine material dominated by silt as indicated by the banks. Water clarity was very poor at the time of sampling.

Riparian vegetation was dominated by a sparse canopy cover of *Eucalyptus* sp. and some smaller native shrubs including tea-tree (*Leptospermum* sp.). The understorey consisted of a variety of grasses, with mat-rush (*Lomandra* sp.) being dominant upstream where the surface flow was absent. Vegetation upstream along the centre of the drainage appeared to be relatively undisturbed with less tree cover and more low grasses. Water Striders (Gerridae) and Backswimmers (Notonectidae) were observed in one of the larger pools indicating the semi-permanence of this habitat. This and the other tributaries within the Coxs River North catchment were not considered to be sensitive fish habitat (Type N/A) as they are ephemeral 1<sup>st</sup> and 2<sup>nd</sup> order streams. They were considered Class 3 (minimal) fish habitat close to the Coxs River and Class 4 (unlikely) fish habitat further upstream according to the NSW DPI (2013) Policy and Guidelines for Fish Habitat Conservation and Management. This location received an RCE score of 35, indicating good quality aquatic habitat.

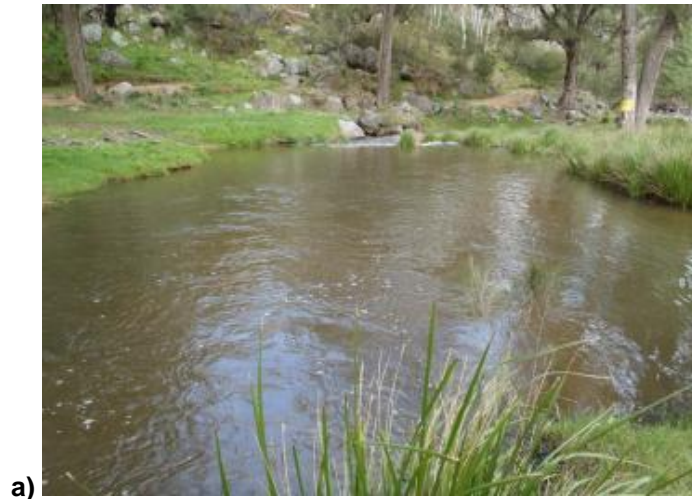
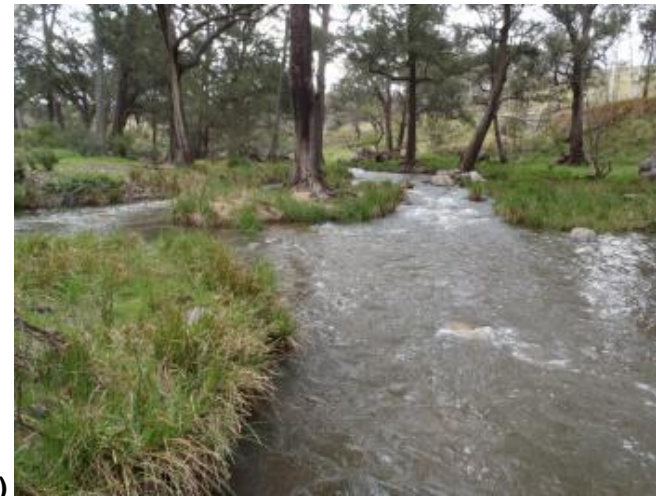
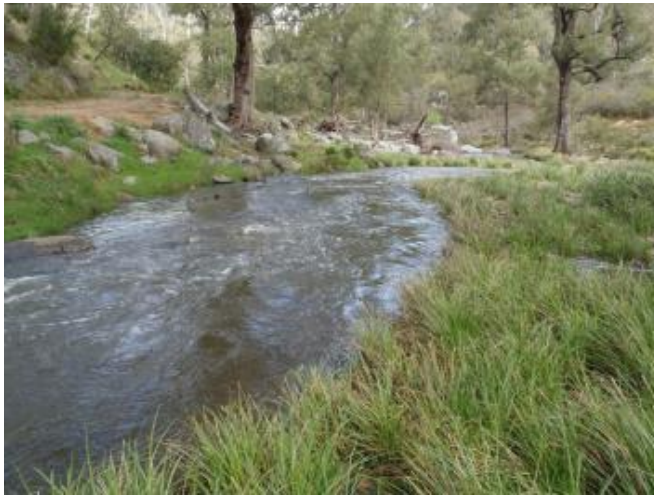
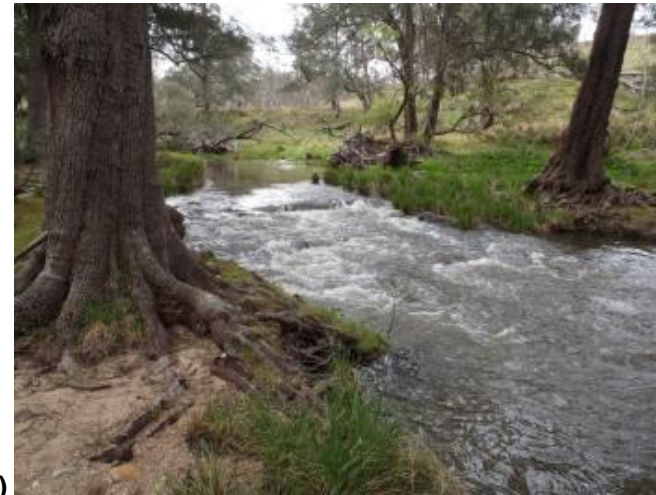
**Plate 5** Coxs River downstream of the North Catchment Unnamed Tributary (Site 2), 17 September 2013: a) looking downstream from the middle of the site at pool habitat; b) looking upstream from the middle of the site at riffle habitat; c) looking downstream from the bottom of the site at riffle habitat; and, d) looking upstream from the top of the site at riffle habitat.

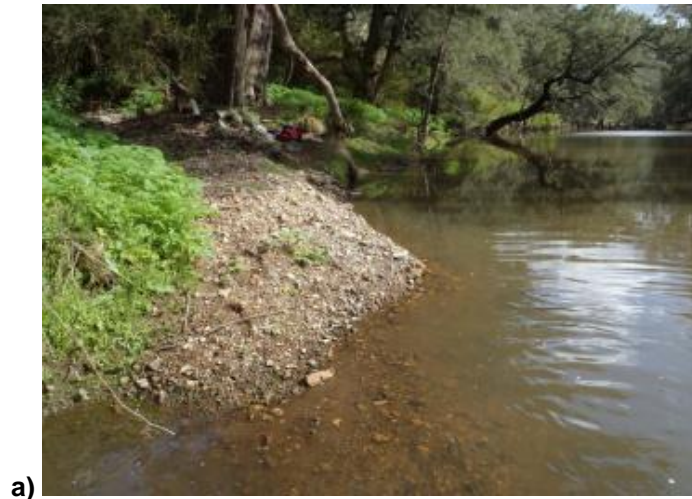
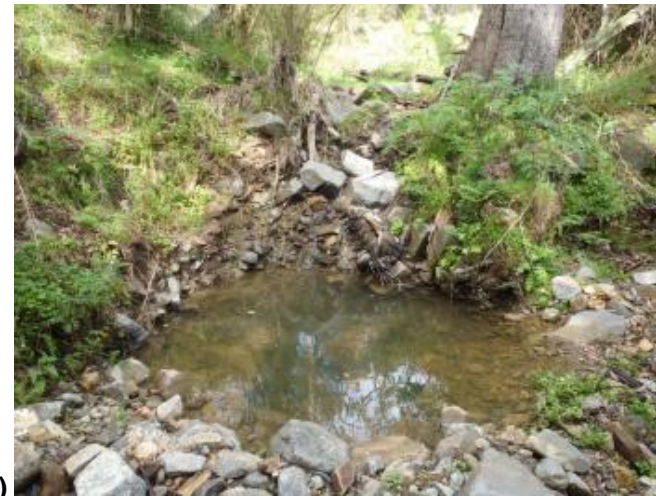
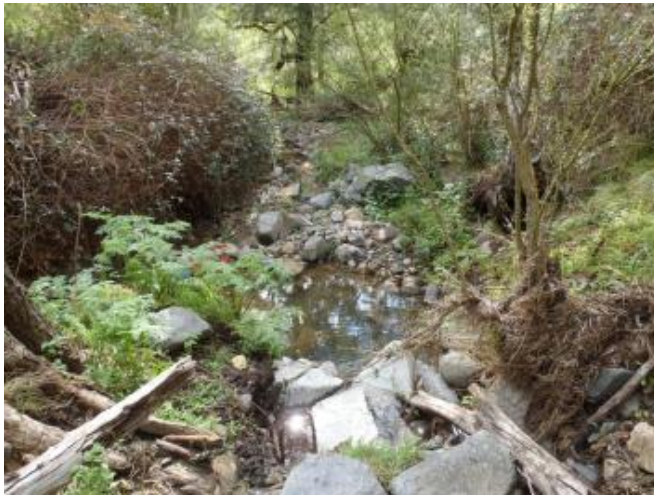
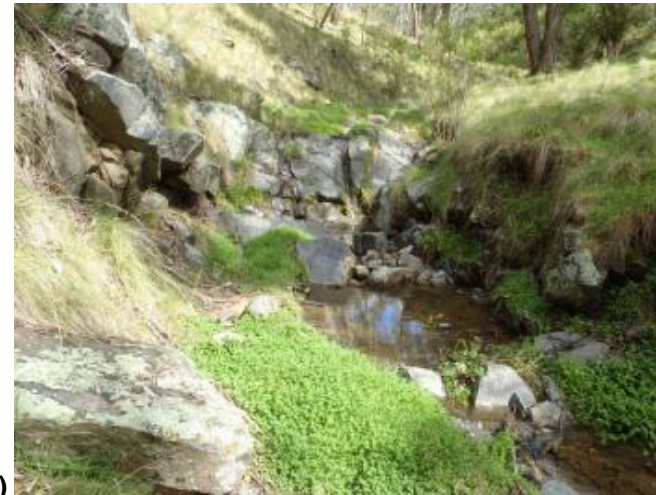
**Plate 6 Unnamed Tributary of the Stage 2 Extension South Catchment (Site SC1), 18 September 2013: a) looking upstream along the Coxs River at the sediment bar at the tributary confluence; b) looking downstream at a larger pool on the creek line; c) looking downstream along the creek line, with at pool habitat; and, d) looking upstream at another pool and small waterfall approximately 200 metres upstream from the Coxs River.**

This site was located along the channel of the larger of the Coxs River South catchment waterway, close to the confluence with the Coxs River (**Plate 6**). This site had also not been visited previously. The drainage consisted of small pools (maximum diameter of approximately 2 metres and 50 centimetres deep) that were interconnected at the time of observation by a flow of approximately 2 litres per second. Substratum was primarily boulder and cobble, with some pebble, sand and silt also present. A large gravel, sand and silt bar formed by deposited material from the catchment protruded into the Coxs River at the confluence point. Moderate bank undercutting was observed along the channel upstream of this point.

Riparian vegetation was *Eucalyptus* sp. woodland with some shrub cover and a grassy understorey. Several tall *Casuarina cunninghamiana* were present closer to the Coxs River confluence, where weeds, including Blackberry (*Rubus fruticosus* spp. agg.) and Willow (*Salix* sp.), were more common. Some green alga was present in some pools. The tributary at this location was considered a Type 3 (minimally sensitive), Class 3 (minimal) fish habitat according to the NSW DPI (2013) Policy and Guidelines for Fish Habitat Conservation and Management. Upstream of this location where the creek becomes a 2<sup>nd</sup> and 1<sup>st</sup> order tributary, fish habitat classification was reduced to Type N/A, Class 3 and/or 4. This location received an RCE score of 35, indicating good quality aquatic habitat.

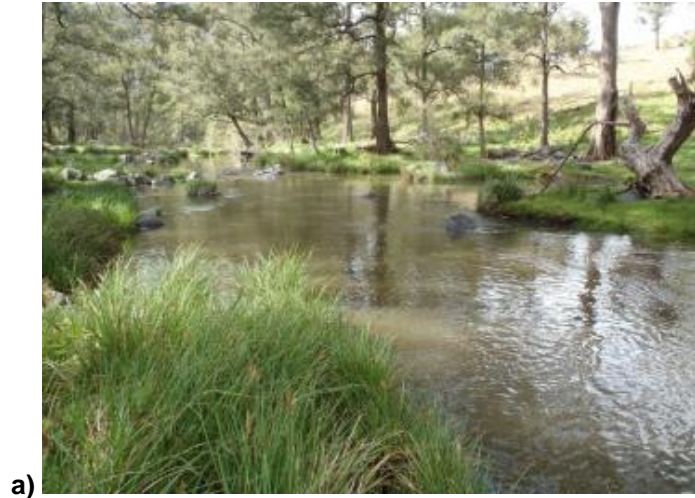
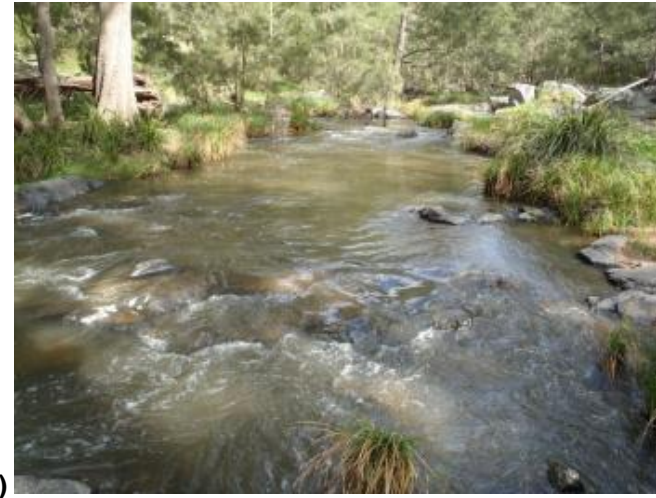
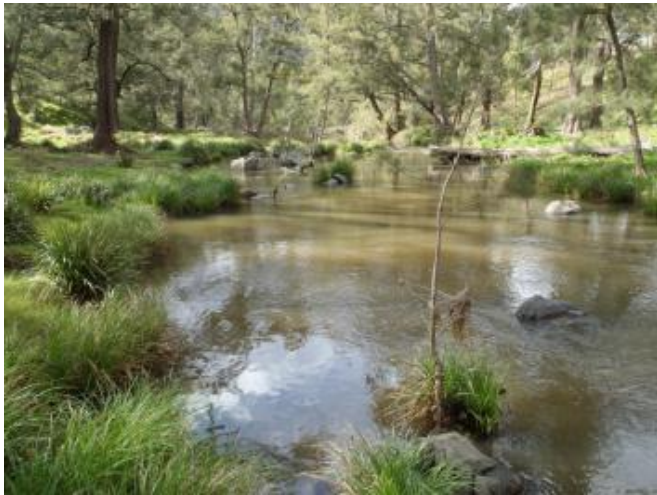
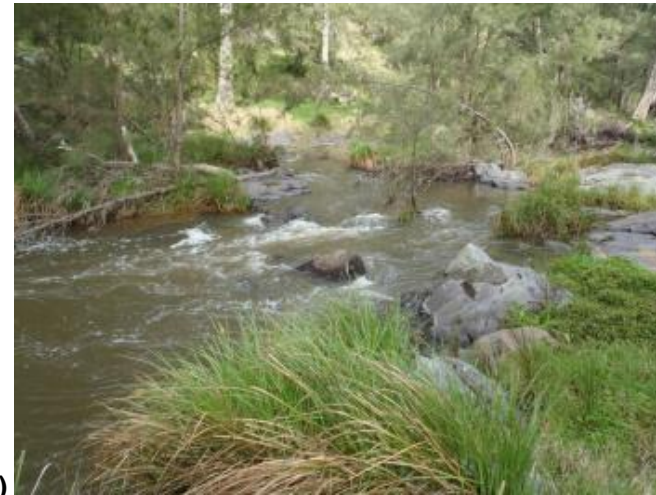
**Plate 7** Coxs River downstream of the South Catchment Unnamed Tributary (Site 11), 18 September 2013: a) looking downstream from the middle of the site at pool habitat; b) looking upstream from near the top of the site at riffle habitat; c) looking downstream near the top of the site at pool habitat; and, d) looking upstream the top of the site at riffle habitat.

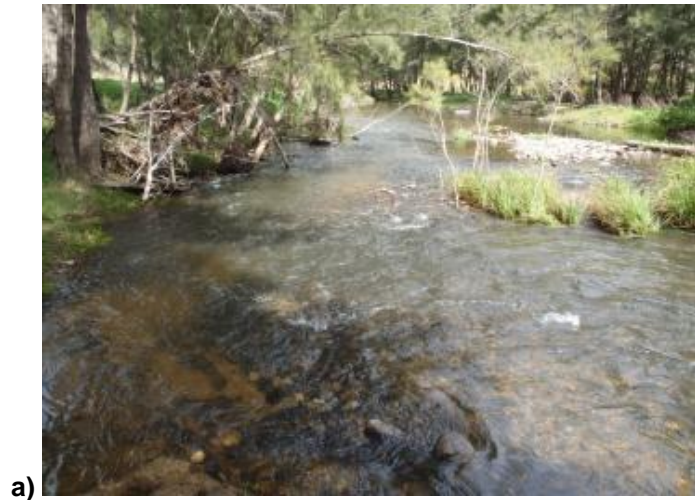
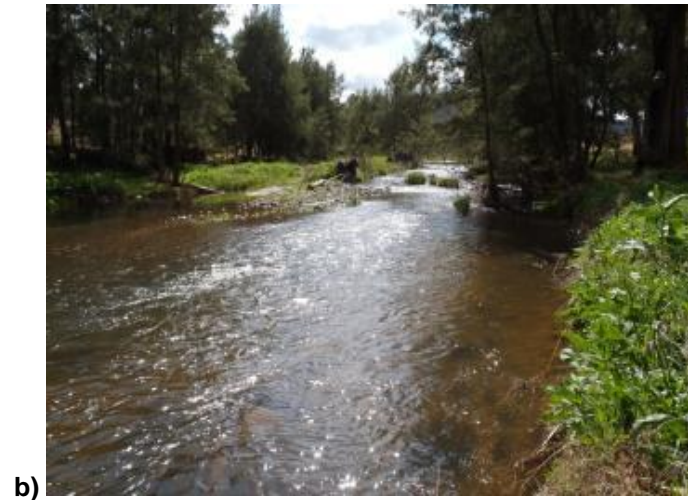
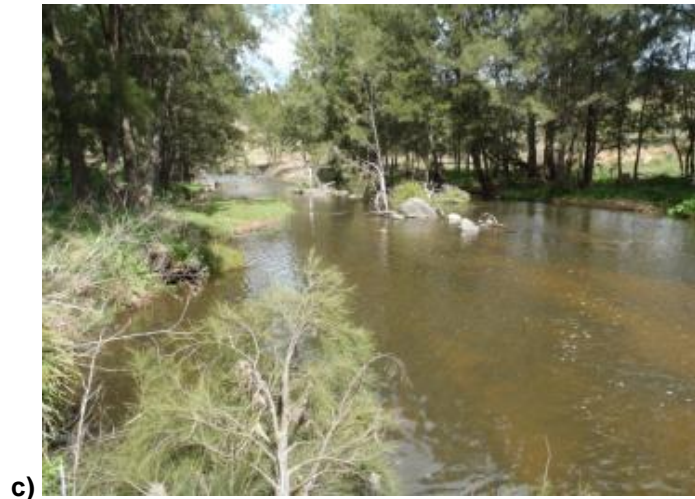
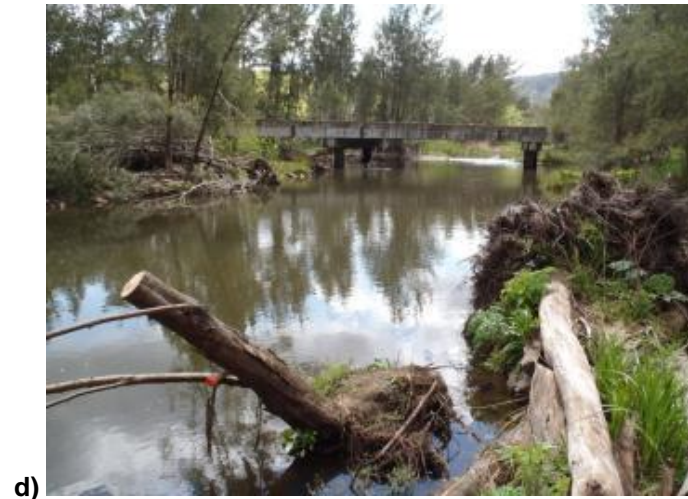
**Plate 8 Coxs River at the Downstream Control location (Site 9), 18 September 2013: a) looking downstream from near the top of the site riffle habitat; b) looking upstream from the middle of the site at riffle habitat; c) looking downstream from the bottom of the site at pool habitat; and, d) looking upstream from near the top of the site at pool habitat and the Duddawarra bridge.**

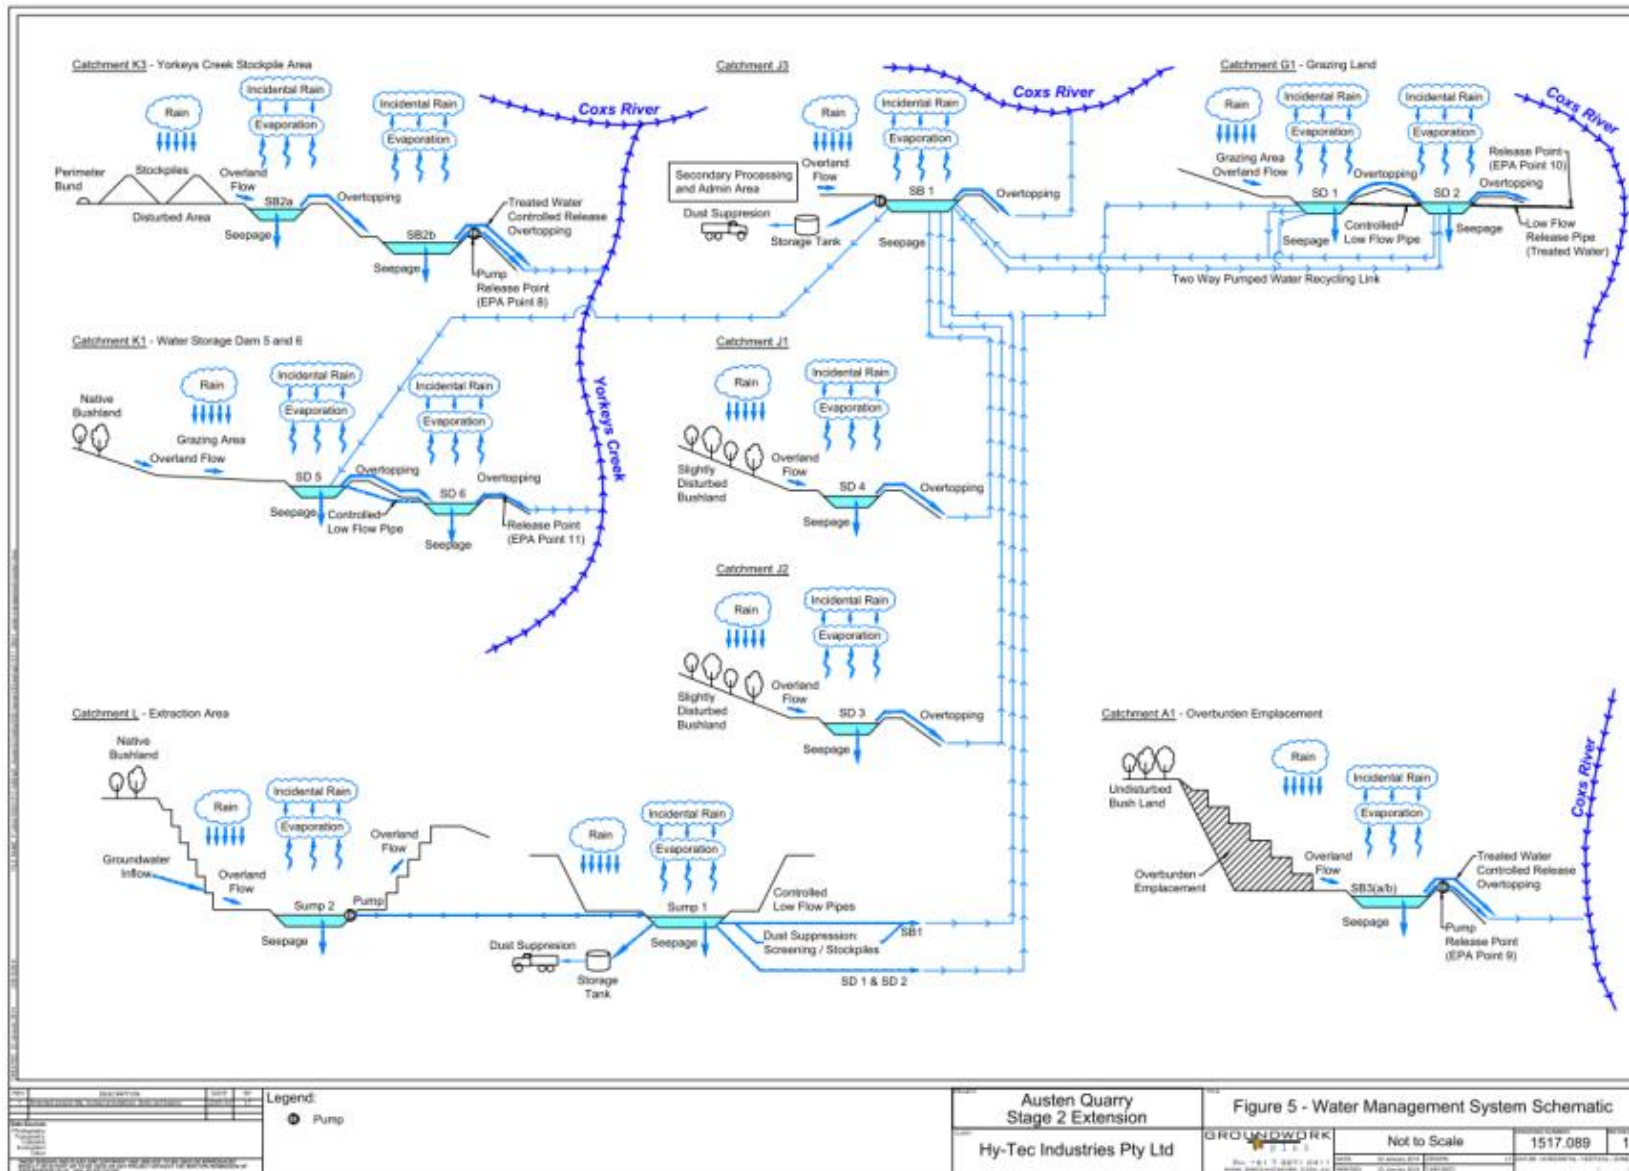
Figure 5-2 Water management diagram for the Stage 2 extension (Groundwater plus 2014)
