2018 Annual Review

Tinda Creek Quarry

R.W. CORKERY & CO. PTY. LIMITED

Period: 1 January 2018 to 31 December 2018

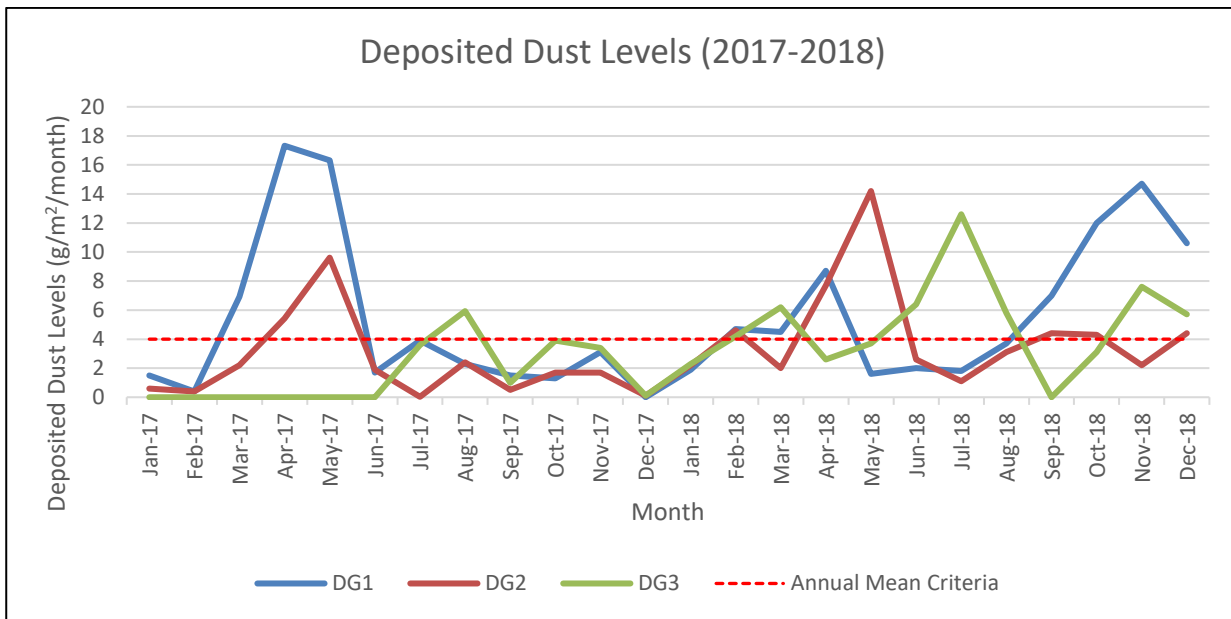
Figure 4 Deposited Dust Levels for 2017 and 2018

It is noted that observations made by ALS during monthly deposited dust monitoring recorded consistently high levels of insects, organic matter and bird droppings in samples. **Appendix 3** presents a summary of analysis observations for the reporting period. Representative dust samples collected in March and April were also sent for further analysis at a laboratory operated by UQ Materials Performance. Samples were examined by stereo and scanning electron microscopy in order to ascertain the composition of the materials present in the samples. High levels of polysaccharide slime and fungi, insect debris and plant debris were typical in all samples accounting for between 20% to 35% of total particle types. It is, therefore, appropriate to consider that samples showing high deposited dust levels do not accurately reflect quarry-generated dust.

It is further noted that Hy-Tec installed bird deterrence collars on all dust gauges on 4 January 2019 in an effort deter birds from landing on the gauges and introducing matter into the gauge when perching on the edge. **Plate 6** displays a dust gauge with the installed bird control. It is considered that the bird controls do not influence air flow in the vicinity of the gauges and that the gauges remain consistent with the *Approved methods for the sampling as analysis of air pollutants* (DEC, 2007) The installation of the bird deterrence has resulted in a significant drop in deposited dust levels with results of <math><0.1\text{g/m}^2</math> (DG1), 1.1g/m^2 (DG2) and <math><0.01\text{g/m}^2</math> (DG3) recorded in January 2019. It is appropriate to conclude that the bird spikes have contributed to the reduction in deposited dust since their installation. As these results are more in line with expectations presented in the EIS it is considered that birds were in fact contributing to the dust recorded each month. Hy-Tec will continue to monitor the deposited dust levels during the next reporting period to confirm the ongoing effectiveness of the bird controls.

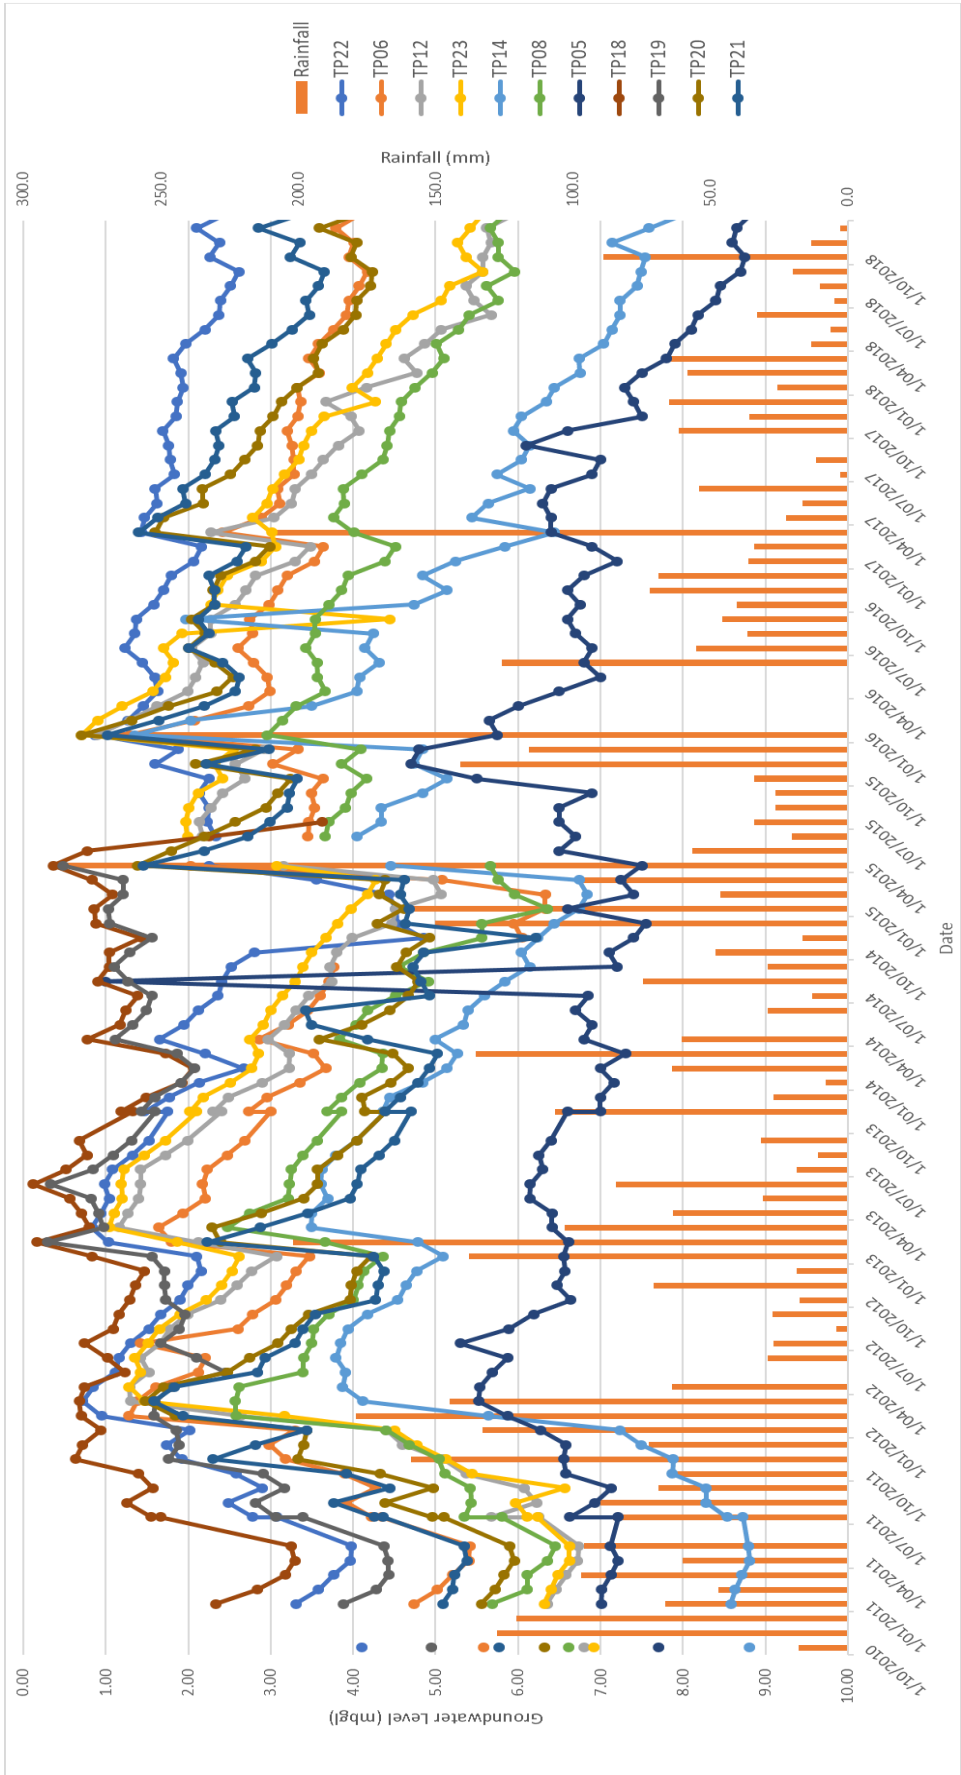
Figure 5 Hydrography for Site Bore with Monthly Rainfall

No exceedances of the relevant groundwater trigger levels were noted during the reporting period except at TP05 which exceeded the relevant trigger level from September 2018 to December 2018. **Figure 5** displays hydrographs for site bores with monthly rainfall which clearly shows that groundwater levels respond quickly to recharge.

Figure 5 also clearly displays the effects of the weather experienced throughout 2018 with groundwater levels falling consistently throughout the reporting period in response to atypically dry conditions.

Monitoring bore TP5 is located to the south of the Domain 6 and recorded a decline in groundwater level of 1.7 m in the period from October 2017 to October 2018. This decline in water level exceeded the trigger set in the approved *Water Management Plan*.

A groundwater investigation was undertaken by Ms Katarina David in December 2018 to understand the driver for the change in groundwater level at TP05. This report was submitted to DPE on 7 December 2018 and is included in full as **Appendix 5**. It is noted that Hy-Tec has not yet received any formal correspondence from DPE regarding this investigation.

The groundwater investigation noted that the observed change in groundwater levels across the site during 2018 coincided with a prolonged absence of rain. The investigation concluded that the decline in groundwater levels at TP05 was mostly attributable to a reduction in rainfall. This conclusion was based on comparison with historical data and other bores located upgradient or downgradient and not considered to be influenced by site activities. It was determined that the variables that could not be explained by the model were likely due to Quarry operations, primarily due to the proximity of TP05 to the extraction area. These variables included temporary changes in drainage patterns, soil consolidation and/or temporary disturbance of groundwater levels during the extraction of sand. The variables were considered to be within the natural seasonal variation and were determined to only contribute to minor groundwater level changes.

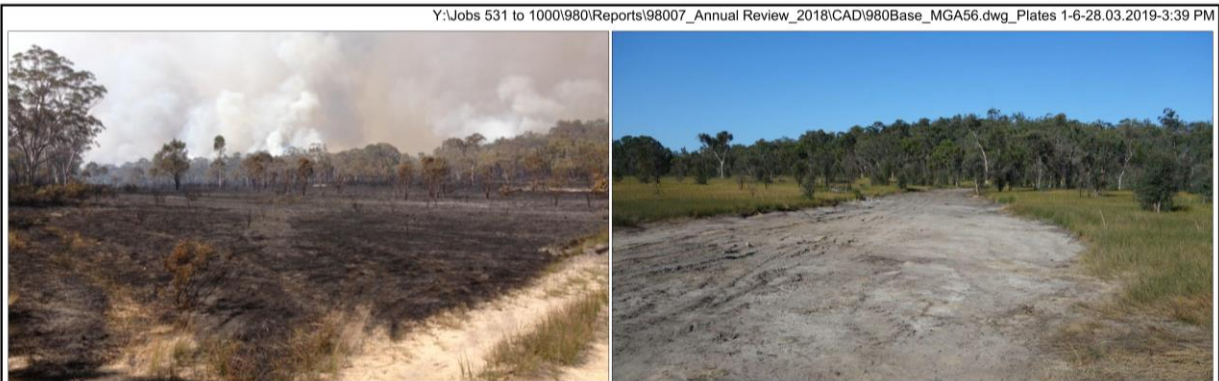
Plate 11: View of the Mellong Sandmass Sedgeland immediately after bushfires in October 2013 (left) and one year later (right)
(Photo source: HyTec)

Hy-Tec considers that the potential for successful rehabilitation of the Quarry Site remains positive. During the life of the Quarry, natural regeneration following bush fire has demonstrated the natural resilience of the vegetation. **Plate 11** presents photos of the Mellong Sandmass Sedgeland immediately after fires in October 2013 and the same location in October 2014. Quarry personnel report that within a matter of months the vegetation was re-establishing and within one year there was almost no evidence of the fire.

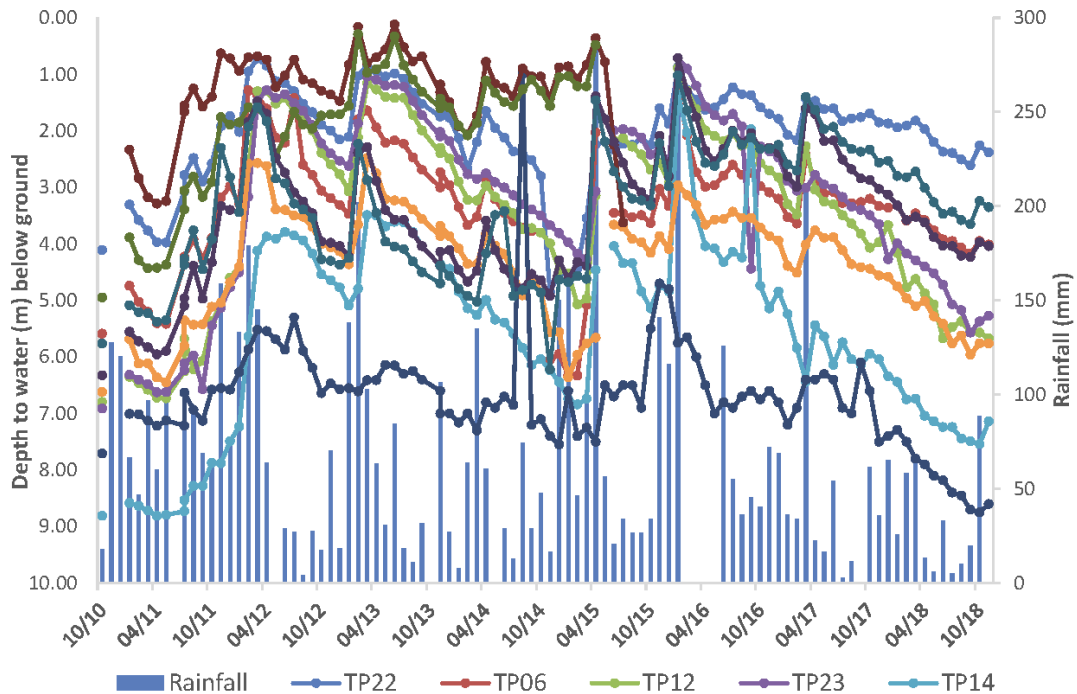
Figure 3 Hydrographs for site bores with monthly rainfall

Positive, rising trends in RM represent above average rainfall periods and negative trends represent below average rainfall periods. The RM curve helps interpretation of the water level fluctuations and allows differentiation between climate and other impacts on groundwater.

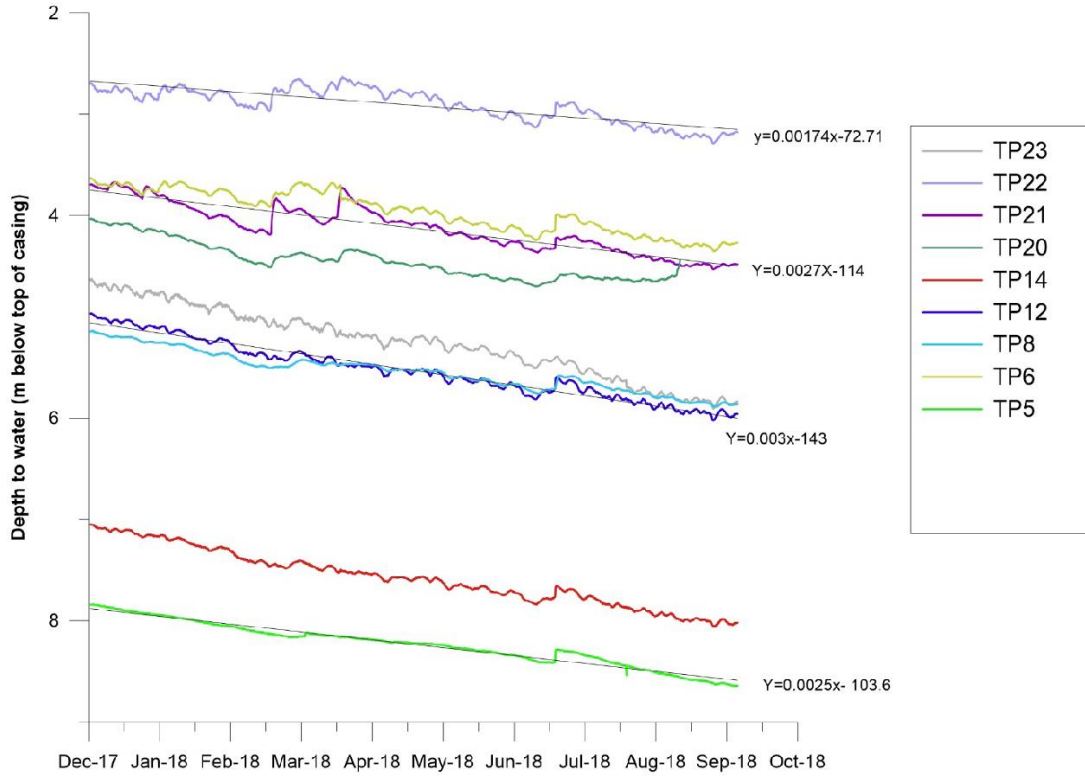
Figure 6 High frequency groundwater data (4 hourly) plotted with linear regression for TP5 and upgradient bores

The slope of linear regression for these bores varies in a small range from 0.0017 to 0.003 with a high R-squared indicating similar trend (Figure 6) in both upgradient and downgradient bores compared to TP5. Overall, based on the linear regression, the variation in groundwater levels in TP5 during 2018 is observed to be consistent with changes in upgradient and downgradient bores.

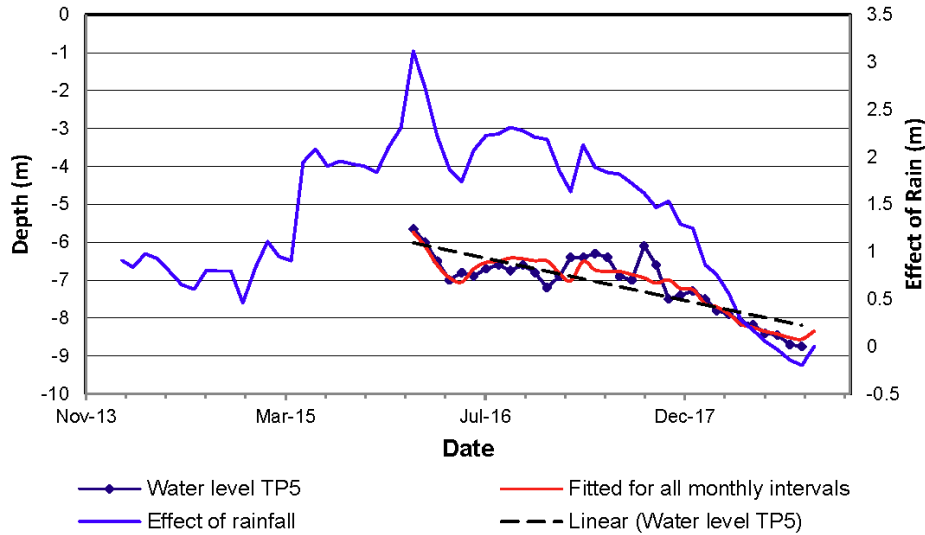
Figure 8 Water levels with accumulative monthly residual rainfall for TP5 (1 months delay)

There has been no change in standard deviation from long term average for individual bores since late 2017. This indicates that site groundwater conditions have not changed.

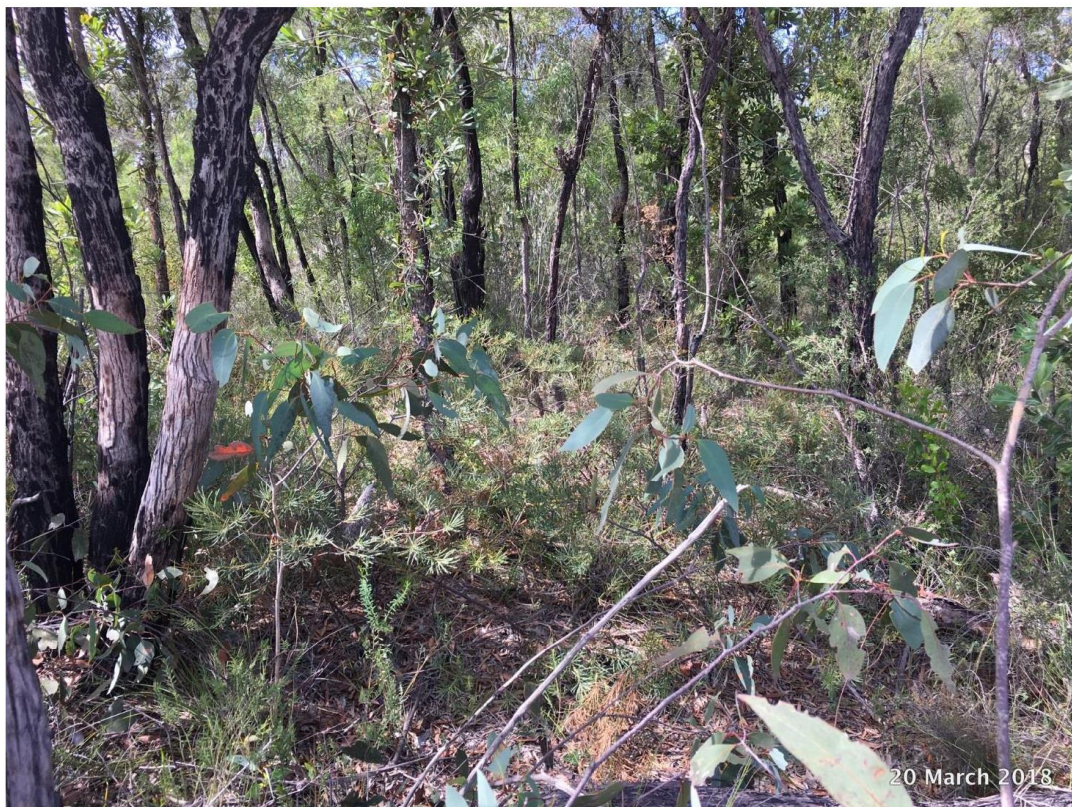
An additional photo point was established at the edge of the approved disturbance area (about 7 metres north of plot 1) with photos taken looking south-east (Plate 2) and south west (Plate 3).

Plate 2: Additional photo point looking south-east

Because the photo point is at the edge of the disturbance, any continuing encroachment of the pit into the *Grevillea parviflora* habitat will be relatively obvious

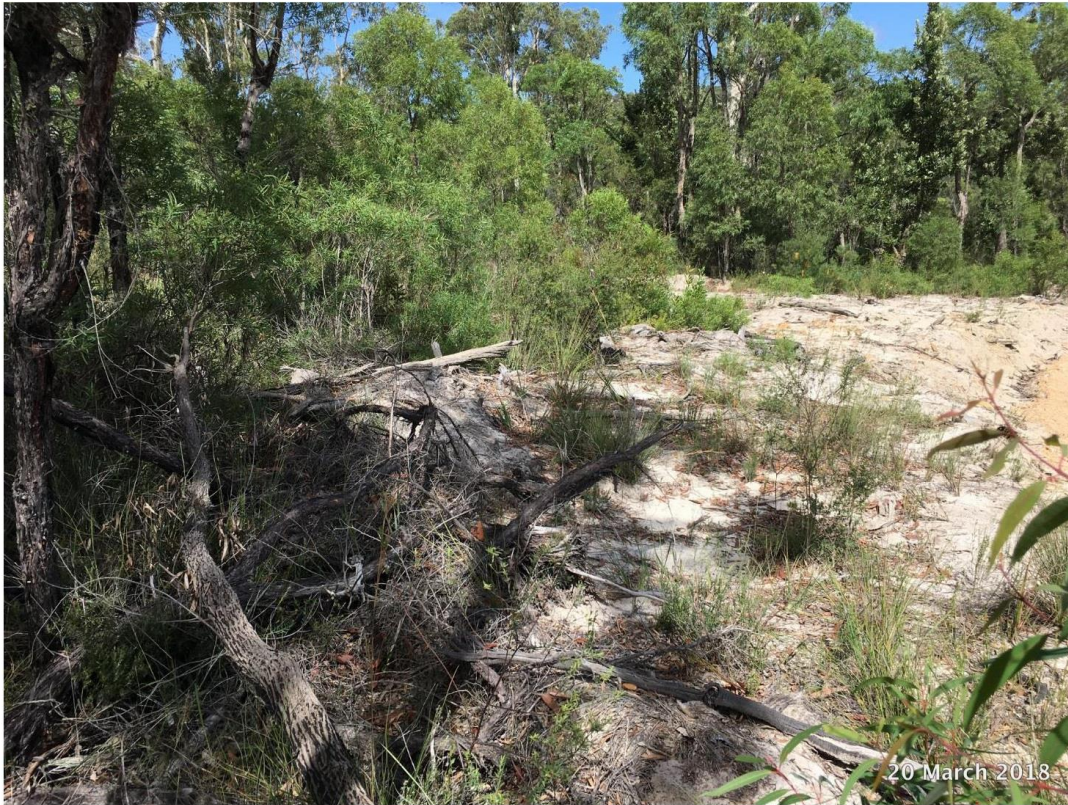
Plate 3: Additional photo point looking south-west

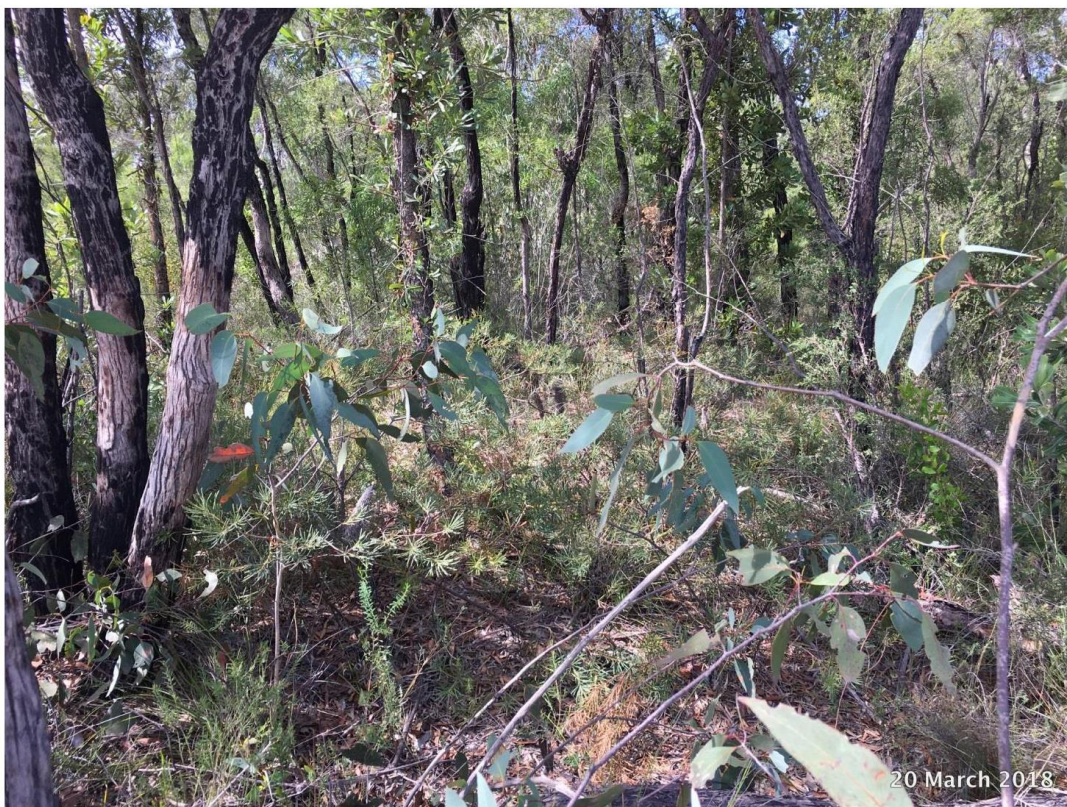
Plate 2: Additional photo point looking south-east

An additional photo point was established at the edge of the approved disturbance area (about 7 metres north of plot 1) with photos taken looking south-east (Plate 2) and south west (Plate 3).

Because the photo point is at the edge of the disturbance, any continuing encroachment of the pit into the *Grevillea parviflora* subsp. *parviflora* habitat will be relatively obvious.

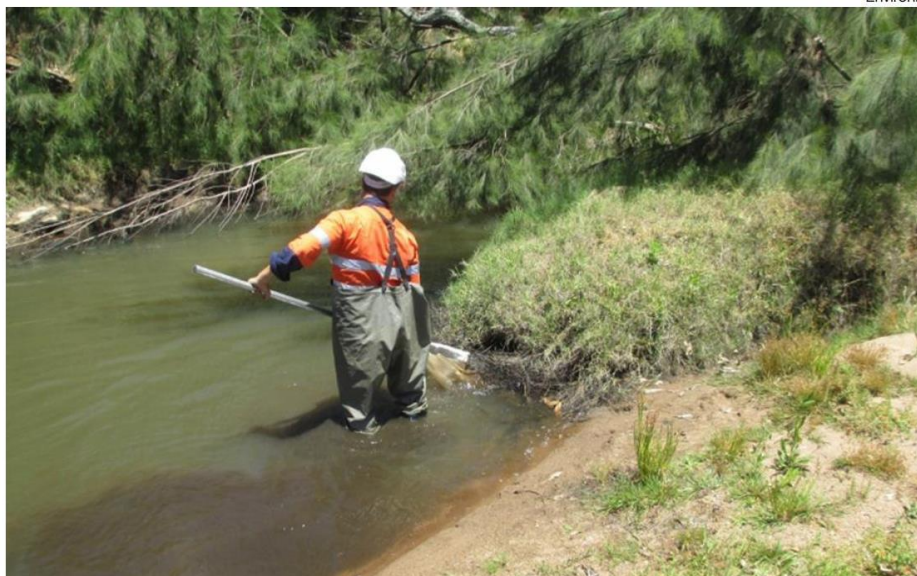
Plate 1: Sampling method

Samples of macroinvertebrates were collected from pool edges for a length of 10 metres, either as a continuous line or in disconnected segments. Sampling in segments was often undertaken to ensure the sampling of sub-habitats such as macrophyte beds, bank overhangs, submerged branches and root mats. Segmented sampling was also employed where pool length was short and it was logistically difficult to sample in a continuous line (e.g. in-stream logs). A 250 µm dip net was drawn through the water with short sweeps towards the bank to dislodge benthic fauna while scraping submerged rocks and debris, sides of the stream bank and the bed substrate (Plate 1). Further sweeps in the water column targeted the suspended fauna.

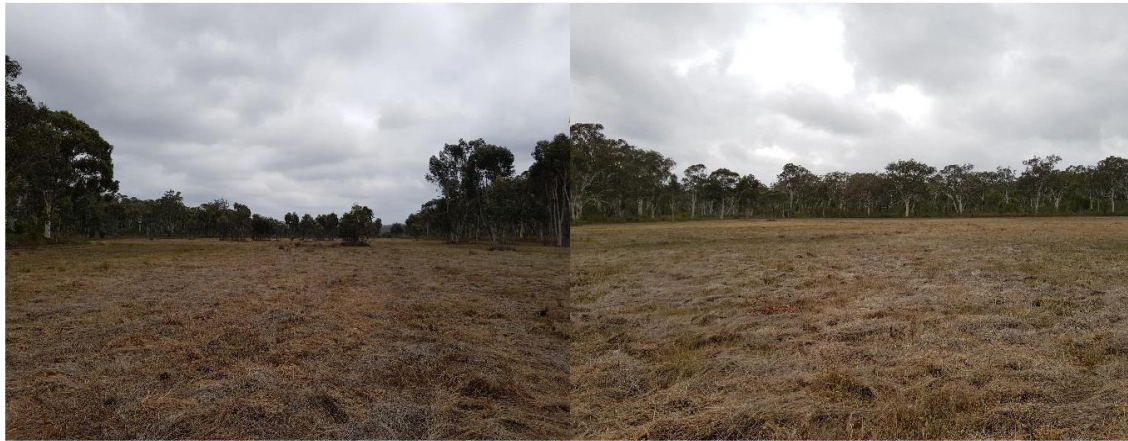
The aquatic habitat at Site 1 (Plate 2) at the time of the spring 2018 monitoring surveys is detailed in Table 6.

Site 1 Downstream

Site 1 Upstream

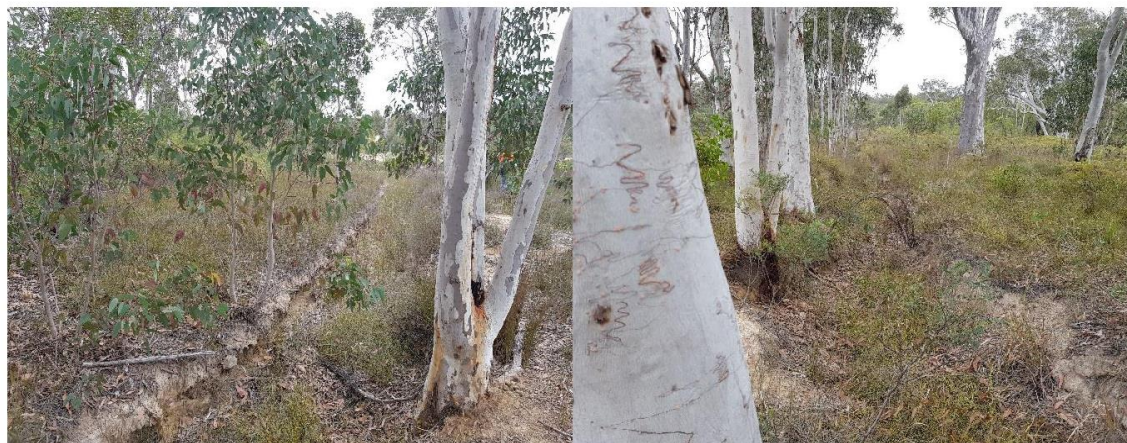
The aquatic habitat at Site 2 (Plate 3) at the time of the spring 2018 monitoring surveys is detailed in Table 7.

Site 2 Downstream

Site 2 Upstream

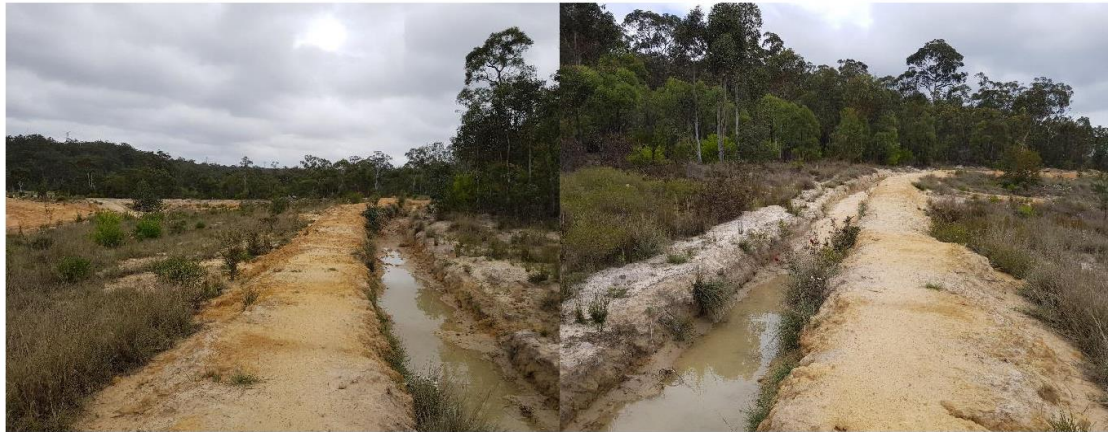
The aquatic habitat at Site 3 (Plate 4) at the time of the spring 2018 monitoring surveys is detailed in Table 8.

Site 3 Downstream

Site 3 Upstream

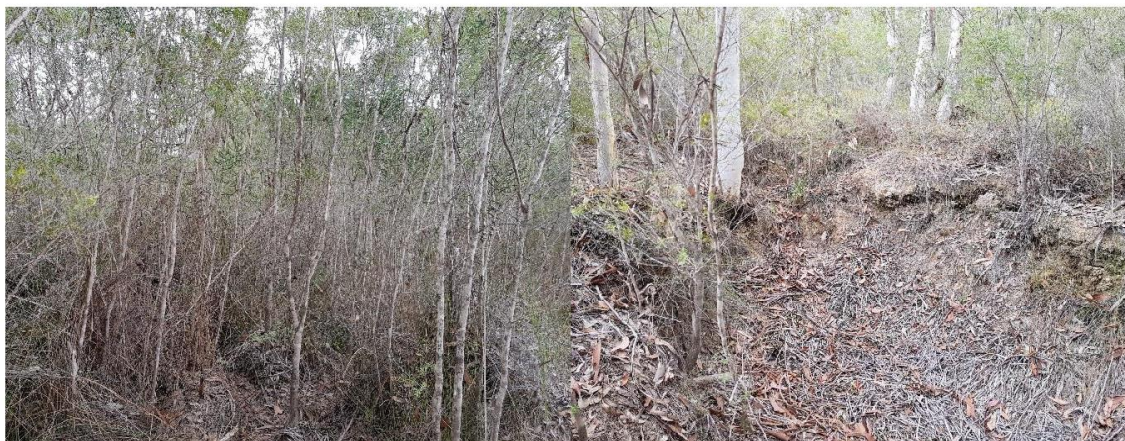
The aquatic habitat at Site 4 (Plate 5) at the time of the spring 2018 monitoring surveys is detailed in Table 9.

Site 4 Downstream

Site 4 Upstream

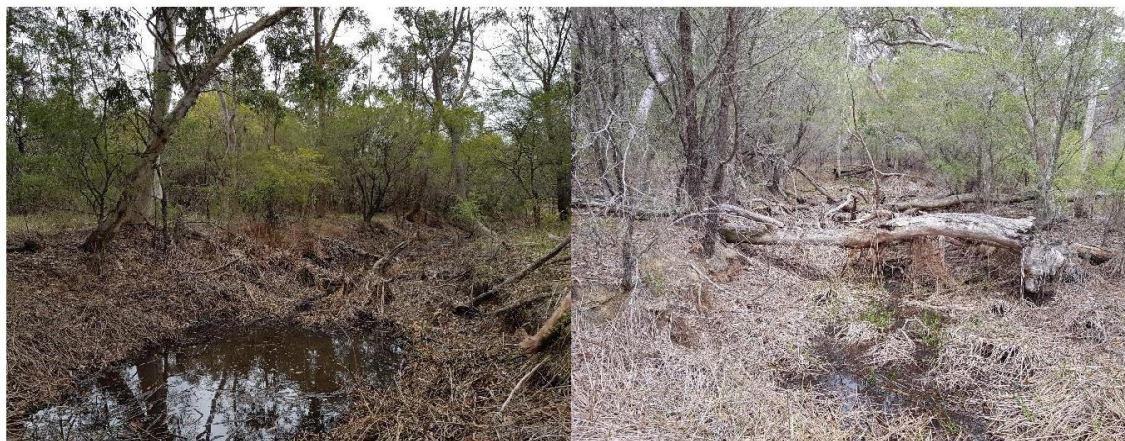
The aquatic habitat at Site 5 (Plate 6) at the time of the spring 2018 monitoring surveys is detailed in Table 10.

Site 5 Downstream

Site 5 Upstream

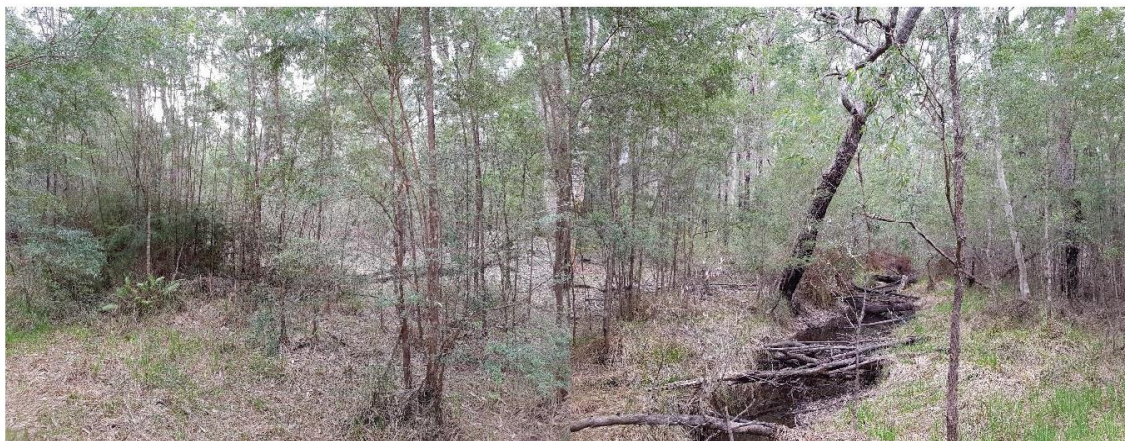
Plate 7: Site 6

The aquatic habitat at Site 6 (Plate 7) at the time of the spring 2018 monitoring surveys is detailed in Table 11.

Attribute	Site 6
	Photograph	Plate 7
Riparian characteristics	RCE score	46
	Vegetation	Forest Red Gum (<i>Eucalyptus tereticornis</i>), White Stringybark (<i>E. globoidea</i>). The mid-storey was dominated by small trees and tall shrubs. The ground cover consisted of native grasses, herbs and ferns.
	Stream shading	Moderate/High
	Exotic vegetation	-
Stream characteristics	Modal width (m)	<3m
	Substrate	Sand 20%, silt 80%
	Flow/depth	Low flow/<1m
	Macrophytes/algae	Macrophytes regenerating
	Water quality observations	Stained
Comments	No flow, stagnant tannin stained pools.

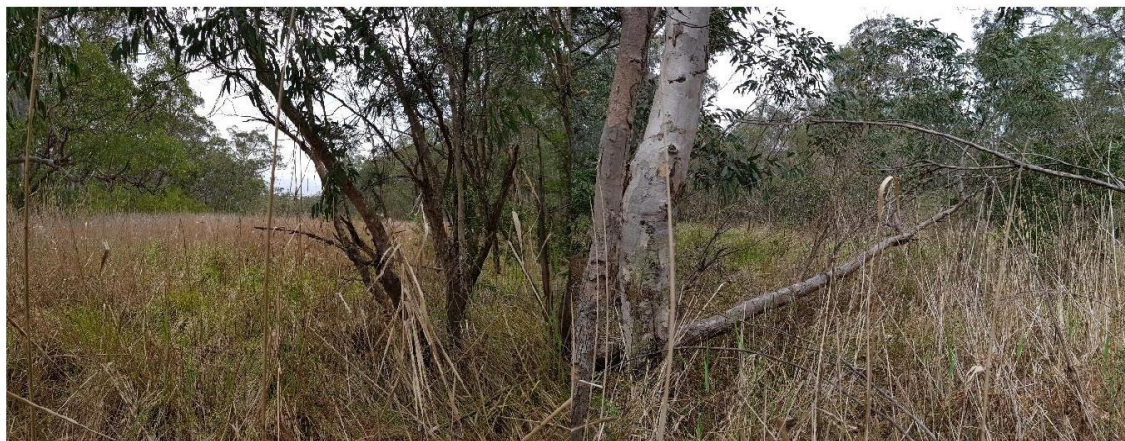
Plate 8: Site 7

The aquatic habitat at Site 7 (Plate 8) at the time of the spring 2018 monitoring surveys is detailed in Table 12.

Attribute	Site 7
	Photograph	Plate 8
Riparian characteristics	RCE score	46
	Vegetation	Canopy vegetation included Grey Gums and Scribbly Gums. The mid-storey was absent. The ground cover consisted of by native grasses, herbs and ferns, as well as Macrophytes.
	Stream shading	Low/moderate
	Exotic vegetation	-
Stream characteristics	Modal width (m)	<5m
	Substrate	Silt 100%
	Flow/depth	No flow/ Dry
	Macrophytes/algae	Cattail Bulrush (<i>Typha</i>)
	Water quality observations	No surface pools
Comments		No Surface water. Overgrown creek bed.

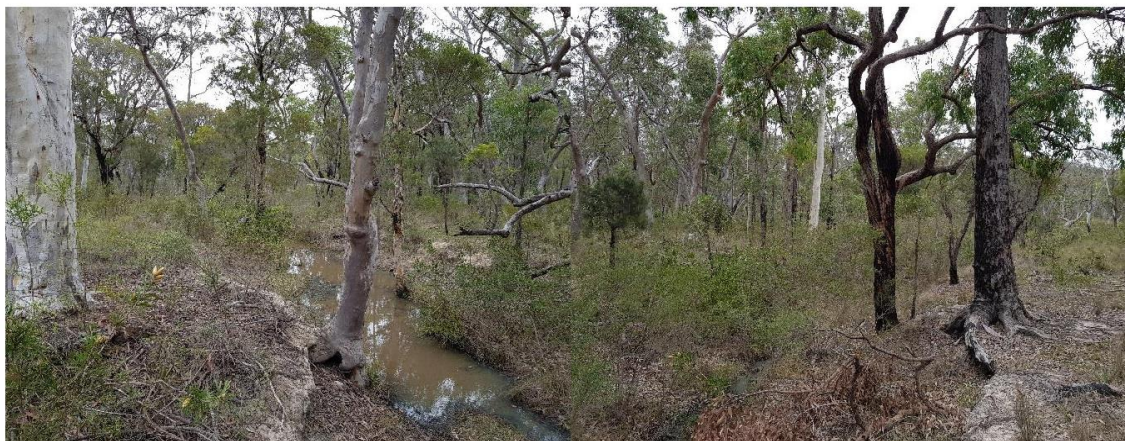
The aquatic habitat at Site 8 (Plate 7) at the time of the spring 2018 monitoring surveys is detailed in Table 13.

Attribute	Site 8
	Photograph	Plate 7
Riparian characteristics	RCE score	46
	Vegetation	Canopy vegetation composed of Grey Gums and Scribbly gums. The mid-storey was dominated by tall shrubs. The ground cover consisted of native grasses, herbs and ferns along with Eucalyptus regeneration and casuarina regeneration.
	Stream shading	Moderate/High
	Exotic vegetation	-
Stream characteristics	Modal width (m)	<2m
	Substrate	Pebble 30%, sand 20%, silt 50%
	Flow/depth	Low flow/<1m
	Macrophytes/algae	Absent-
	Water quality observations	Turbid
Comments		No flow, isolated pools.

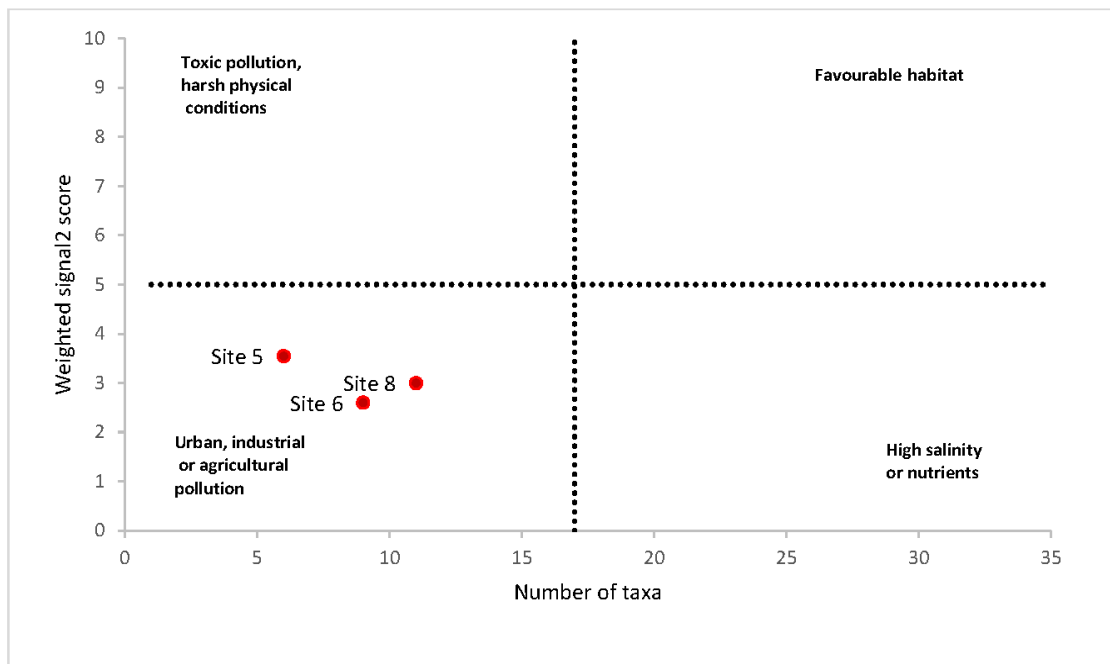
Figure 3. SIGNAL2 Bi-plot

macroinvertebrate communities. However this result can be typical for low flow/ intermittent upland streams. The SIGNAL2 scores indicate that the streams may have a dominance of pollution-tolerant taxa (Table 4). Pollution-sensitive taxa Leptophlebiidae (SIGNAL 8) and Leptoceridae (SIGNAL 6) were observed at Site 8. Other pollution-sensitive taxa (Signal ≥ 6) were Acarina (SIGNAL 6) at Site 5. The SIGNAL biplot (Figure 3), indicates that no sites have favourable aquatic habitat and all locations are exhibiting some form of pollution or natural stress. However, this appears typical for streams in the area as Site 8 also is present in this quadrant. Downstream site SIGNAL2 scores were slightly lower than respective upstream sites (Site 5), however had a slightly higher number of taxa present in the samples.

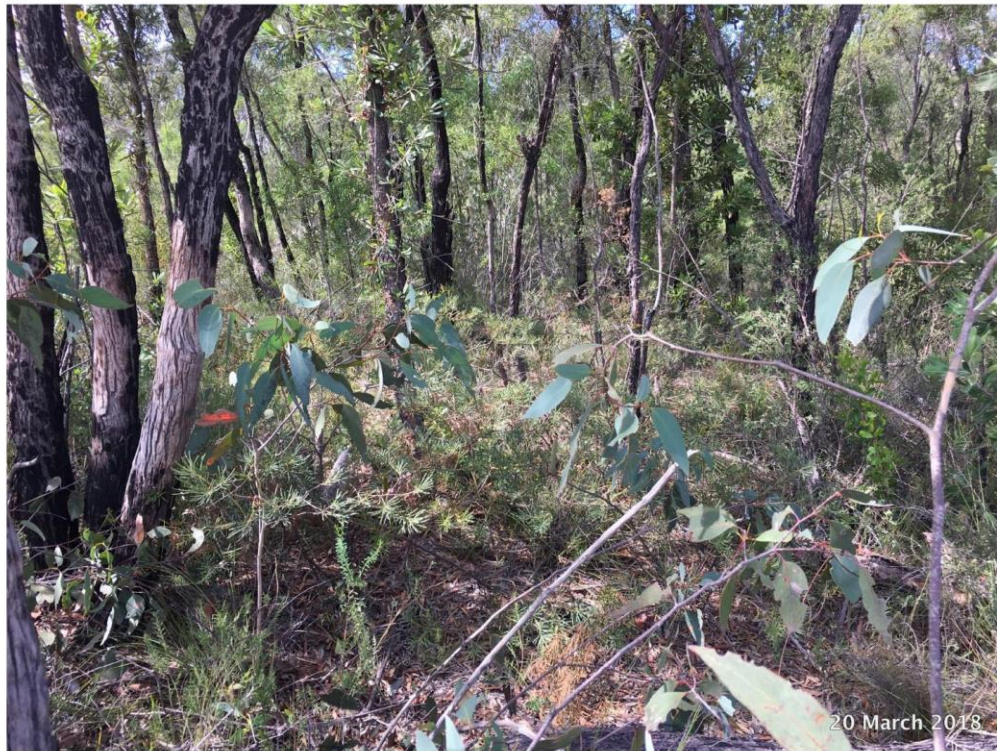
Plate 2: Additional photo point looking south-east

An additional photo point was established at the edge of the approved disturbance area (about 7 metres north of plot 1) with photos taken looking south-east (Plate 2) and south west (Plate 3).

Because the photo point is at the edge of the disturbance, any continuing encroachment of the pit into the *Grevillea parviflora* habitat will be relatively obvious

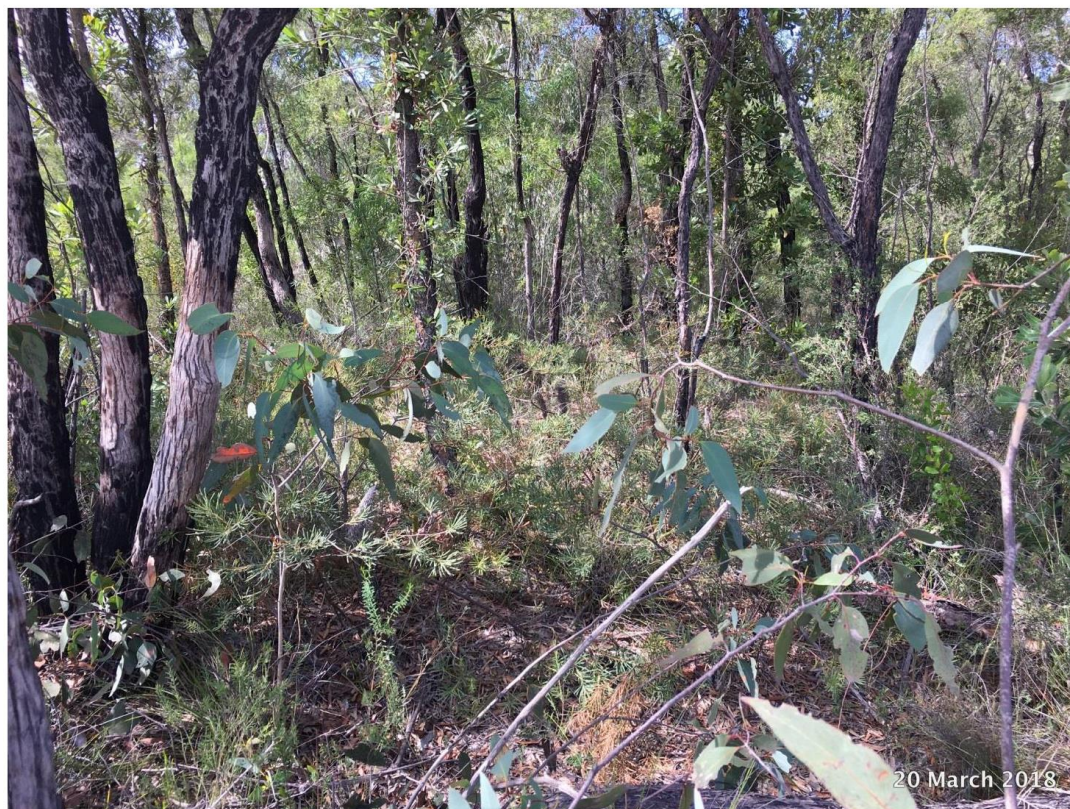
Plate 2: Additional photo point looking south-east

An additional photo point was established at the edge of the approved disturbance area (about 7 metres north of plot 1) with photos taken looking south-east (Plate 2) and south west (Plate 3).

Because the photo point is at the edge of the disturbance, any continuing encroachment of the pit into the *Grevillea parviflora* subsp. *parviflora* habitat will be relatively obvious.
