# Noise Monitoring Assessment

Austen Quarry, Hartley, NSW.

Prepared for : R.W. Corkery & Co. Pty Limited  
December 2017

Document ID	Status	Date	Prepared By	Signed	Reviewed By	Signed
MAC170523RP2V01	Final	14 December 2017	Robin Heaton	<i>Robin Heaton</i>	Oliver Muller	<i>OM</i>

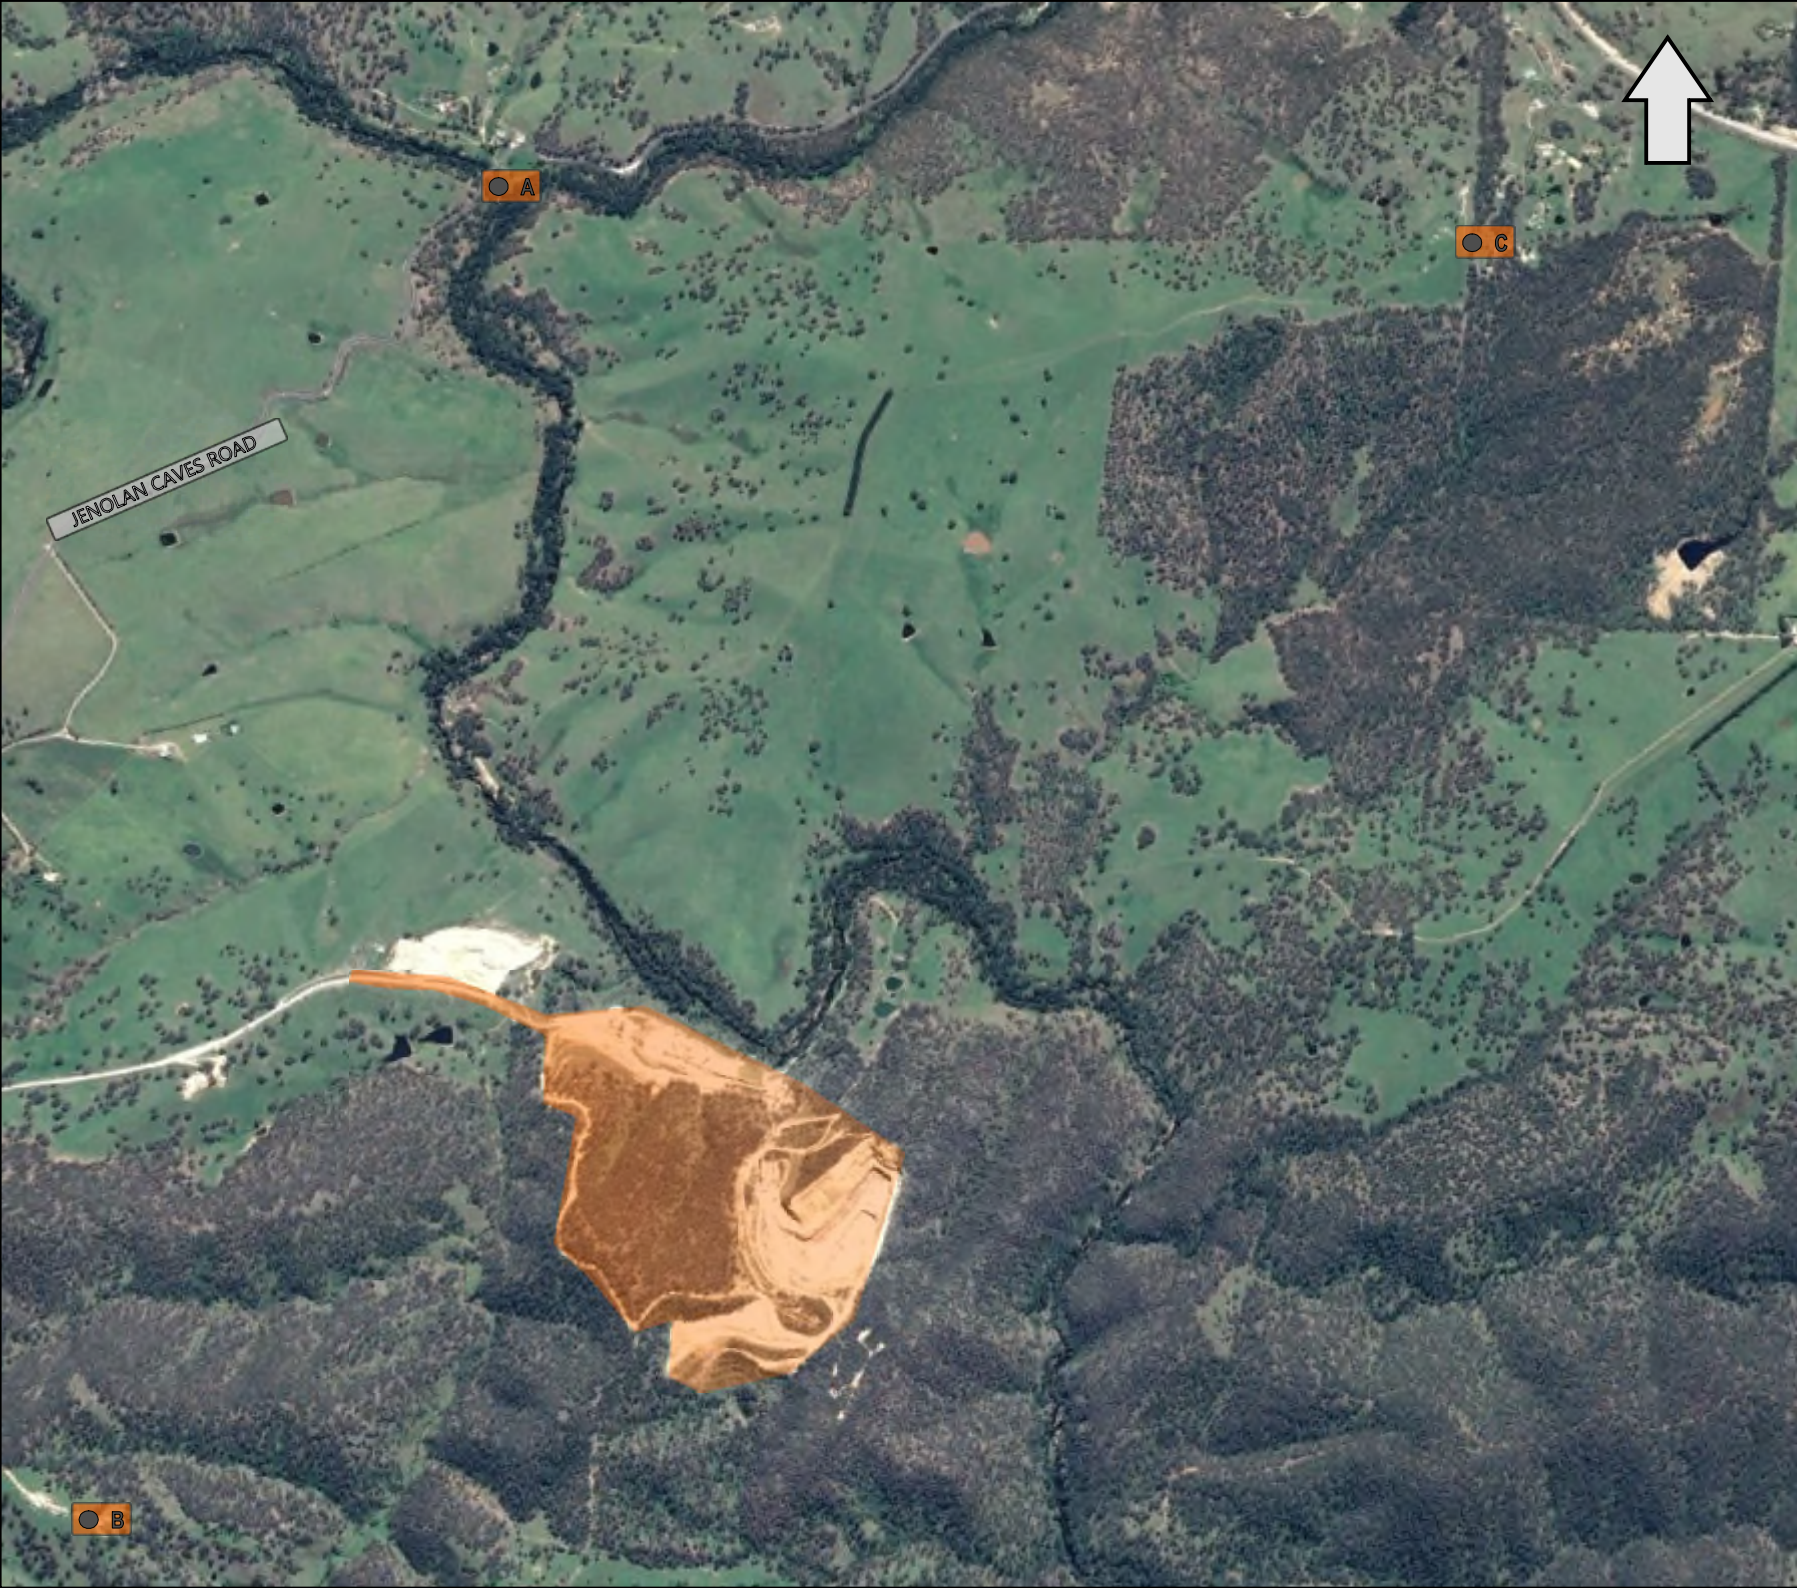
**FIGURE 1**  
**LOCALITY PLAN**  
REF: MAC170523

- Location A (residence identifier R24A as per NMP), is located at 200 Jenolan Caves Road approximately 2.5km north of the project;
- Location B (residence identifier R31 as per NMP), is located at 781 Jenolan Caves Road and approximately 1km south west of the project site; and
- Location C (residential identifier R48 as per NMP) located at 64 Carrol Drive, Hartley which is approximately 2.5km north east of the quarry.

The monitoring locations with respect to quarry location are presented in the locality plan shown in **Figure 1**.
