2020 Annual Review

Tinda Creek Quarry

R.W. CORKERY & CO. PTY. LIMITED

Period: 1 January 2020 to 31 December 2020

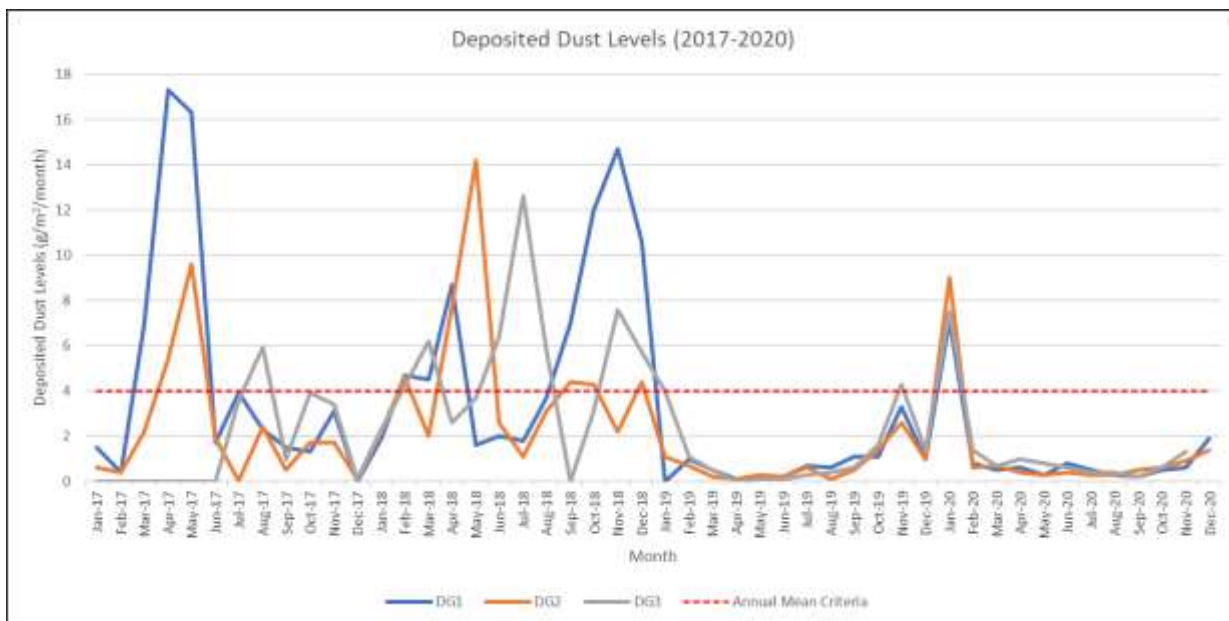
Figure 4 Deposited Dust Levels 2017 to 2020

Monthly deposited dust monitoring was undertaken throughout the reporting period. The location of dust monitoring gauges DG1, DG2 and DG3 are shown on **Figure 3**. **Figure 4** and **Table 6.3** present the results of the deposited dust monitoring program over the reporting period. It is noted that the approved Air Quality Management Plan requires deposited dust monitoring at location DG1 only. Monitoring at locations DG2 and DG3 is undertaken on a voluntary basis and therefore is not subject to compliance under SSD 4978.

Date	Deposited Dust Level ¹			Criterion
	DG1	DG2	DG3	
January	7.1	9.0	7.5	-
February	0.8	0.6	1.4	-
March	0.5	0.7	0.7	-
April	0.6	0.4	1.0	-
May	0.3	0.3	0.8	-
June	0.8	0.4	0.6	-
July	0.5	0.3	0.4	-
August	0.3	0.3	0.4	-
September	0.2	0.5	0.2	-
October	0.5	0.6	0.6	-
November ²	0.6	0.9	1.3	-
December	1.9	1.4	NR	-
Annual Average	1.1	1.3	1.4	4

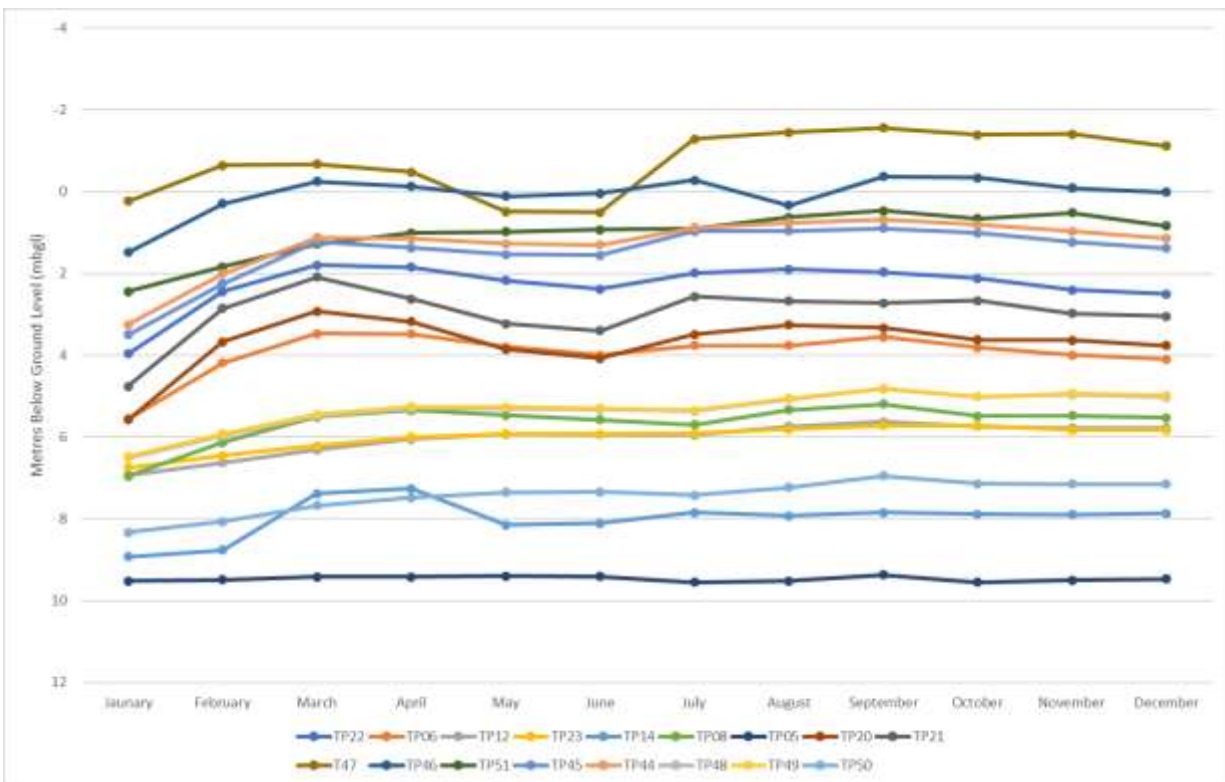
Figure 5 2020 Groundwater Level Monitoring Results

The results of the 2020 groundwater levels monitoring are outlined in **Table 7.5** and displayed in **Figure 5**. The historical groundwater levels are presented in **Figure 6** and **Figure 7**. Monitoring results are displayed for both the original monitoring bores and the newly constructed bores.

Figure 5, Figure 6 and Figure 7 clearly display the declining trend in groundwater levels evident across all monitoring bores within the monitoring program prior to the reporting period with the rainfall events in January, February and July 2020 resulting in a groundwater level rise or stabilisation of groundwater decline across all bores.

Groundwater levels in monitoring bore TP05 were below the investigation trigger levels for the entire reporting period. Groundwater levels at this bore were also below the investigation trigger level throughout the 2019 reporting period, indicating that this trigger level may no longer be appropriate for this bore. Groundwater levels at TP5 increased only slightly following rainfall events and it is expected that only minor changes to water levels in this bore would occur following prolonged dry or wet weather periods. It is noted that TP5 is expected to be removed during the 2021 reporting period as it is within the approved extraction area. It is envisaged that a replacement bore would be located parallel with TP5 on the opposite side of the Quarry Access Road. The final location of the bore would be presented in an updated Water Management Plan.

Groundwater levels below the investigation trigger level have also been recorded for bores TP12, TP08, TP48, TP45, TP44, TP48, TP49 and TP50 between January and February 2020. These results are considered to have been the result of local drought conditions prior to January 2020 and groundwater levels in all these bores remained above trigger levels following the rainfall events in January and February 2020.

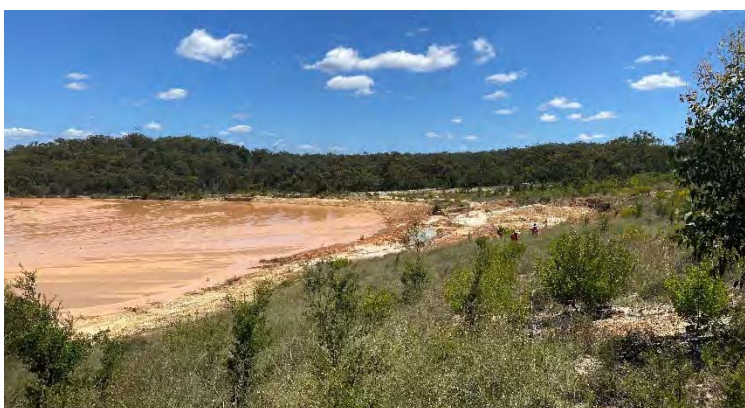
Weed occurrence and abundance appears to be similar to that described in the 2019 monitoring report with the exception of the regeneration area where weed cover has increased from 38% to 46%. The regeneration area is infested with *Eragrostis curvula* (African Lovegrass) along with other less prominent weeds such as *Andropogon virginicus* (Whisky Grass) and *Stenotaphrum secundatum* (Buffalo Grass) (site shown in **Figure 2**).

Figure 2: The regeneration area has a heavy African Lovegrass infestation, increasing from 38% to 46% from the last monitoring survey.

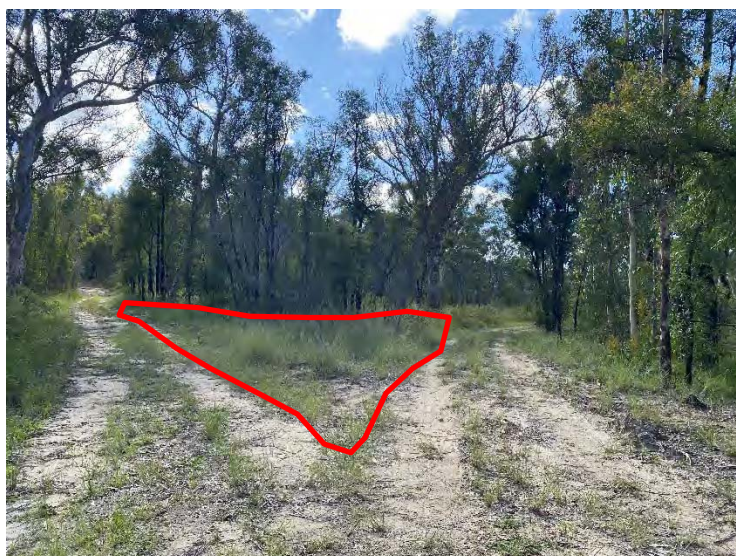
Within the biodiversity offset area, minor areas of concern are scattered along the vehicular tracks, the electricity easement and other small areas previously subject to disturbance (**Map 5**). A similar pattern occurs around the fringes of the offset area (e.g. the works site, front paddock and Putty Road), where weeds encroach into bushland for up to 1 or 2 metres in intermittent locations (**Map 5** and site photos below in **Figure 1**).

Figure 3: African Lovegrass is scattered along tracks within biodiversity offset area, including at this junction in the west of the site

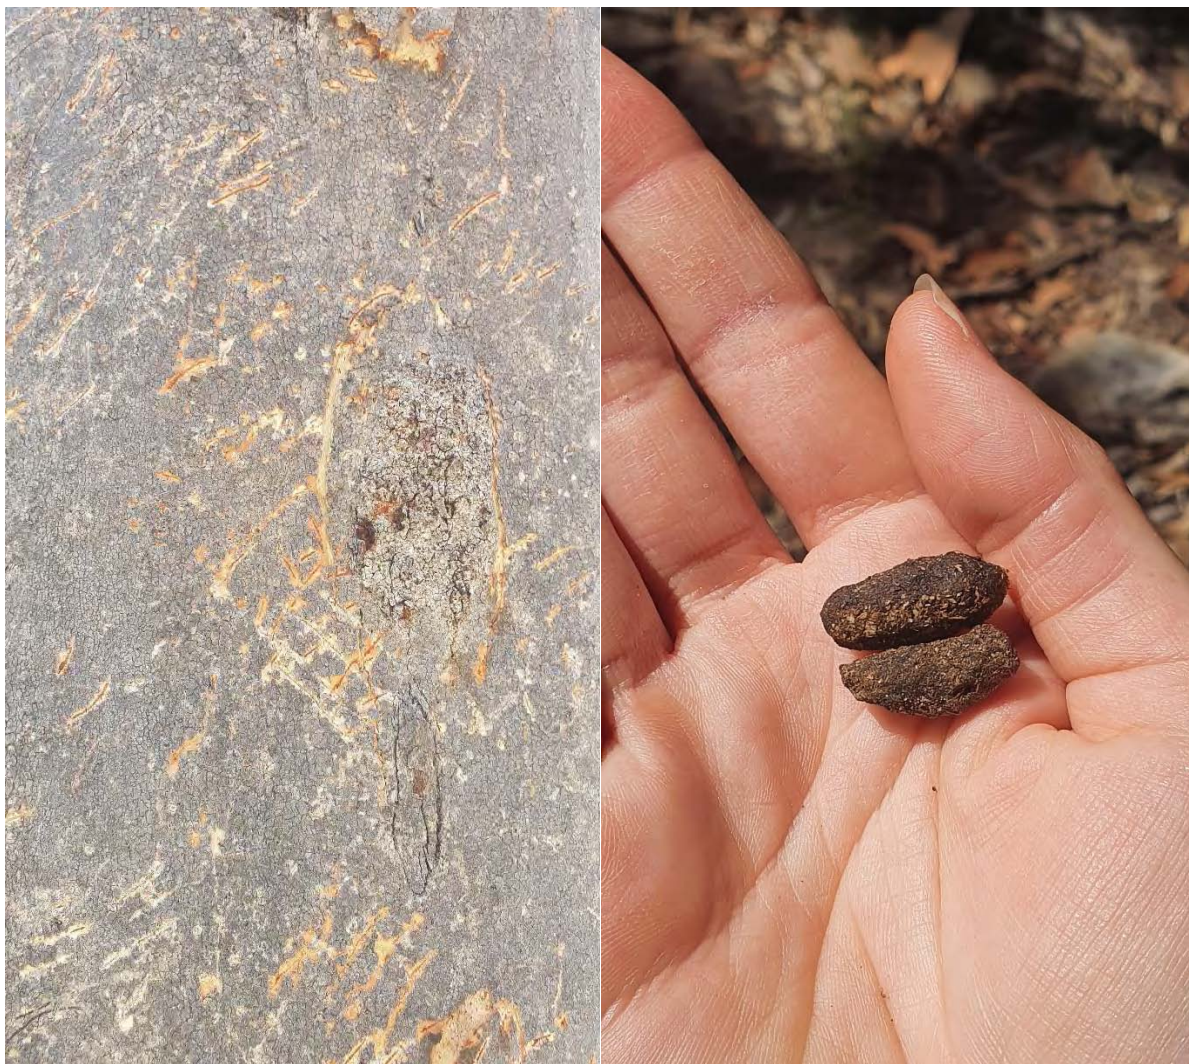
As suggested in the 2018 monitoring by Niche (2019), potential scats and scratch trees are consistent but not definitive evidence of Koala presence. Scratch trees were recorded at a number of sites. The age and density of scratches was also noted as being either a high, moderate or low use tree. An abundance of Possum and Lace Monitor could be responsible for many of the marks left on the trees, however in some instances, both scats and scratch marks consistent with Koala make their presence considerably likely (**Figure 4**). During the current survey, signs of Koala (scats or tree scratches) were found in six of the 17 offset area vegetation plots, namely plots 1, 3, 4, 5, 8, and 13. The 2018 monitoring survey found signs of Koala in plots 11 and 13, while the 2019 monitoring survey found signs in plots 1, 4, 7 and 11.

Figure 4: Scratch trees and scats are evidence of Koala presence.

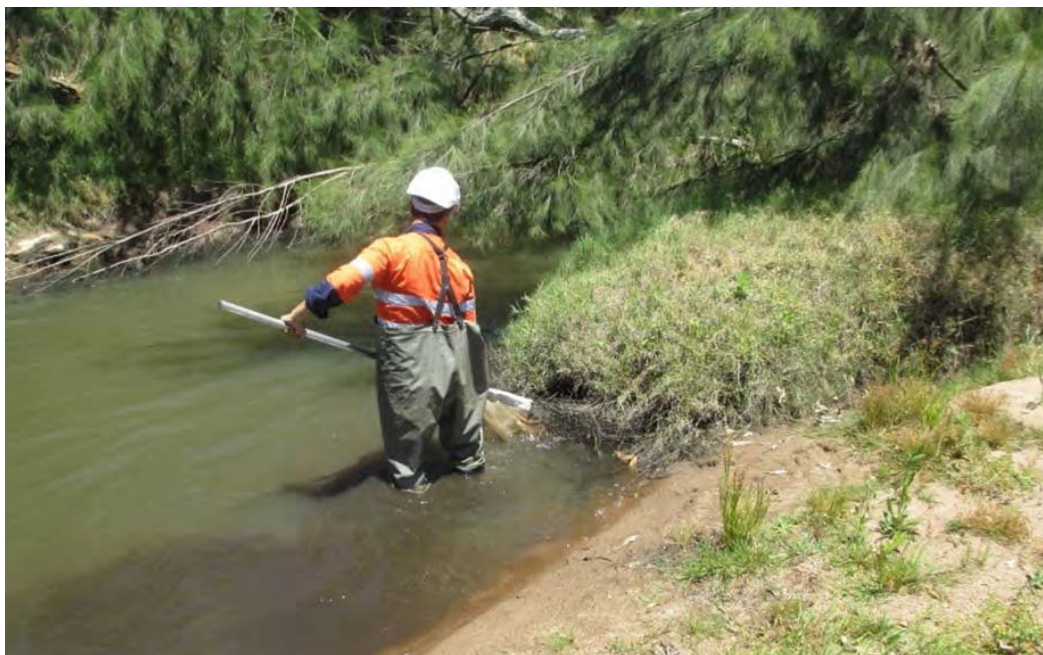
4. OPERATIONS SUMMARY

WAL 24367 and the nominated works approval 10WA112531 permit the use of groundwater sourced via a production bore from the underlying aquifer. This water, when required is used to top up the dredge pond to ensure the dredge can operate efficiently. WAL 24381 and the nominated works approval 10WA112523 permit the use of water accessed from the groundwater setting through extraction activities and principally accounts for evaporation from exposed faces. Anecdotally, Quarry personnel have observed very little seepage into operating domains, however this license accounts for the possible evaporation.

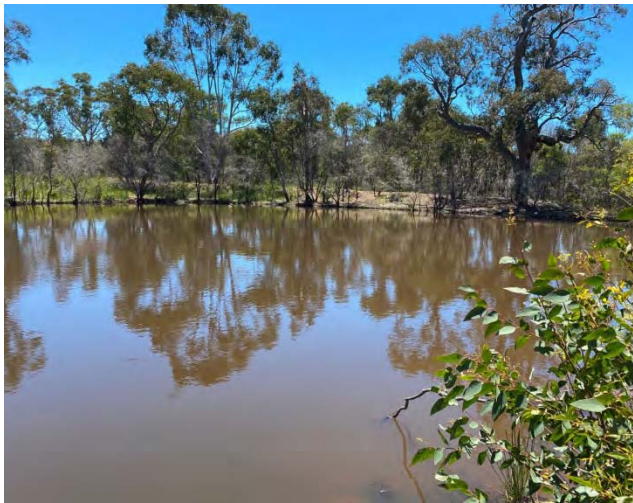
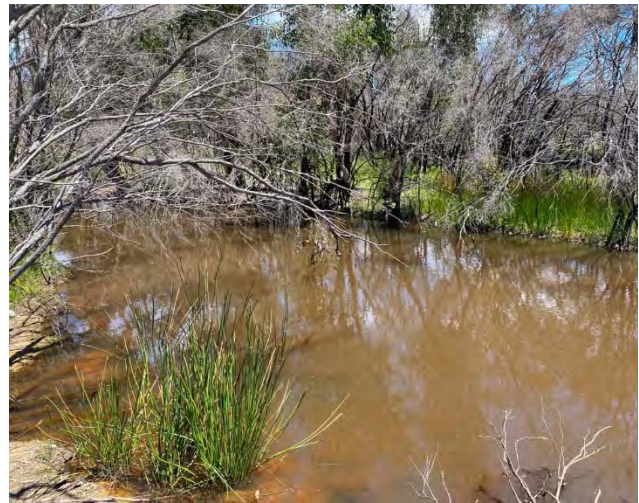
Plate 6: Site 5

Site 5 Downstream

Site 5 Upstream

Attribute	Site 5
	Photograph	Plate 6
Riparian	RCE score	41
	Vegetation	Canopy present and comprised of <i>Eucalyptus haemastoma</i> , Mid-story supporting dense cover of small trees and tall shrubs (<i>Acacia spp</i> and <i>Cassurina spp</i>). There were signs of regrowth of ground covering including regenerative Cat-tailed bulrush (<i>Typha</i>) and Round headed bristle sedge (<i>Chorizandra spaeocephala</i>).
	Stream shading	Low-Moderate
	Exotic vegetation	-
Stream characteristics	Modal width (m)	<4m
	Substrate	Silt 90%, sand 10%
	Flow/depth	No flow/deep >1m
	Macrophytes/algae	Present (<i>Typha</i>)
	Water quality observations	Dam and creek were at bank full with relatively clear water.
Comments		Riparian and macrophyte vegetation present, European carp (<i>Cyprinus carpio</i>) was present in dam

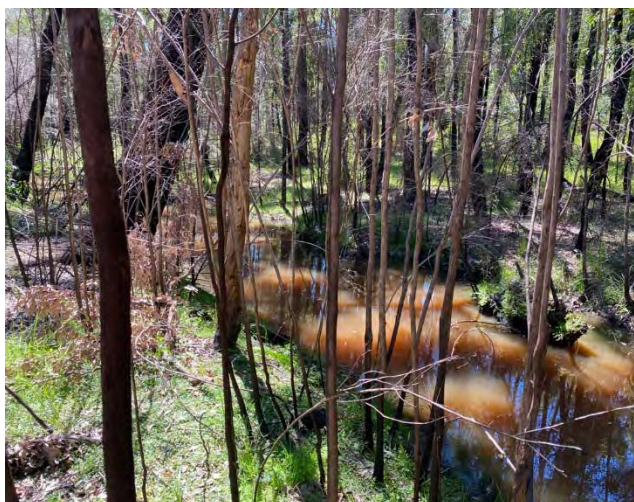
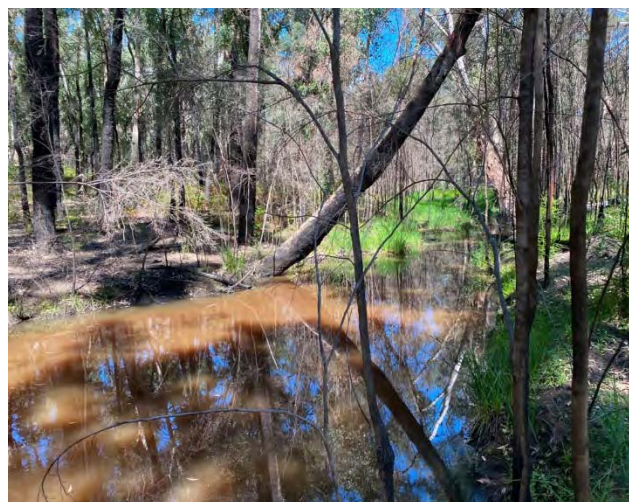
Plate 7: Site 6

Site 6 Downstream

Site 6 Upstream

Attribute	Site 6
	Photograph	Plate 7
Riparian characteristics	RCE score	45
	Vegetation	Forest Red Gum (<i>Eucalyptus tereticornis</i>), White Stringybark (<i>E. globoidea</i>) dominated the canopy vegetation. The mid-storey was dominated by small trees and tall shrubs. The ground cover consisted of regenerating native grasses, herbs and ferns.
	Stream shading	Low/Moderate
	Exotic vegetation	-
Stream characteristics	Modal width (m)	<3m
	Substrate	Sand 20%, silt 80%
	Flow/depth	No flow/ >1m deep
	Macrophytes/algae	Green algae present
	Water quality observations	Turbid water. The creek was bank full.
Comments		Good level of post bushfire regrowth, water level elevated from heavy rainfall..

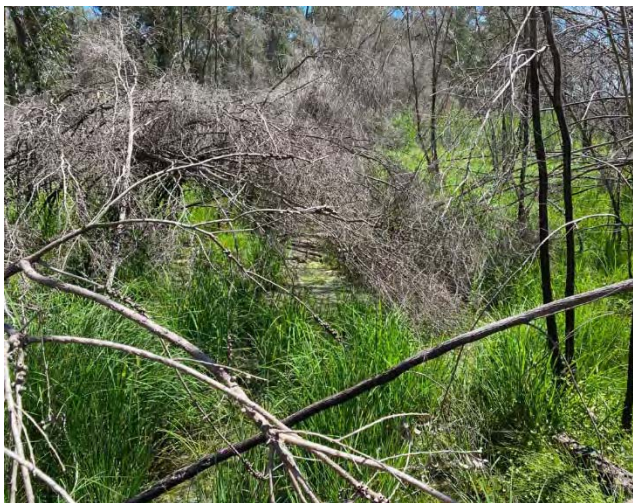
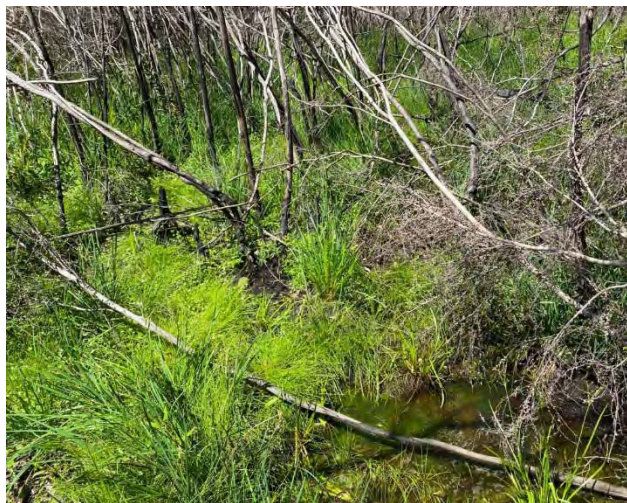
Plate 8: Site 7

Site 7 Downstream

Site 7 Upstream

Attribute	Site 7
	Photograph	Plate 8
Riparian characteristics	RCE score	45
	Vegetation	Canopy vegetation included Grey Gums (<i>Eucalyptus punctata</i>) and Scribbly Gums (<i>Eucalyptus haemastoma</i>). The ground cover consisted of by native grasses, herbs and ferns, as well as macrophytes.
	Stream shading	Low/moderate
	Exotic vegetation	-
	Stream characteristics	Modal width (m)
	Substrate	Silt 100%
	Flow/depth	No flow, <10cm deep
	Macrophytes/algae	Cat tail Bulrush (<i>Typha</i>), Saw sedge (<i>Gahnia</i> sp.)
	Water quality observations	Very damp. Shallow water
Comments		Shallow surface water. Overgrown creek bed. Evidence of large mammal activity

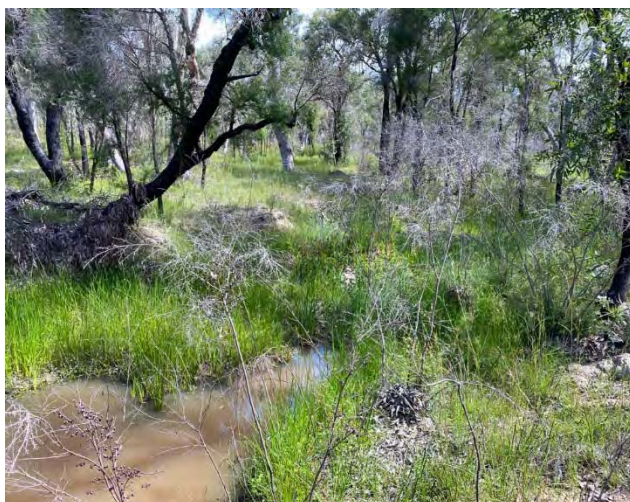
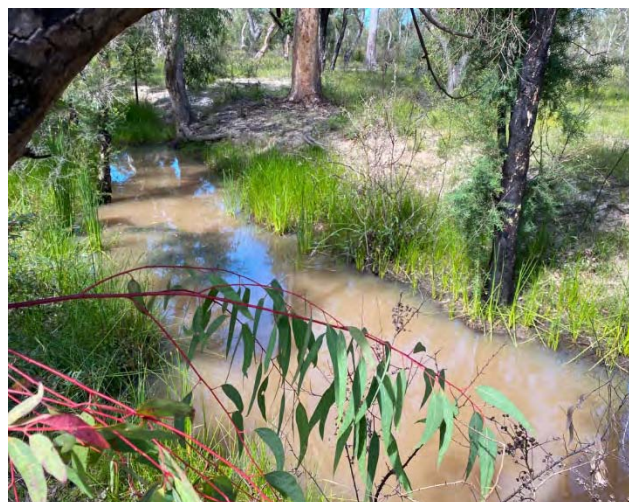
Plate 9: Site 8

Site 8 Downstream

Site 8 Upstream

Attribute	Site 8
	Photograph	Plate 9
Riparian characteristics	RCE score	45
	Vegetation	Canopy vegetation included Grey Gums (<i>Eucalyptus punctata</i>) and Scribbly Gums (<i>Eucalyptus haemastoma</i>). The mid-storey was heavily damaged due to bushfires. The ground cover consisted of by native grasses, herbs and ferns along with Eucalyptus and Casuarina regeneration post fires.
	Stream shading	Low/Moderate
	Exotic vegetation	-
	Stream characteristics	Modal width (m)
	Substrate	Pebble 30%, sand 20%, silt50%
	Flow/depth	Low flow/<1m
	Macrophytes/algae	Absent-
	Water quality observations	Turbid/low flow at bank-full max
Comments		Animal activity at water edge. High water level form recent rainfall

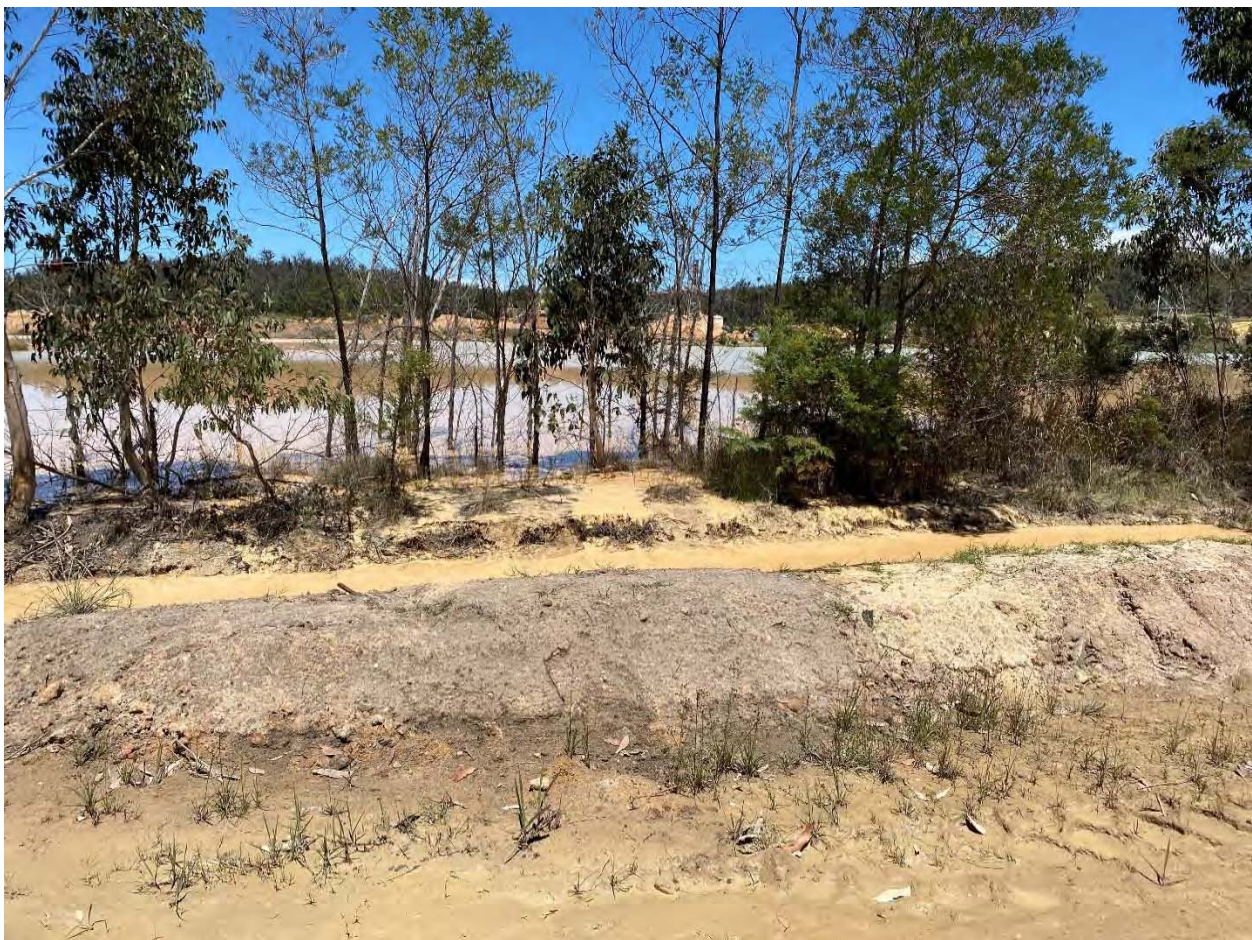
Figure 3. Overflow from Tinda Creek Quarry tailing pond, flowing upstream of Site 4.
