# Aus 10 Rhyolite Pty Limited

## 2021 Annual Review

## Tinda Creek Quarry

Period: 1 January 2021 to 31 December 2021

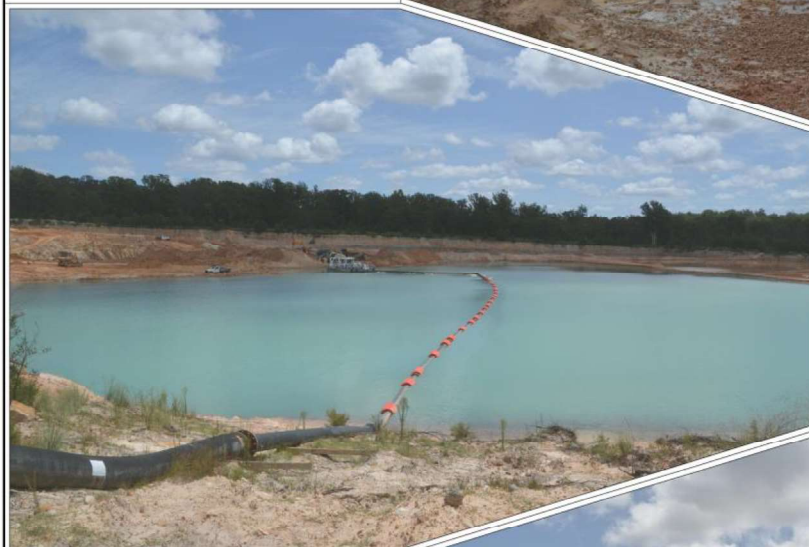
**Plate 3:** Dredge Pond with Pump in the Foreground and Cutter Suction Dredge in the Background - February 2022

Extraction and processing during the reporting period occurred entirely within Domain 6 (see **Figure 2**). The total volume of sand produced 94 041t which is within the limits specified in Condition 6 of Schedule 2 of SSD\_4978. Sand was extracted via excavator then loaded onto a single articulated dump truck and hauled to the dredge where the material was tipped into a dump pocket in front of the dredge throughout the reporting period (refer **Plate 3**).

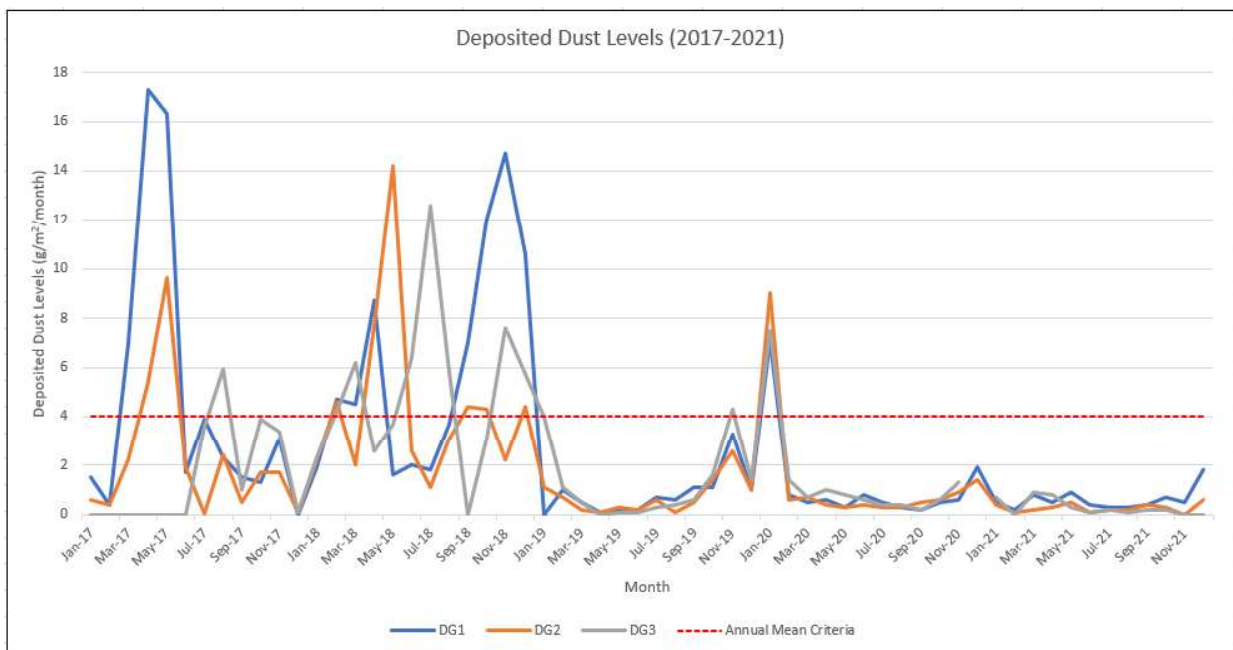
Monthly deposited dust monitoring was undertaken throughout the reporting period. The location of dust monitoring gauges DG1, DG2 and DG3 are shown on **Figure 3**. **Figure 4** and **Table 8** present the results of the deposited dust monitoring program over the reporting period. It is noted that the approved Air Quality Management Plan requires deposited dust monitoring at location DG1 only. Monitoring at locations DG2 and DG3 is undertaken on a voluntary basis and therefore is not subject to compliance under SSD 4978.

**Figure 4** Deposited Dust Levels 2017 to 2021

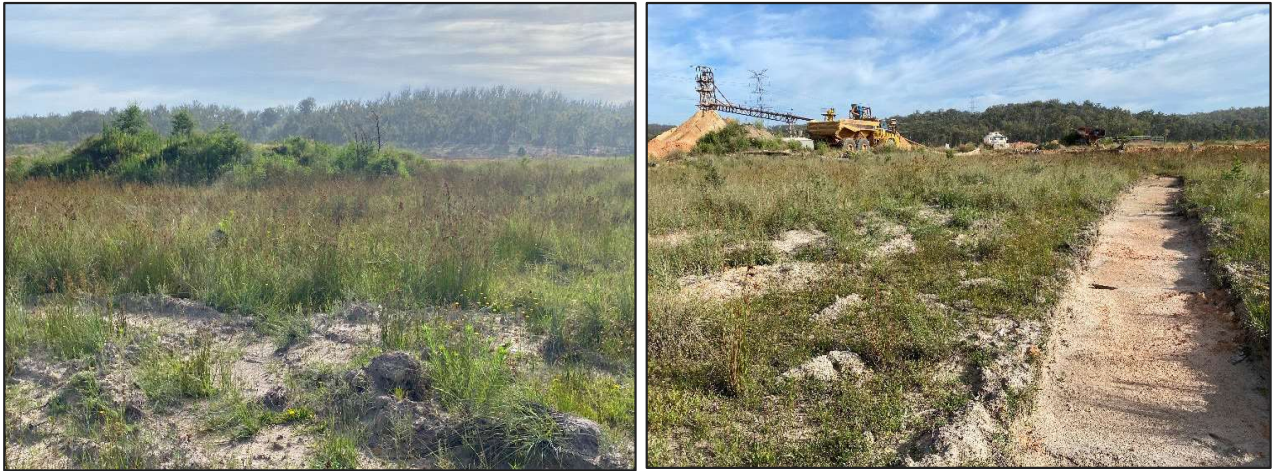
**Plate 2.1** BAM Plot 1 – surveys deferred until further rehabilitation has been undertaken

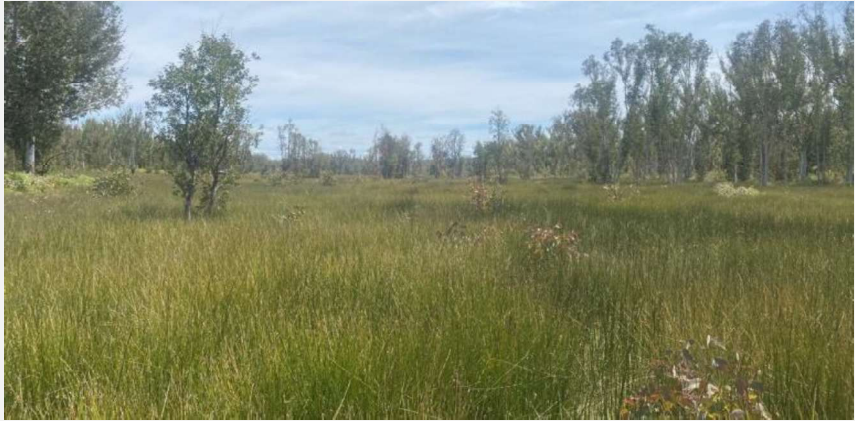
<b>Plate 2: Site 1</b>	<b>Downstream</b>

Criteria	Attribute	Site 1
<b>Riparian</b>	RCE score	40.
	Vegetation	Canopy absent. Scattered Parramatta Red Gum ( <i>Eucalyptus parramattensis</i> ) regenerating within this location. Mid-story absent. Groundcover dominated by sedge, low shrub, herb and grasses including <i>Leptocarpus tenax</i> ; <i>Juncus</i> sp.; <i>Lepyrodia scariosa</i> ; <i>Schoenus brevifolius</i> ; <i>Entolasia stricta</i> ; <i>Gonocarpus micranthus</i> ; <i>Melaleuca thymifolia</i> ; <i>Micromyrtus ciliata</i> and <i>Dampiera stricta</i> .
	Stream shading	Low <5%.
	Exotic vegetation	-
<b>Stream characteristics</b>	Modal width (m)	<1 m.
	Substrate	Majority sand and silt.
	Flow/depth	No flow.
	Macrophytes/algae	Absent.
Water quality observations	Dry.	
<b>Comments</b>		Very shallow and generally narrow channel form (<1 m). Open sandy floodplain with the flow channel identified by the change in vegetation, indicating the more permanent presence of surface water or subsurface flow.

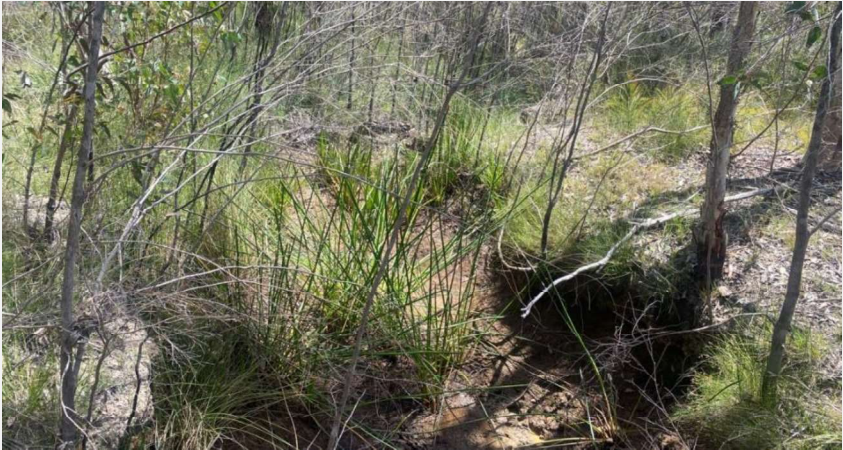
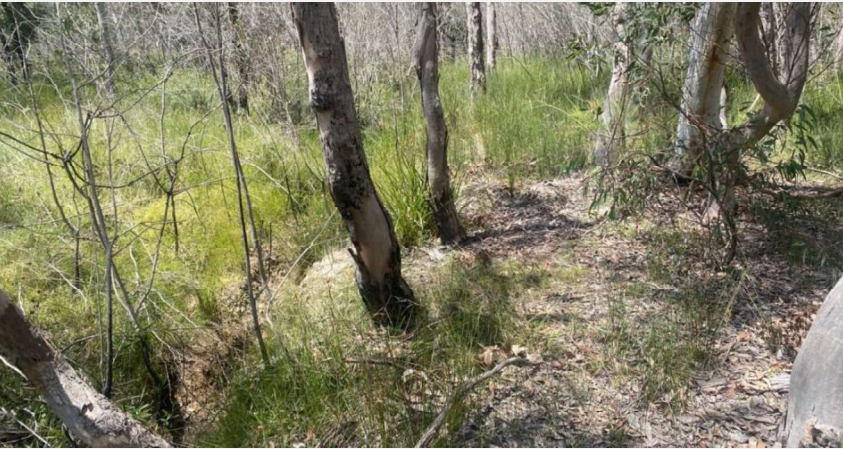
Following the event the existing silt fencing was taken down and replaced with new silt fencing. Many of the existing hay bales were removed and replaced with new hay bales. At some of the sediment control walls, additional hay bales were placed as a second row. Existing rock lined sediment traps were sediment traps were taken up and replaced with new rock lined sediment traps in the affected area. The ruptured pipe was replaced.

#### Incident – 2 March 2021

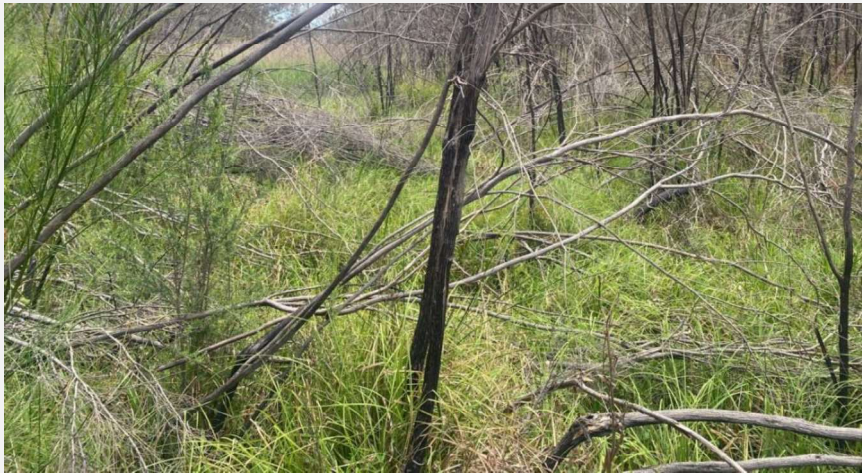
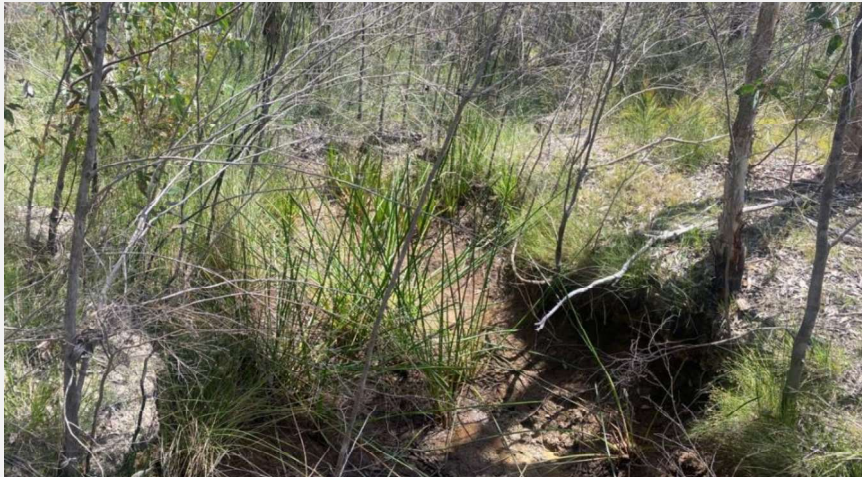
- Continuation of progressive rehabilitation as practicable. This will primarily continue within the south-eastern rehabilitation area, utilising topsoil to begin revegetation of the area.

- The production forecast for 2022 is to extract, process and transport approximately 144 000t of sand product.
- Ongoing monitoring and maintenance of erosion and sediment controls and diversion drains.
