2022 Annual Review

Tinda Creek Quarry

Period: 1 January 2022 to 31 December 2022

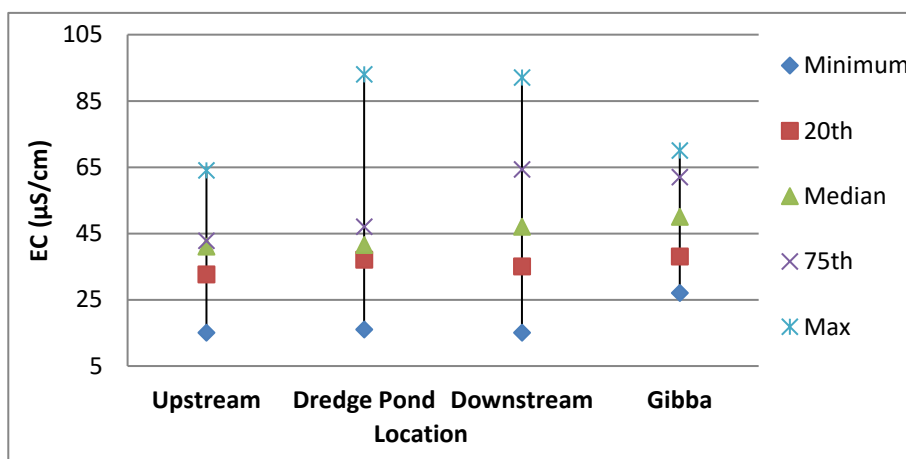
Figure 9 Summary Statistical Plot for Discharge Water Quality Monitoring: Electrical Conductivity

As shown in **Table 24** and **Figure 9** the measured EC at all locations were within the bounds recommended by ANZECC. Of note are the maximum values recorded in Quarry discharge and downstream that are not coincident (Quarry = 7 October 2022, Downstream = 1 April 2021). This suggests runoff from other sources is potentially influencing water quality downstream of the Quarry.

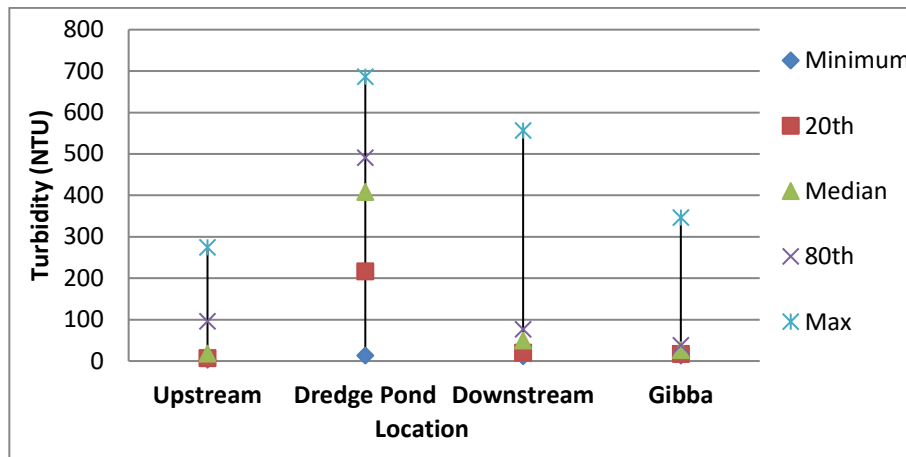
Figure 10 Summary Statistical Plot for Discharge Water Quality Monitoring: Turbidity

Whilst **Table 25** and **Figure 10** identifies elevated turbidity in Quarry discharge, the calculated median at the Gibba also exceeds the upper threshold recommended by ANZECC (2000). This suggests that elevated turbidity is (periodically) representative of natural conditions. This is noted in ANZECC that states high values may be observed during high flow events. It is however recognised that, whilst not measured in orders of magnitude, turbidity in Quarry discharge is higher than that recorded at other locations. This is likely attributable to the placement of the pump inlet during discharge which may have led to the collection of deposited materials. However, again the record maxima in discharge and downstream of the Quarry are not coincident with the date of the Quarry maximum (9 March 2022) returning a turbidity of 48.4NTU, similar to the calculated median (50NTU).

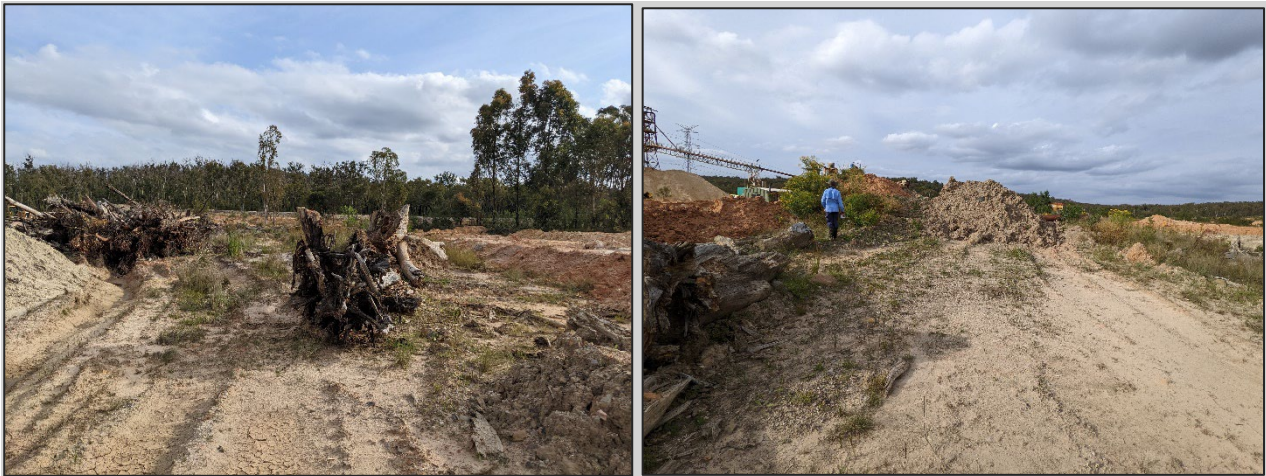
Plate 2.1 BAM Plot 1 – surveys deferred until rehabilitation has been undertaken

Plot B1 was checked, however it is understood that this area of the quarry (Domain 4) is under active quarry workings and the landform has not been completed to a stage where rehabilitation can be established. The plot will be deferred until a time when rehabilitation has been established (refer to Section 2.5.1ii and Plate 2.1).

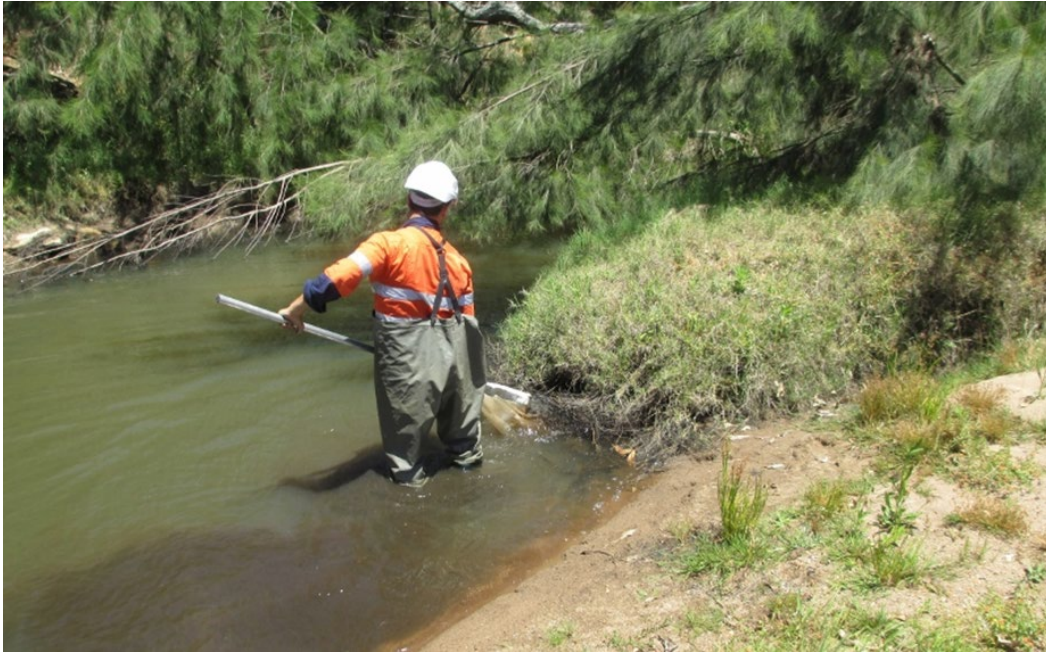
Samples of macroinvertebrates were collected from pool edges for a length of 10 metres, either as a continuous line or in disconnected segments. Sampling in segments was often undertaken to ensure the sampling of sub-habitats such as macrophyte beds, bank overhangs, submerged branches and root mats. Segmented sampling was also employed where pool length was short and it was logistically difficult to sample in a continuous line (e.g. in-stream logs). A 250 µm dip net was drawn through the water with short sweeps towards the bank to dislodge benthic fauna while scraping submerged rocks and debris, sides of the stream bank and the bed substrate (Plate 1). Further sweeps in the water column targeted the suspended fauna.

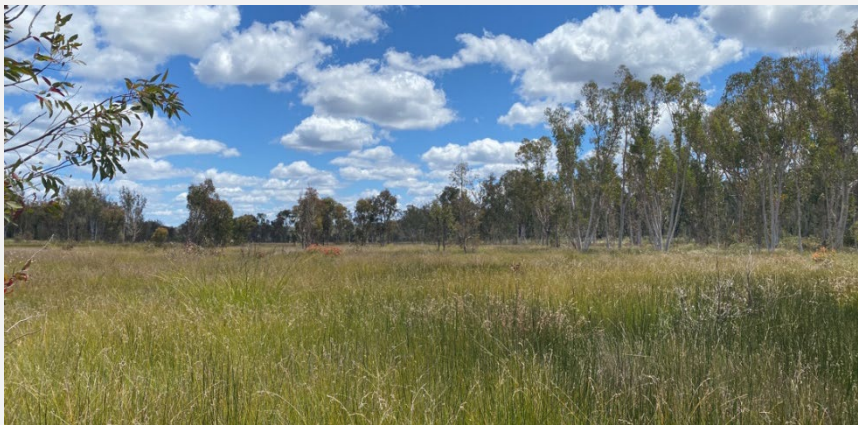
Plate 2: Site 1	Downstream

Criteria	Attribute	Site 1
Riparian	RCE score	42.
	Vegetation	Canopy absent. Scattered Parramatta Red Gum (<i>Eucalyptus parramattensis</i>) regenerating within this location. Mid-story absent. Groundcover dominated by sedge, low shrub, herb and grasses including <i>Leptocarpus tenax</i> ; <i>Juncus</i> sp.; <i>Lepyrodia scariosa</i> ; <i>Schoenus brevifolius</i> ; <i>Entolasia stricta</i> ; <i>Gonocarpus micranthus</i> ; <i>Melaleuca thymifolia</i> ; <i>Micromyrtus ciliata</i> and <i>Dampiera stricta</i> .
	Stream shading	Low <5%.
	Exotic vegetation	-
Stream characteristics	Modal width (m)	<1 m.
	Substrate	Majority sand and silt.
	Flow/depth	Low flow across floodplain
	Macrophytes/algae	Algae present
	Water quality observations	Clear
Comments		Very shallow and generally narrow channel form (<1 m). Open sandy floodplain with the flow channel identified by the change in vegetation, indicating the more permanent presence of surface water or subsurface flow.

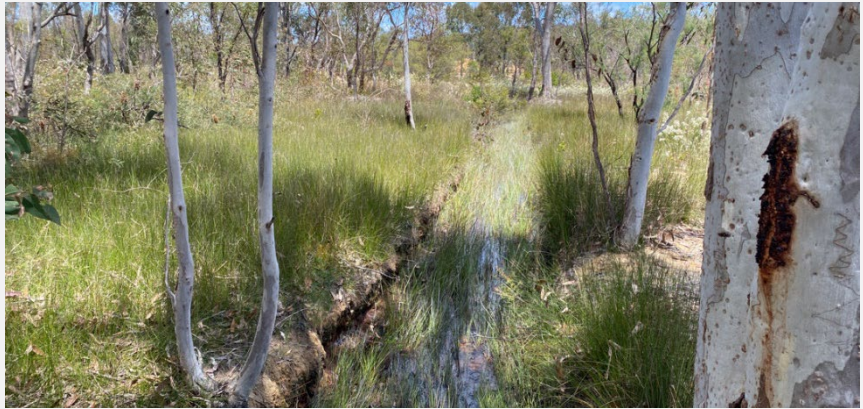
Criteria	Attribute	Site 2
Riparian	RCE score	35 (Constructed drainage channel).
	Vegetation	Canopy consisted of sparse Scribbly Gums (<i>Eucalyptus haemastoma</i>), with a scattered grass/shrub land dominated by <i>Chorizandra spaerocephala</i> .
	Stream shading	Low/moderate.
	Exotic vegetation	-
Stream characteristics	Modal width (m)	<1 m.
	Substrate	Sand 80%, Silt 20%.
	Flow/depth	No flow.
	Macrophytes/algae	Absent.
	Water quality	Clear
Comments		Constructed channel to drain farm dam.
Plate 3: Site 2	Downstream

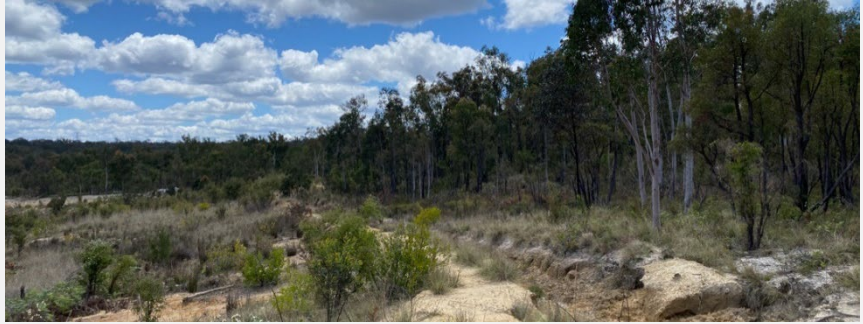
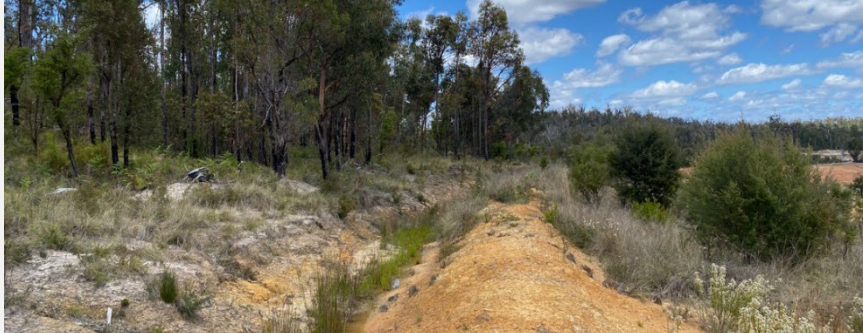
Criteria	Attribute	Site 3
Riparian	RCE score	30 (Constructed channel).
	Vegetation	Canopy and mid-story absent. Groundcover dominated by <i>Chorizandra spaerocephala</i> .
	Stream shading	Low/none.
	Exotic vegetation	-
Stream characteristics	Modal width (m)	<2 m.
	Substrate	Sand 70%, silt 30%.
	Flow/depth	No flow.
	Macrophytes/algae	Absent.
	Water quality observations	Clear
Comments		Very loose and unstable banks.
Plate 4: Site 3	Downstream

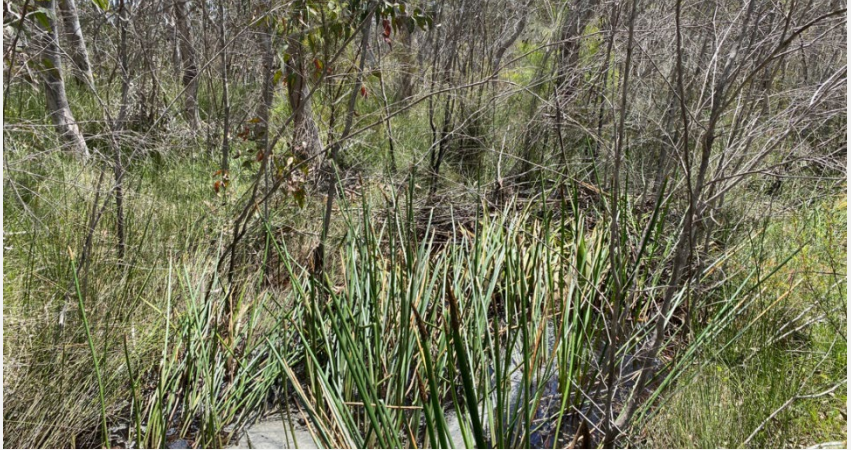
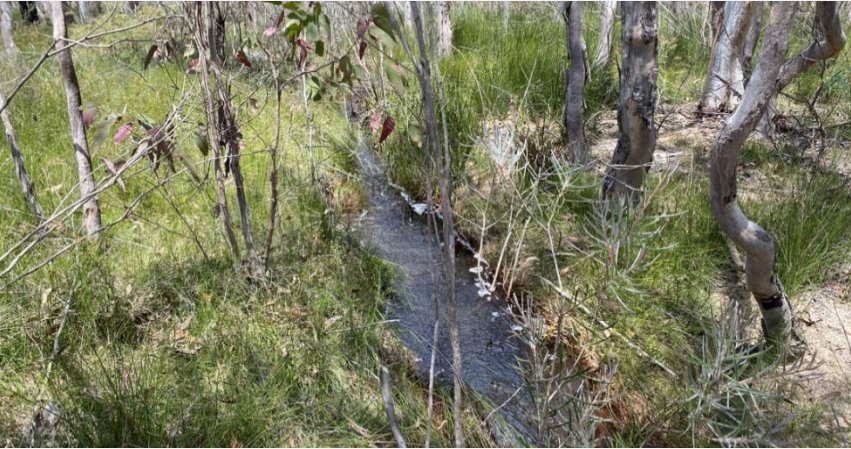
Criteria	Attribute	Site 4
Riparian	RCE score	45
	Vegetation	Canopy composed of <i>Eucalyptus haemastoma</i> (<5%). Mid-story dominated by small trees and tall shrubs. Ground cover was sparse with signs of slight post fire regrowth and dominated by <i>Chorizandra spaerocephala</i> .
	Stream shading	Low.
	Exotic vegetation	-
Stream characteristics	Modal width (m)	2 m.
	Substrate	80% silt, 20% sand.
	Flow/depth	Low flow
	Macrophytes/algae	Macrophytes and algae present
	Water quality observations	Dark tannin colour
Comments	None.	
Plate 5: Site 4	Downstream

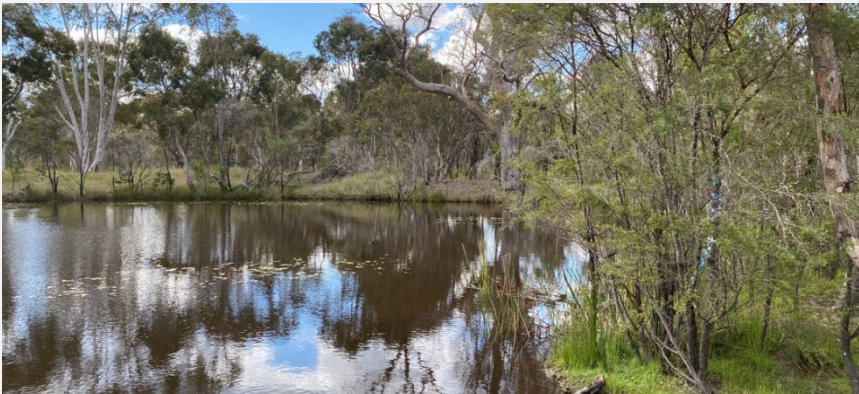
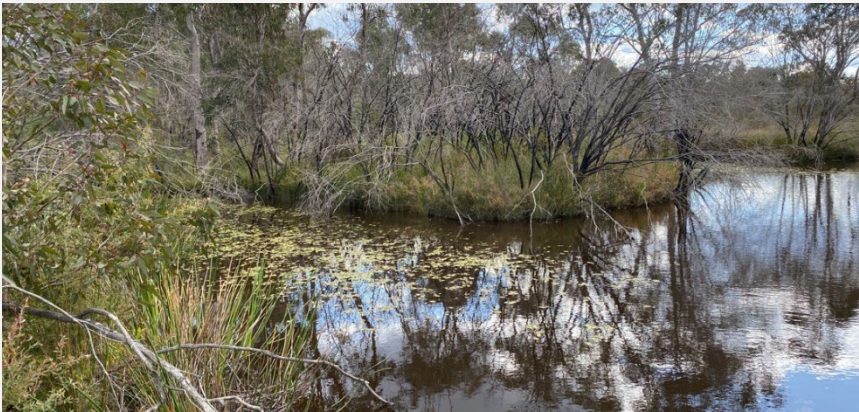
Criteria	Attribute	Site 5
Riparian	RCE score	46.
	Vegetation	Canopy present and comprised of <i>Eucalyptus haemastoma</i> , Mid-story supporting dense cover of small trees and tall shrubs (<i>Acacia</i> spp and <i>Cassurina</i> spp). There were signs of regrowth of ground covering including regenerative Cat-tailed bulrush (<i>Typha</i>) and Round headed bristle sedge (<i>Chorizandra spaerocephala</i>).
	Stream shading	Low-moderate.
	Exotic vegetation	-
Stream characteristics	Modal width (m)	6 m.
	Substrate	Silt 90%, sand 10%.
	Flow/depth	No flow/deep >1 m.
	Macrophytes/algae	Cat tail Bulrush (<i>Typha</i> sp.) and floating macrophyte <i>Potamogetan sulcus</i>
	Water quality observations	Water availability was relatively high; conditions were highly turbid.
Comments		Riparian and macrophyte vegetation present, European carp (<i>Cyprinus carpio</i>) was present in dam
Plate 6: Site 5	Downstream

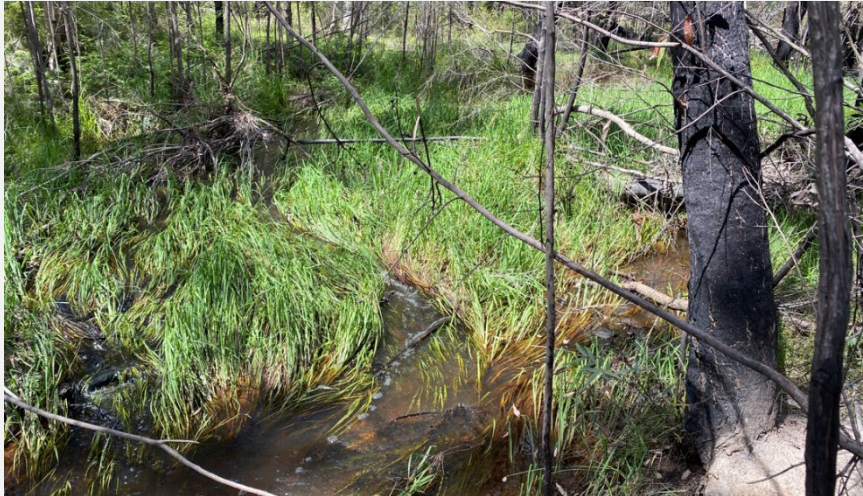
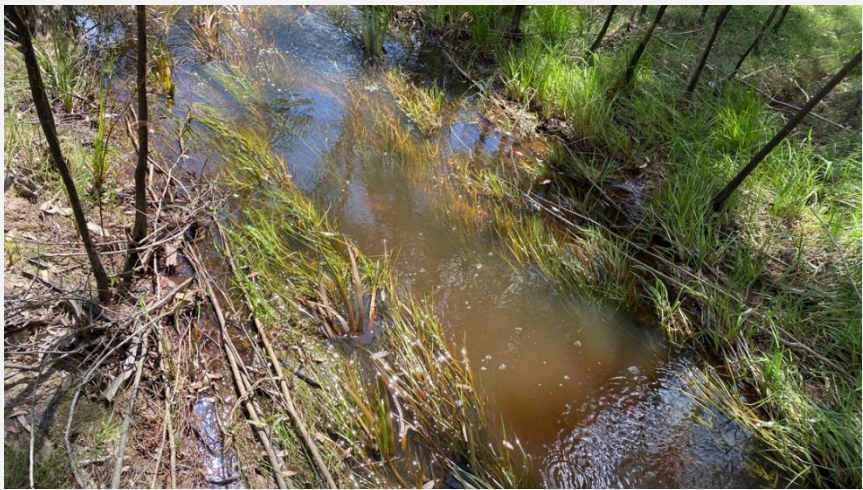
Criteria	Attribute	Site 6
Riparian characteristics	RCE score	48.
	Vegetation	Forest Red Gum (<i>Eucalyptus tereticornis</i>), White Stringybark (<i>E. globoidea</i>) dominated the canopy vegetation. The mid-storey was dominated by small trees and tall shrubs. The ground cover consisted of regenerating native grasses, herbs and ferns.
	Stream shading	Low/moderate.
	Exotic vegetation	-
Stream characteristics	Modal width (m)	4 m.
	Substrate	Sand 20%, silt 80%.
	Flow/depth	No flow/ >1 m deep.
	Macrophytes/algae	Green algae present.
	Water quality observations	Water availability was relatively high; conditions were highly turbid.
Comments		Good level of post bushfire regrowth.
Plate 7: Site 6	Downstream

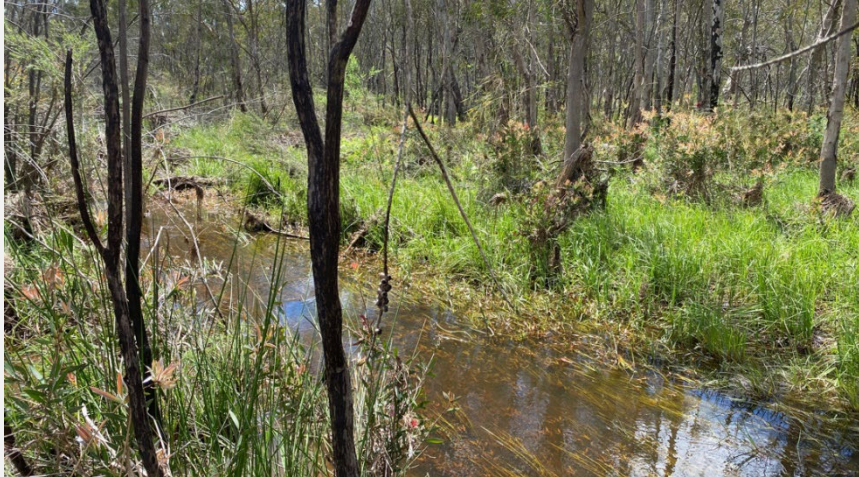
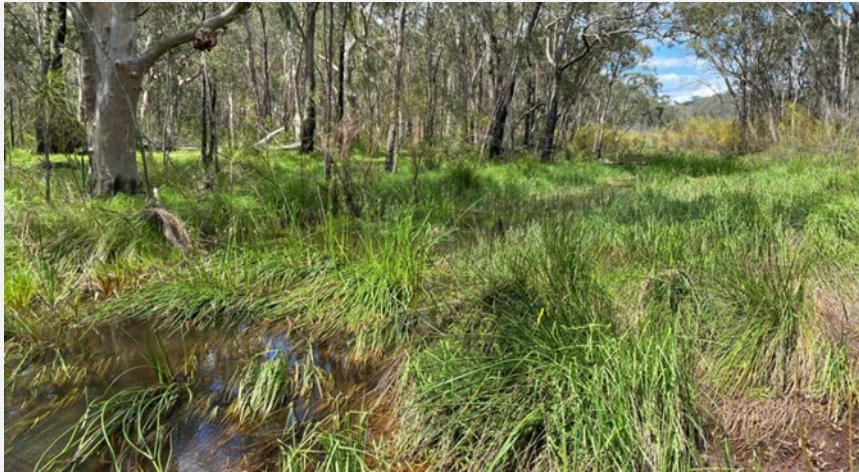
The aquatic habitat at Site 7 (Plate 8) at the time of the spring 2022 monitoring surveys is detailed in Table 13.

Criteria	Attribute	Site 7
Riparian characteristics	RCE score	48.
	Vegetation	Canopy vegetation included Grey Gums (<i>Eucalyptus punctata</i>) and Scribbly Gums (<i>Eucalyptus haemastoma</i>). The ground cover consisted of by native grasses, herbs and ferns, as well as macrophytes.
	Stream shading	Low/moderate.
	Exotic vegetation	-
Stream characteristics	Modal width (m)	<5 m.
	Substrate	Silt 100%.
	Flow/depth	Low flow
	Macrophytes/algae	Cat tail Bulrush (<i>Typha</i> sp.), Saw sedge (<i>Gahnia</i> sp.).
	Water quality observations	Visually clear and tannin colour
Comments	Overgrown creek bed flattened by high flows.	
Plate 8: Site 7	Downstream

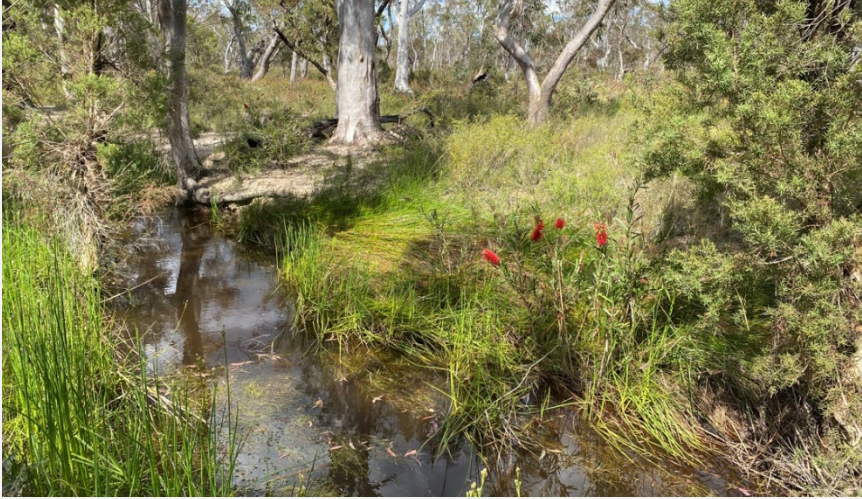
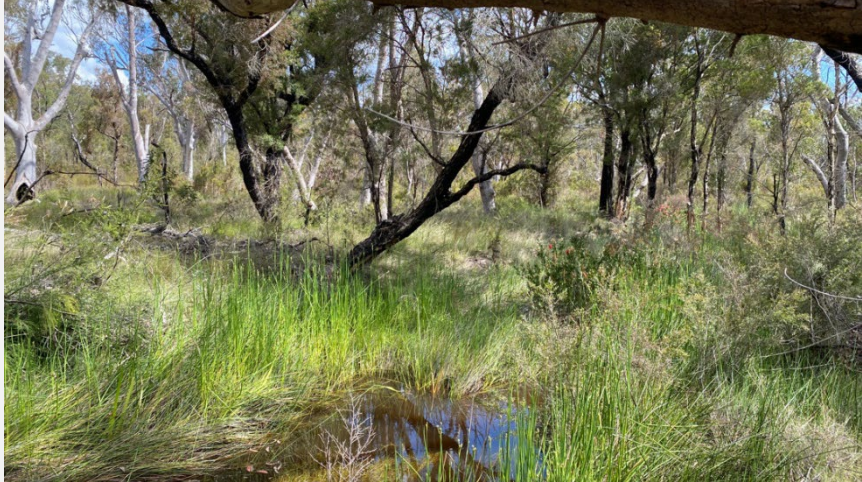
The aquatic habitat at Site 8 (Plate 9) at the time of the spring 2022 monitoring surveys is detailed in Table 14.

Criteria	Attribute	Site 8
Riparian characteristics	RCE score	48.
	Vegetation	Canopy vegetation included Grey Gums (<i>Eucalyptus punctata</i>) and Scribbly Gums (<i>Eucalyptus haemastoma</i>). The mid-storey was heavily damaged due to bushfires. The ground cover consisted of native grasses, herbs and ferns along with Eucalyptus and Casuarina regeneration post fires.
	Stream shading	Low/moderate.
	Exotic vegetation	-
Stream characteristics	Modal width (m)	3 m.
	Substrate	Pebble 30%, sand 20%, silt 50%.
	Flow/depth	Low flow
	Macrophytes/algae	A green macro algae was present
	Water quality observations	Turbid, low flow conditions.
Comments		
Plate 9:Site 8	Downstream

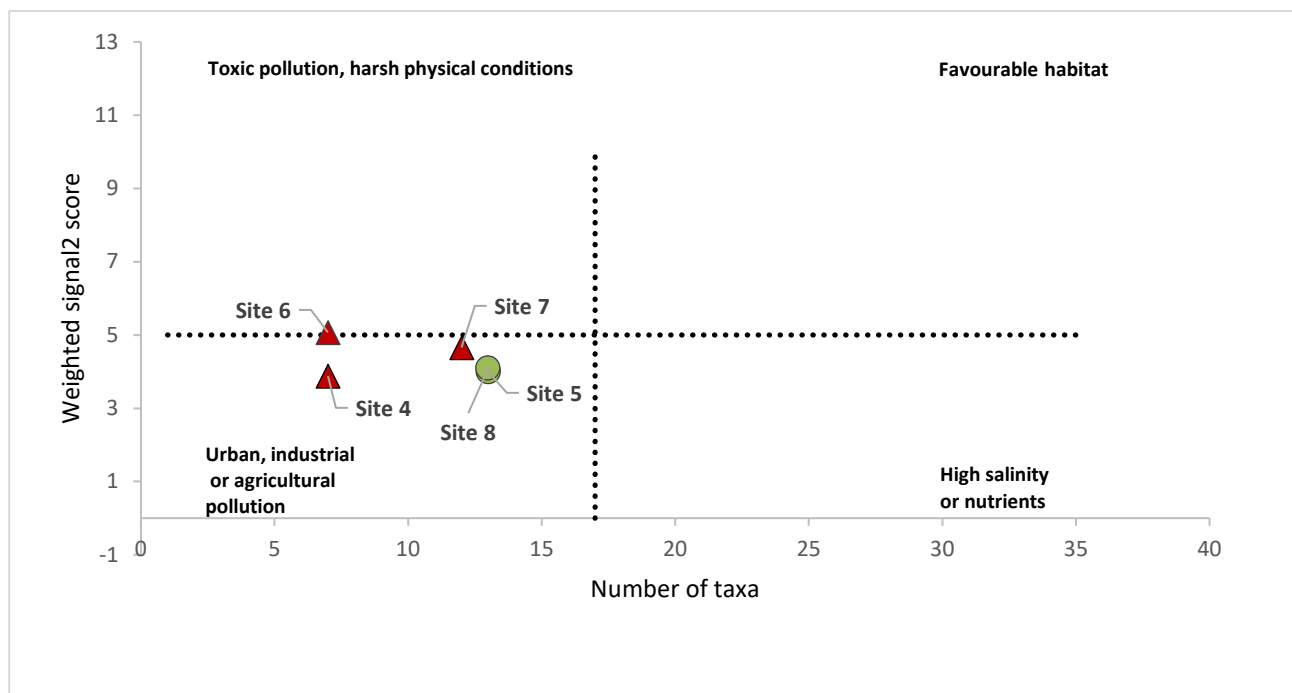
Figure 3: SIGNAL2 Bi-plot – Spring 2022

The low weighted scores SIGNAL2 scores recorded at all sites in spring 2022 indicate that the macroinvertebrate assemblage present in the streams is dominated by predominantly pollution-tolerant taxa (Figure 3). The Biplot, indicates that no sites have favourable aquatic habitat, and all locations are exhibiting some form of pollution or natural stress. However, this appears typical for streams in the area as two reference sites also cluster together in this quadrant. Pollution-sensitive taxa recorded include Mayfly Leptophlebiidae (SIGNAL 8) observed at all sites, Caddis Fly Hydrobiosidae (SIGNAL 8) observed at sites 6 and 7, flies Dixidae (SIGNAL 7) at Site 5 and Beetle Elmidae (SIGNAL 7) at site 8.

Note: reference sites represented as green circles, while test sites represented as red triangles.
