# Aus 10 Rhyolite Pty Limited

## 2019 Annual Review

## Tinda Creek Quarry

Period: 1 January 2019 to 31 December 2019

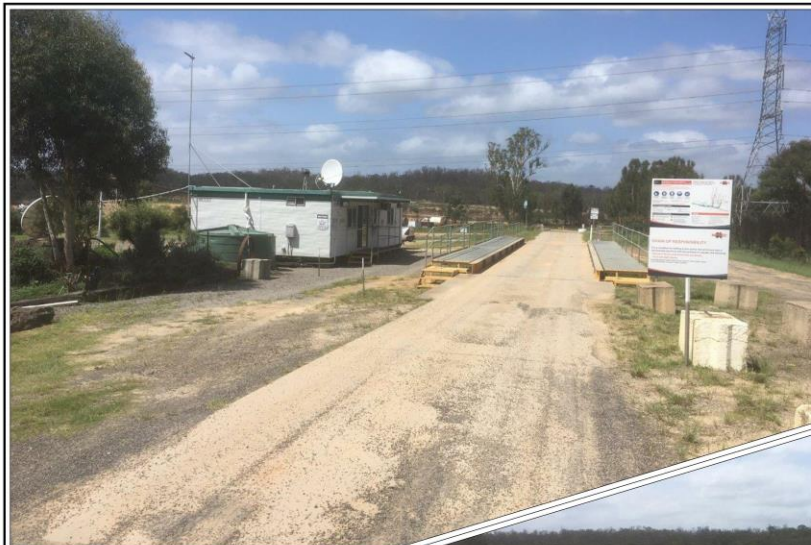
**Plate 1:** Weighbridge Office and Weighbridge - February 2020  
(Ref: E980B\_009)

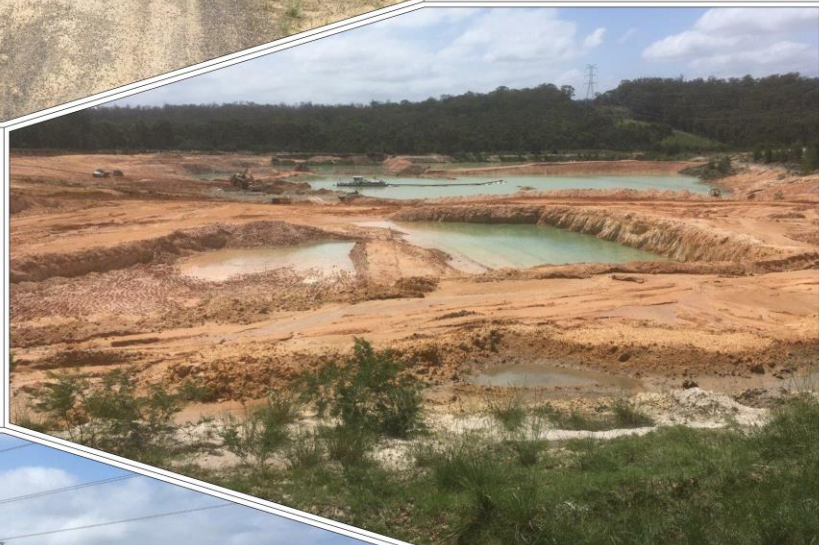
**Plate 2:** Dredge Pond - February 2020  
Sand extraction within the Dredge Pond  
(Ref: E980B\_006)

Extraction and processing during the reporting period occurred entirely within Domain 6 (see **Figure 2**). The total volume of sand extracted and processed was 44 354t which is within the limits specified in Condition 6 of Schedule 2 of SSD\_4978. Sand was extracted using a cutter-suction dredge throughout the reporting period (refer **Plate 2**).

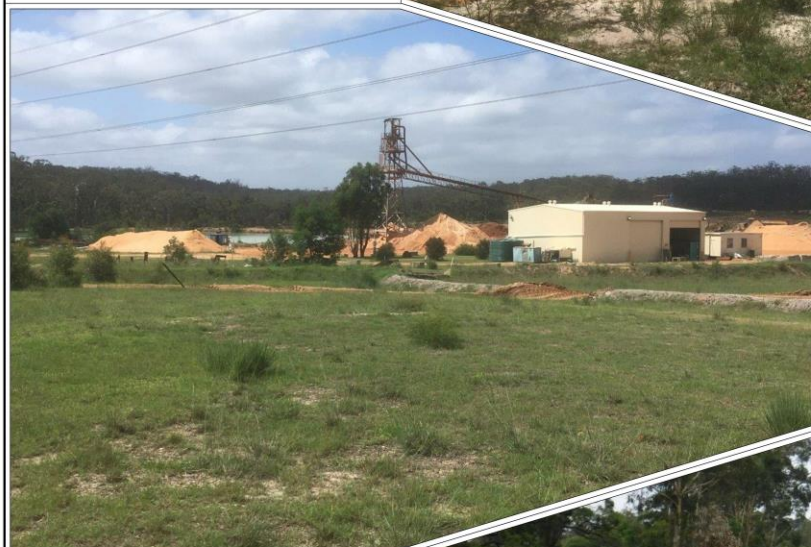
**Plate 3:** Sand Stockpile and Plant Infrastructure - February 2020  
(Ref: E980B\_010)

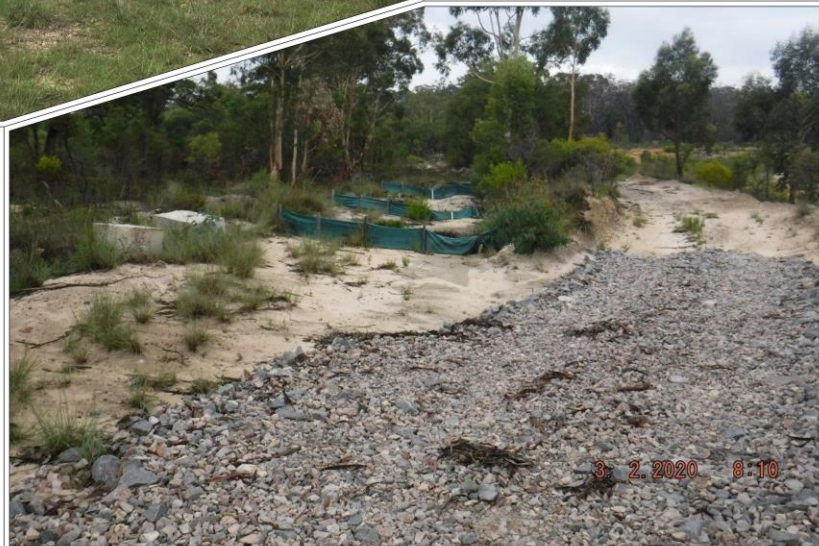
**Plate 4:** View of erosion sediment controls in the headwaters of Tinda Creek - February 2020  
(Ref: E980B\_007)

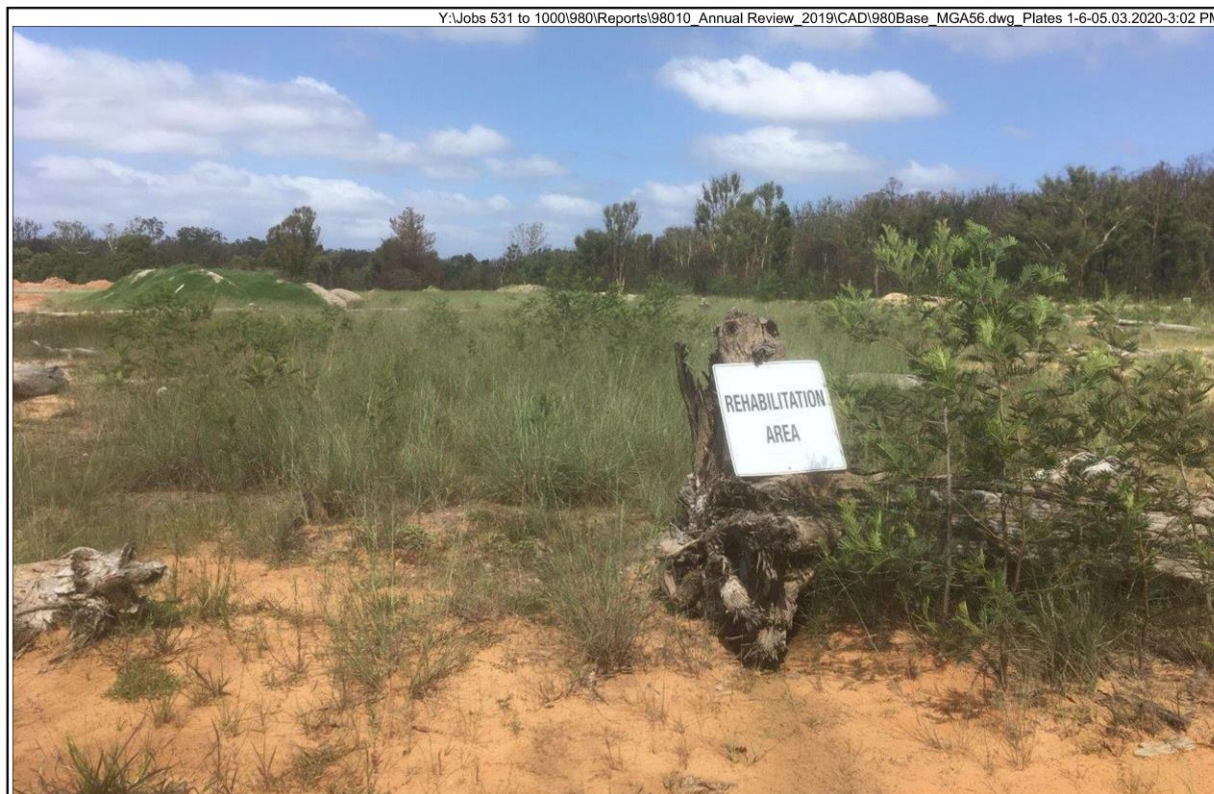
**Plate 5:** Rehabilitation progress within a rehabilitation area showing signs of new vegetation growth - February 2020  
The area is sign-posted to restrict access  
(Ref: E980B\_002)

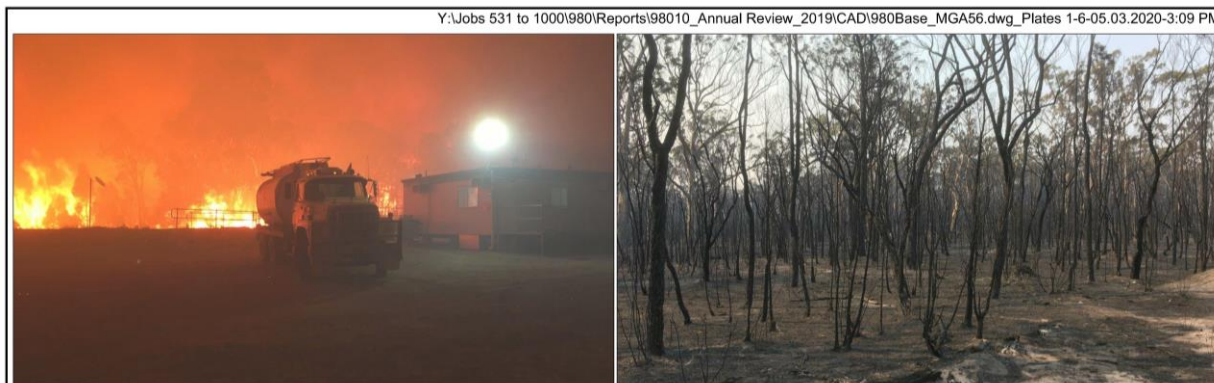
**Plate 6:** Photo during firefighting of Gaspers Mountain Fire (left) and after bushfires in November 2019 (right)  
(Photo source: HyTec)

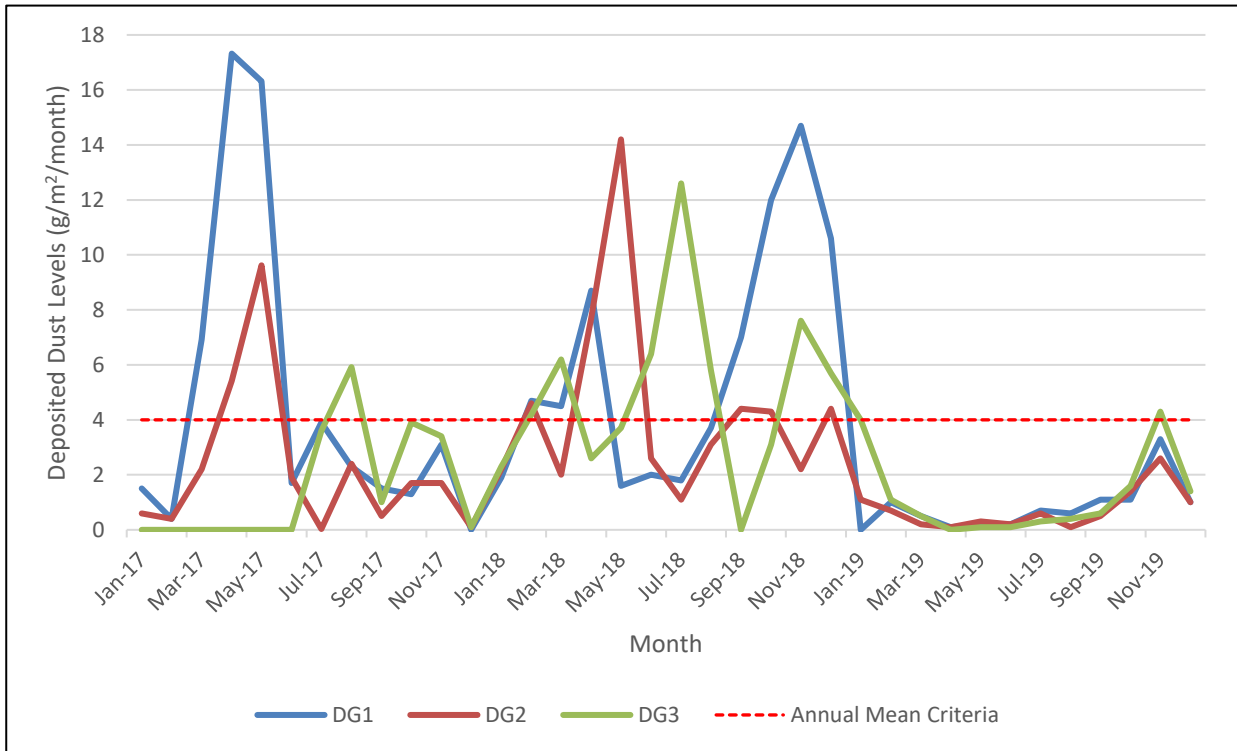
Figure 4 Deposited Dust Levels 2017 to 2019

Deposited dust levels were all well below the trigger value at each dust gauge throughout the reporting period, with the exception of one observation in DG3 in the month of November. Deposited dust levels in November were significantly higher than the rest of the year because of the Gaspers Mountain Bush Fire. The deposited dust levels in DG3 exceeded the 12-month average limit. Deposited dust levels decreased significantly compared to 2018 deposited dust levels (**Figure 4**) due to the installation of bird deterrence collars on 4 January 2019, which prevented the entry of insects, organic matter, and bird droppings in samples. As a result of the low records, the annual average level is well below the criteria level for the reporting period.

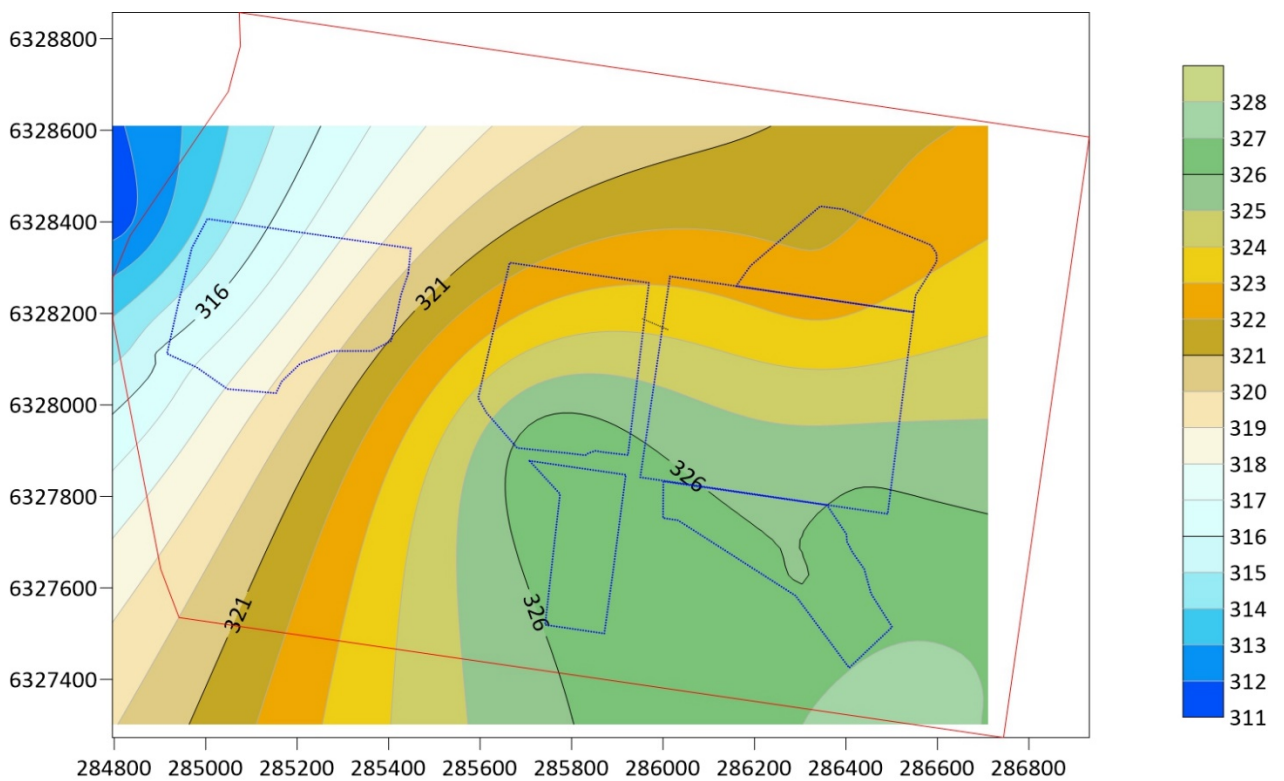
**Figure 4** Groundwater flow map with interpreted contours (legend represents the groundwater contours in mAHD)

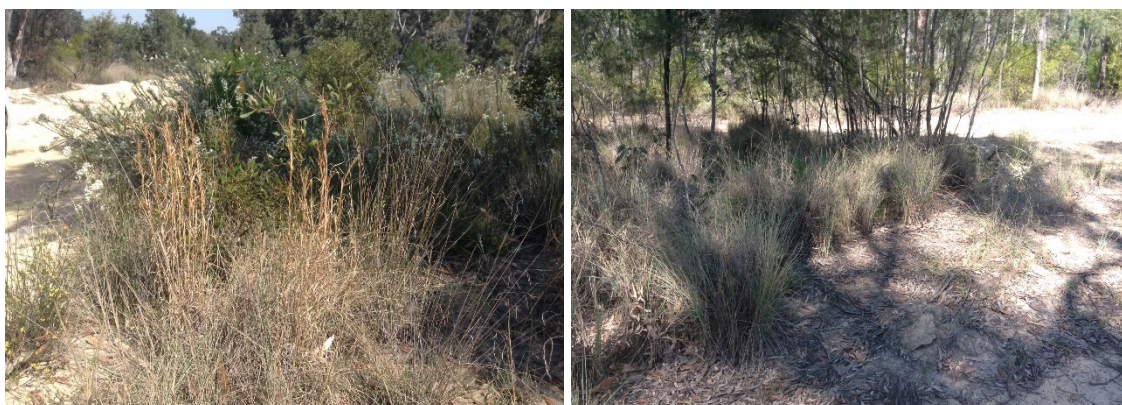
**Figure 1:** African Lovegrass and Whiskey Grass, scattered along tracks within biodiversity offset area.

Within the biodiversity offset area, minor areas of concern are scattered along the vehicular tracks, the electricity easement and other small areas previously subject to disturbance (**Map 5**). A similar pattern occurs around the fringes of the offset area (e.g. the works site, front paddock and Putty Road), where weeds encroach into bushland for up to 1 or 2 metres in intermittent locations (**Map 5** and site photos below in **Figure 1**).

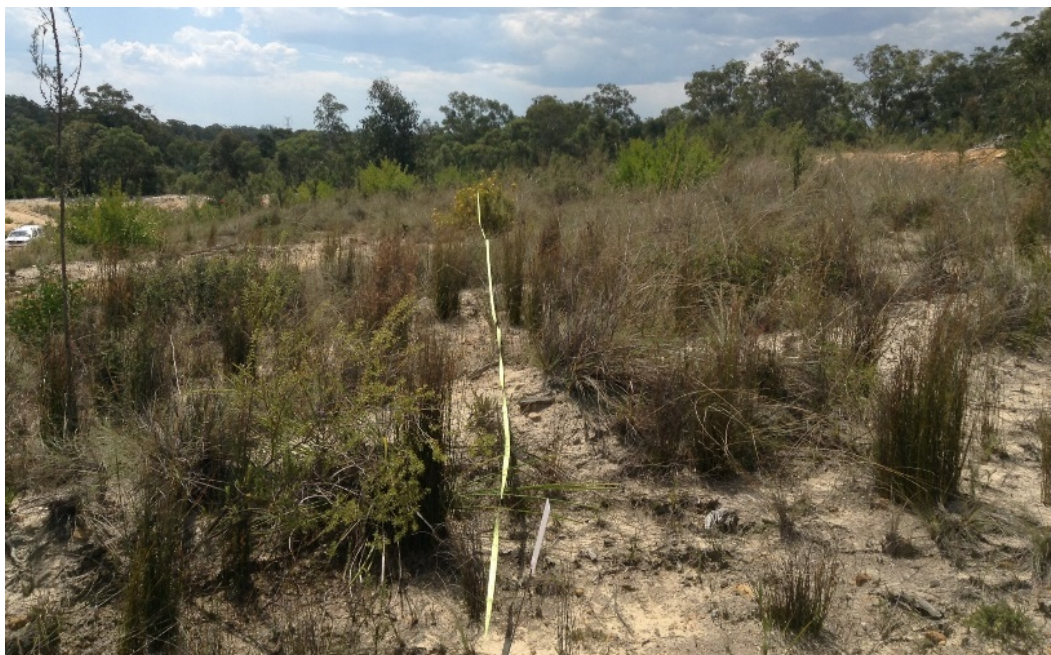
**Figure 2:** Showing heavy African Lovegrass infestation, a lack of eucalypt regeneration and poor topsoil/mulch/leaf litter cover.

Weed occurrence and abundance appears to be similar to that described in the 2018 monitoring report (Niche, 2019). Weeds are only considered to be having a major direct impact in the regeneration area, which is infested with *Eragrostis curvula* (African Lovegrass) along with other less prominent weeds, e.g. plot 18 in that area, contained 38% weed cover, primarily comprising African Lovegrass, with *Andropogon virginicus* (Whisky Grass) and *Stenotaphrum secundatum* (Buffalo Grass) making up the remainder (site shown in **Figure 2**).

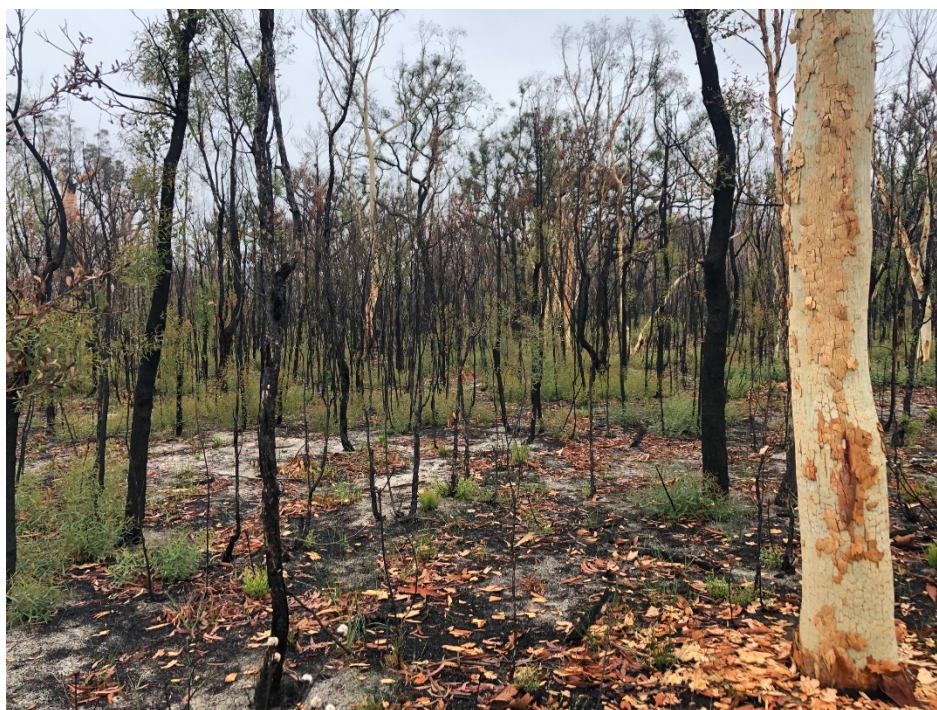
**Figure 4:** Vegetation that has been subjected to a hot wildfire in the south-eastern portion of the site (at main *Grevillea* population area)

It is not expected that the presence of the Quarry operations would hamper post fire regeneration, however weed management will be important to ensure that weeds do not spread to regenerating areas.

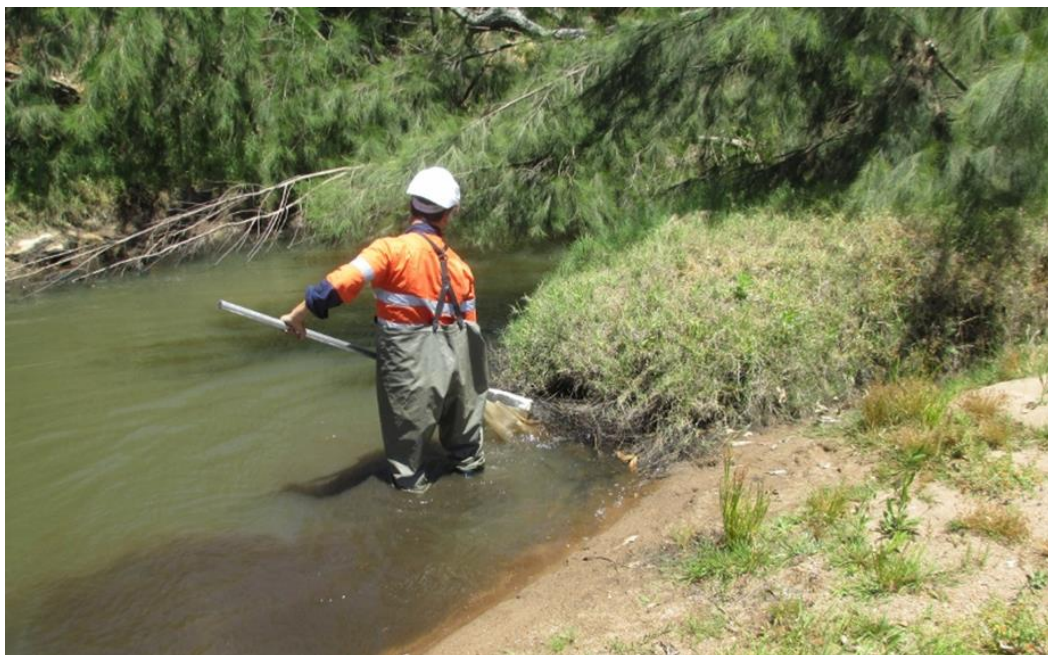
**Plate 1: Sampling method**

Samples of macroinvertebrates were collected from pool edges for a length of 10 metres, either as a continuous line or in disconnected segments. Sampling in segments was often undertaken to ensure the sampling of sub-habitats such as macrophyte beds, bank overhangs, submerged branches and root mats. Segmented sampling was also employed where pool length was short and it was logistically difficult to sample in a continuous line (e.g. in-stream logs). A 250  $\mu\text{m}$  dip net was drawn through the water with short sweeps towards the bank to dislodge benthic fauna while scraping submerged rocks and debris, sides of the stream bank and the bed substrate (Plate 1). Further sweeps in the water column targeted the suspended fauna.

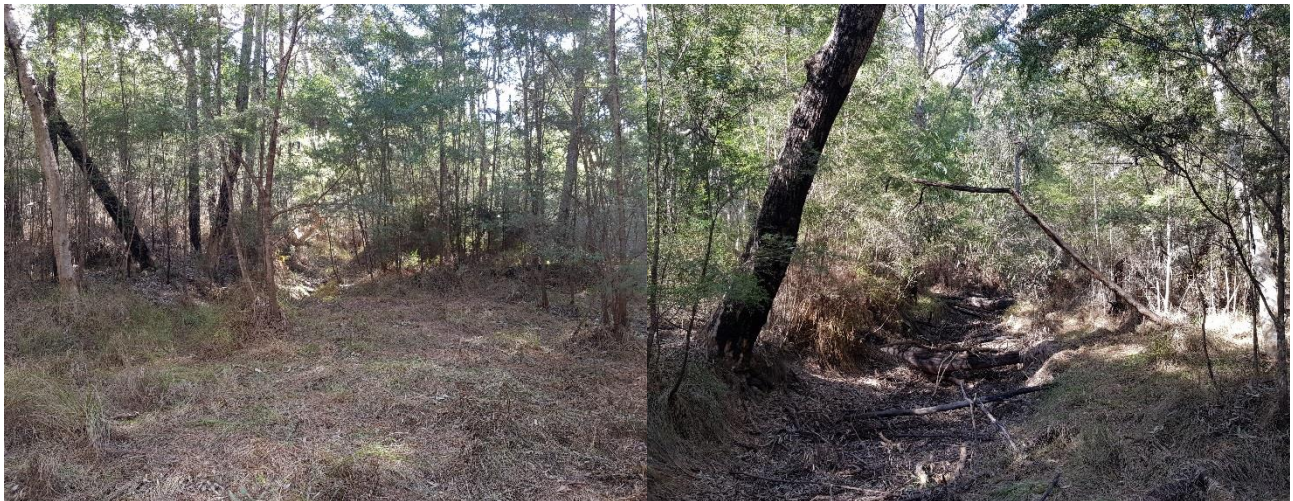
Plate 7: Site 6

The aquatic habitat at Site 6 (Plate 7) at the time of the spring 2019 monitoring surveys is detailed in Table 11.

Site 6 Downstream

Site 6 Upstream

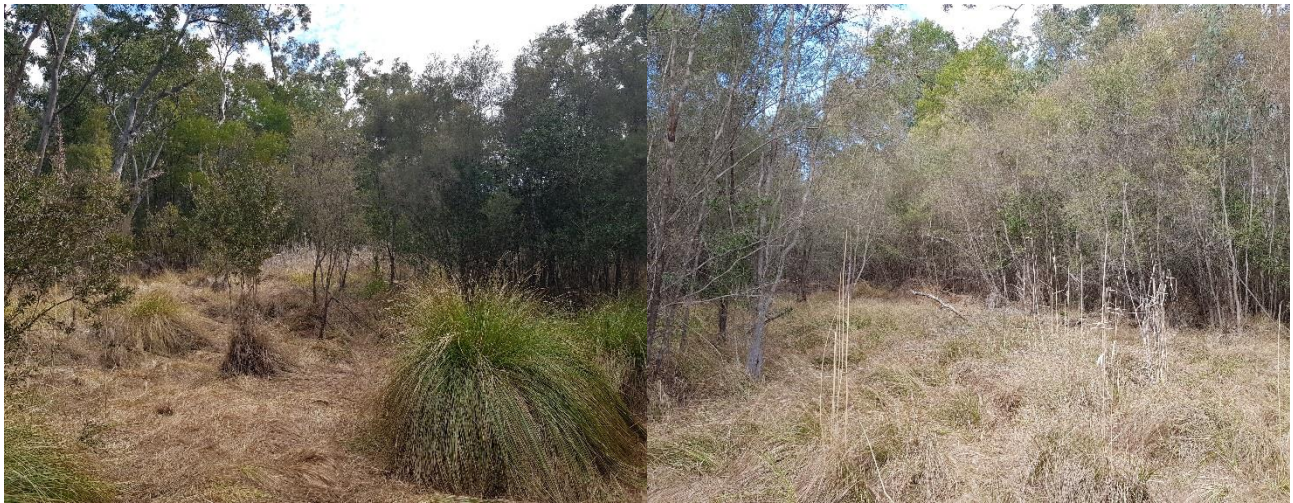
Plate 8: Site 7

The aquatic habitat at Site 7 (Plate 8) at the time of the spring 2019 monitoring surveys is detailed in Table 12.

Site 7 Downstream

Site 7 Upstream

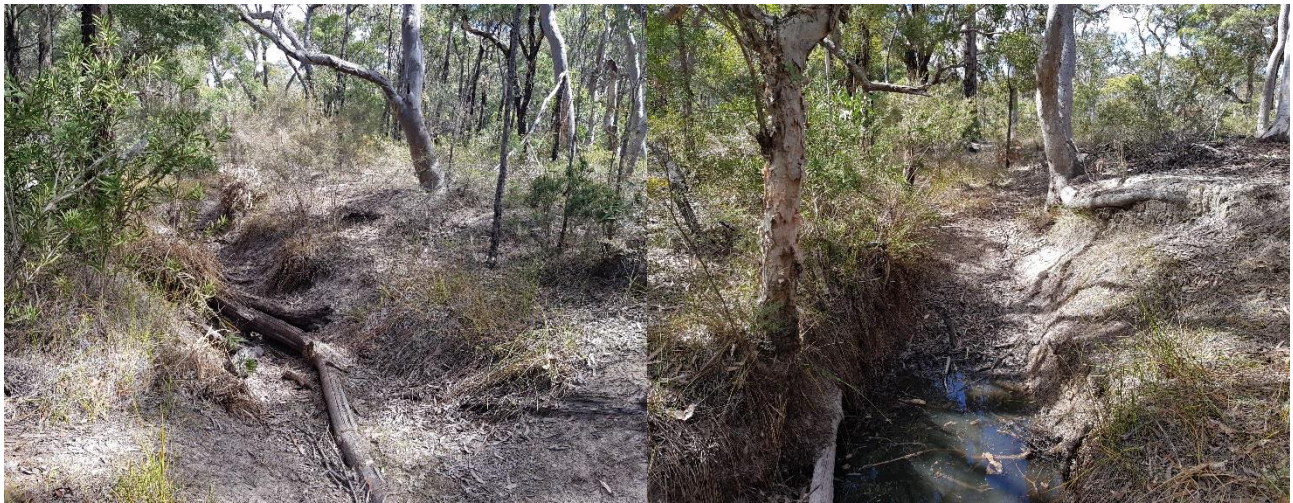
The aquatic habitat at Site 8 (Plate 7) at the time of the spring 2019 monitoring surveys is detailed in Table 13.

Site 8 Downstream

Site 8 Upstream
