2023 Annual Review

Tinda Creek Quarry

Period: 1 January 2023 to 31 December 2023

R.W. Corkery & Co. Pty. Limited
Geological & Environmental Consultants
ABN: 31 002 033 712

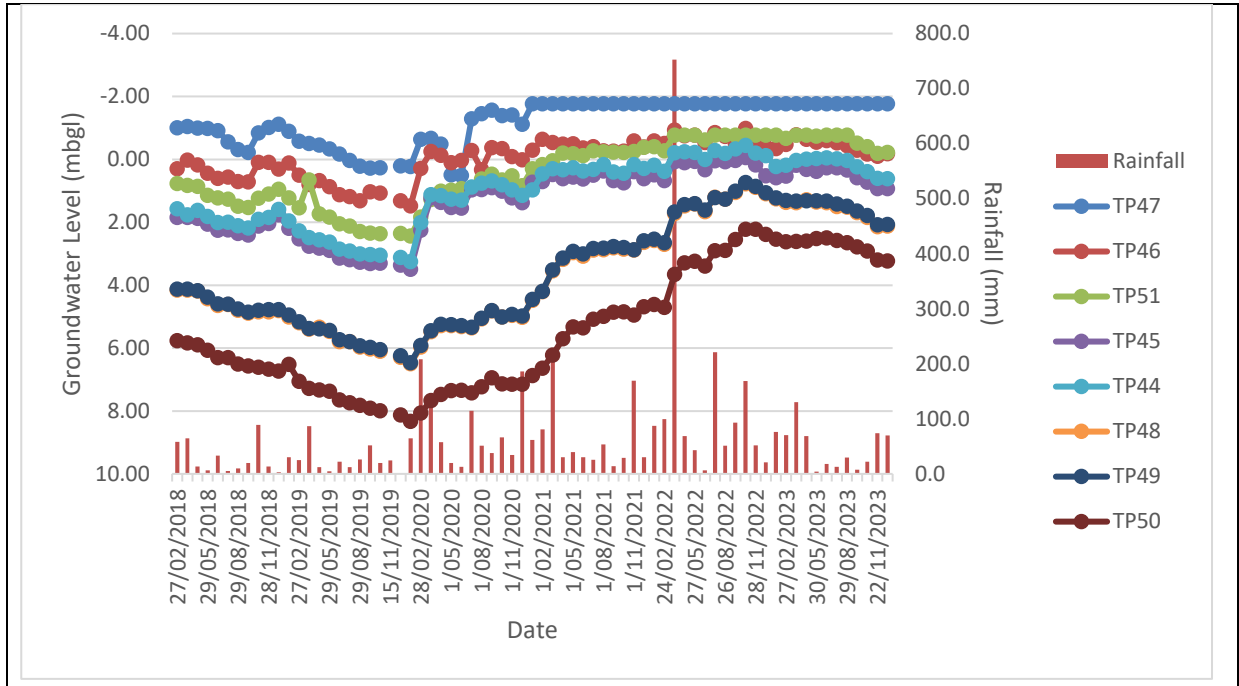
Figure 7
HYDROGRAPHY FOR SITE BORES WITH MONTHLY RAINFALL (2018 BORES)

The results of the 2023 groundwater levels monitoring are outlined in **Table 17** and displayed in **Figure 5**. The historical groundwater levels are presented in **Figure 6** and **Figure 7**. Monitoring results are displayed for both the original monitoring bores and the bores constructed in 2018.

Several bores continue to indicate artesian conditions in the aquifer resulting in water levels above ground level in the monitored bores (within the casing). This is considered to likely represent confined aquifer conditions with subsequent pressure forcing water into the bore and then stabilising within the casing. Monitoring bores TP23, TP46, TP47 and TP51 located downgradient of the Quarry retain higher groundwater level (artesian) conditions, however TP47 and TP51 do not accurately measure the water level as they are often flowing above ground level.

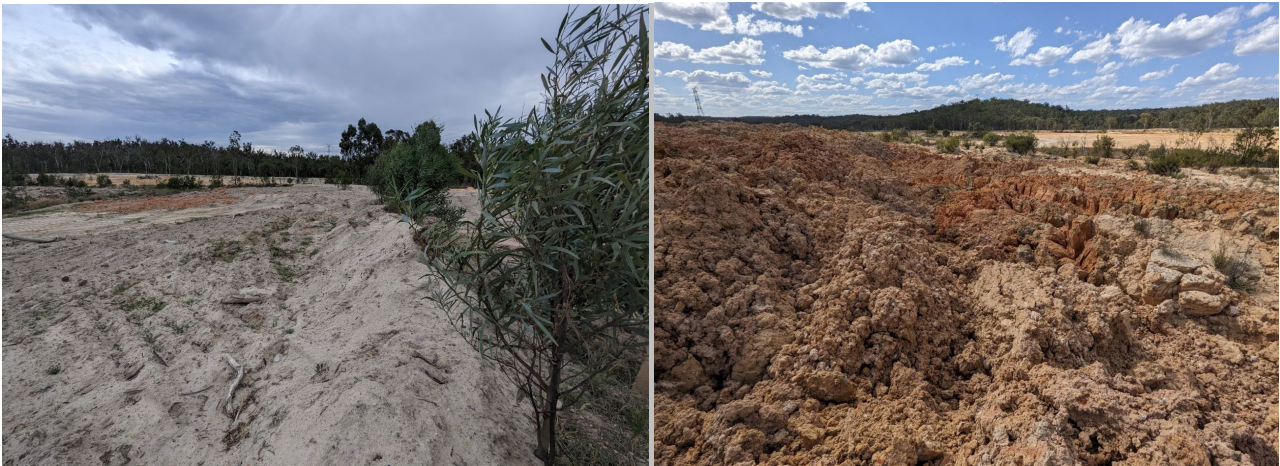
Photograph 3.1 BAM Plot 1 (left) and BAM Plot 2 (right) – surveys deferred until rehabilitation has been undertaken

Vegetation monitoring was conducted at seven locations during the 2023 survey period. Plots B1 and B2 were inspected; however, it is understood that this area of the quarry (Domain 4) is under active quarry workings and the landform has not been completed to a stage where rehabilitation can be established. Monitoring of these plots will be deferred until a time when rehabilitation has been established (refer to Section 2.6.1 and Photograph 3.1).

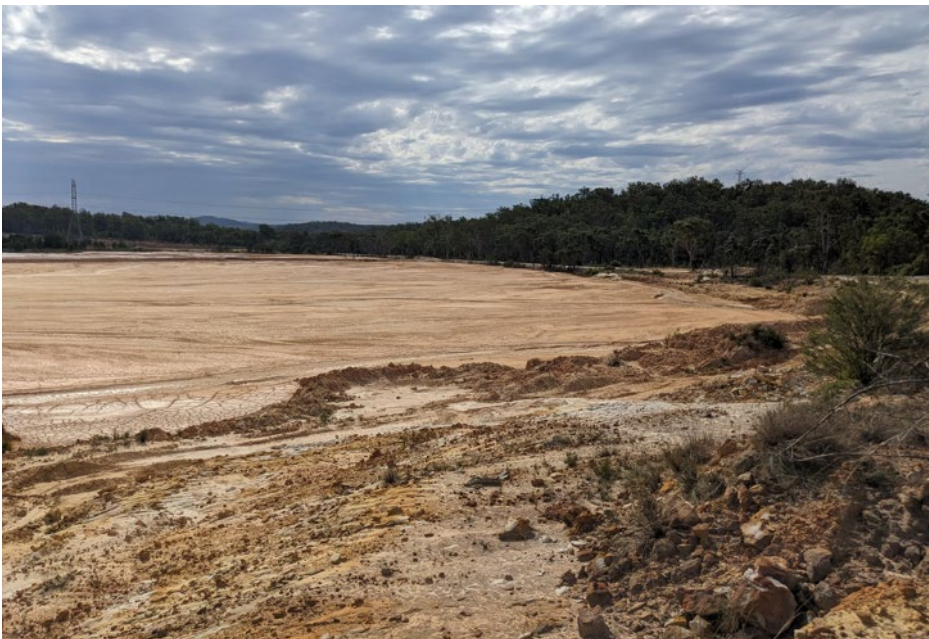
Photograph 3.2 A section of Domain 4 undergoing final profiling in preparation for revegetation

It should be noted that, at the time of survey, a section of Domain 4 was undergoing final landform profiling in preparation for rehabilitation (see Photograph 3.2). Once revegetation has commenced in this area, it is recommended that a monitoring plot be established within the revegetated area to monitor progress of rehabilitation.

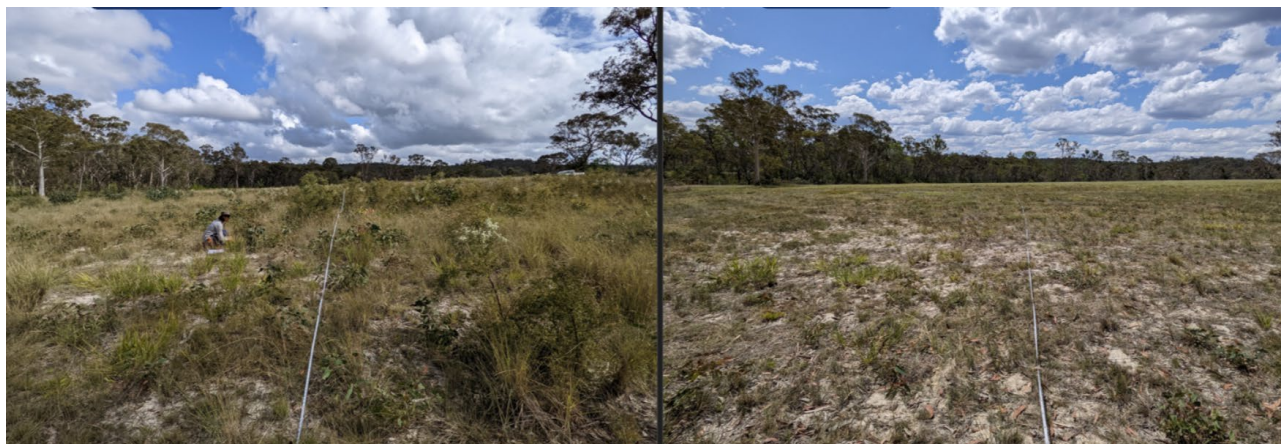
Photograph 3.3 Disturbance in Plot B4 between 2022 (left) monitoring and 2023 monitoring (right)

Plots B4 and B5 appeared to have been subject to substantial disturbance since the 2022 monitoring period (see Photograph 3.3). It is noted that slashing of African Lovegrass and other weed species was conducted a week or two prior to monitoring surveys in the vicinity of Plots B4 and B5 and within a portion of Plot B3, which may have had an impact on species detectability.

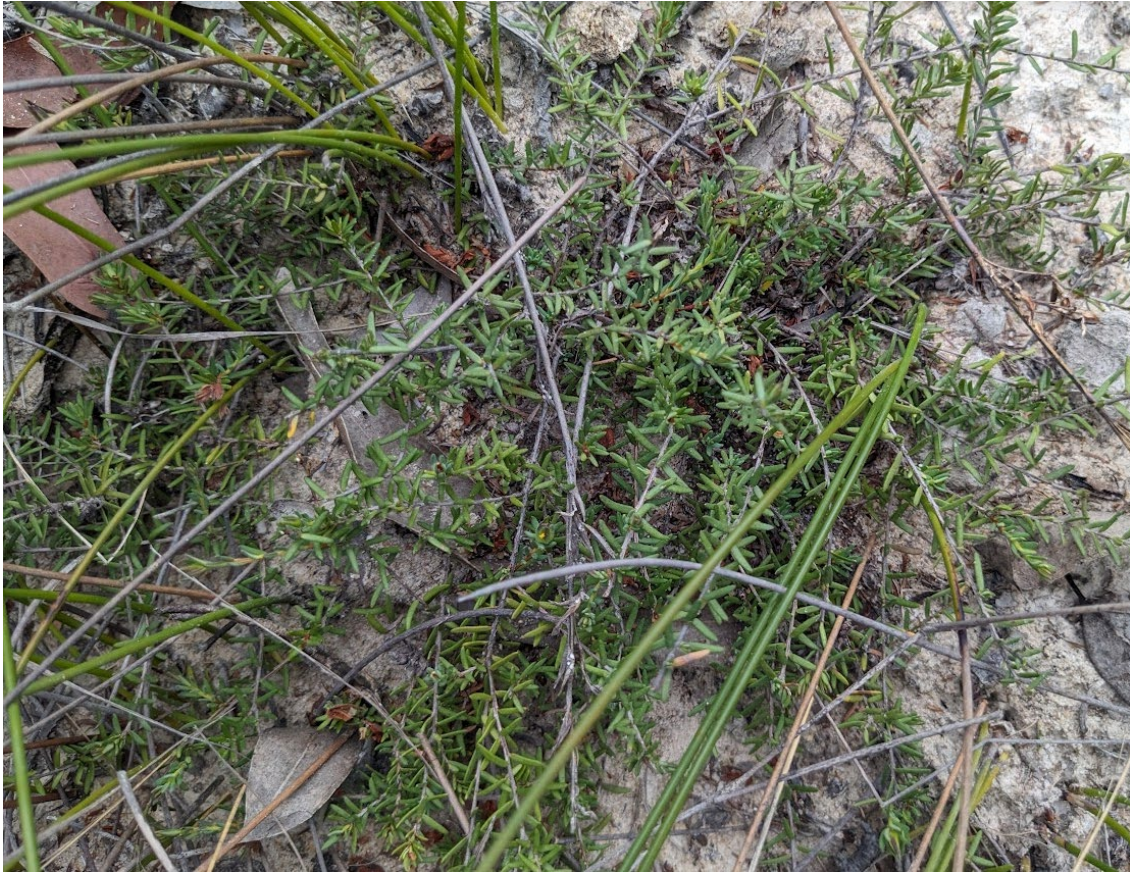
Photograph 3.4 *Hibbertia puberula* subsp. *extensa* observed within the Biodiversity Offset Area (BOA)

Prior to commencing broader habitat assessment and survey for *Hibbertia puberula* subsp. *extensa*, previous records of the species within the BOA and within Plot B3 were identified. It should be noted that the individuals recorded were in areas of previous disturbance (i.e. old tailings and artificial bunds) in low-lying areas within proximity to heath and sedgelands. Additionally, the majority of individuals identified on site were in bud, with minimal flowering occurring at the time of survey (see Photograph 3.4 and Photograph 3.5).

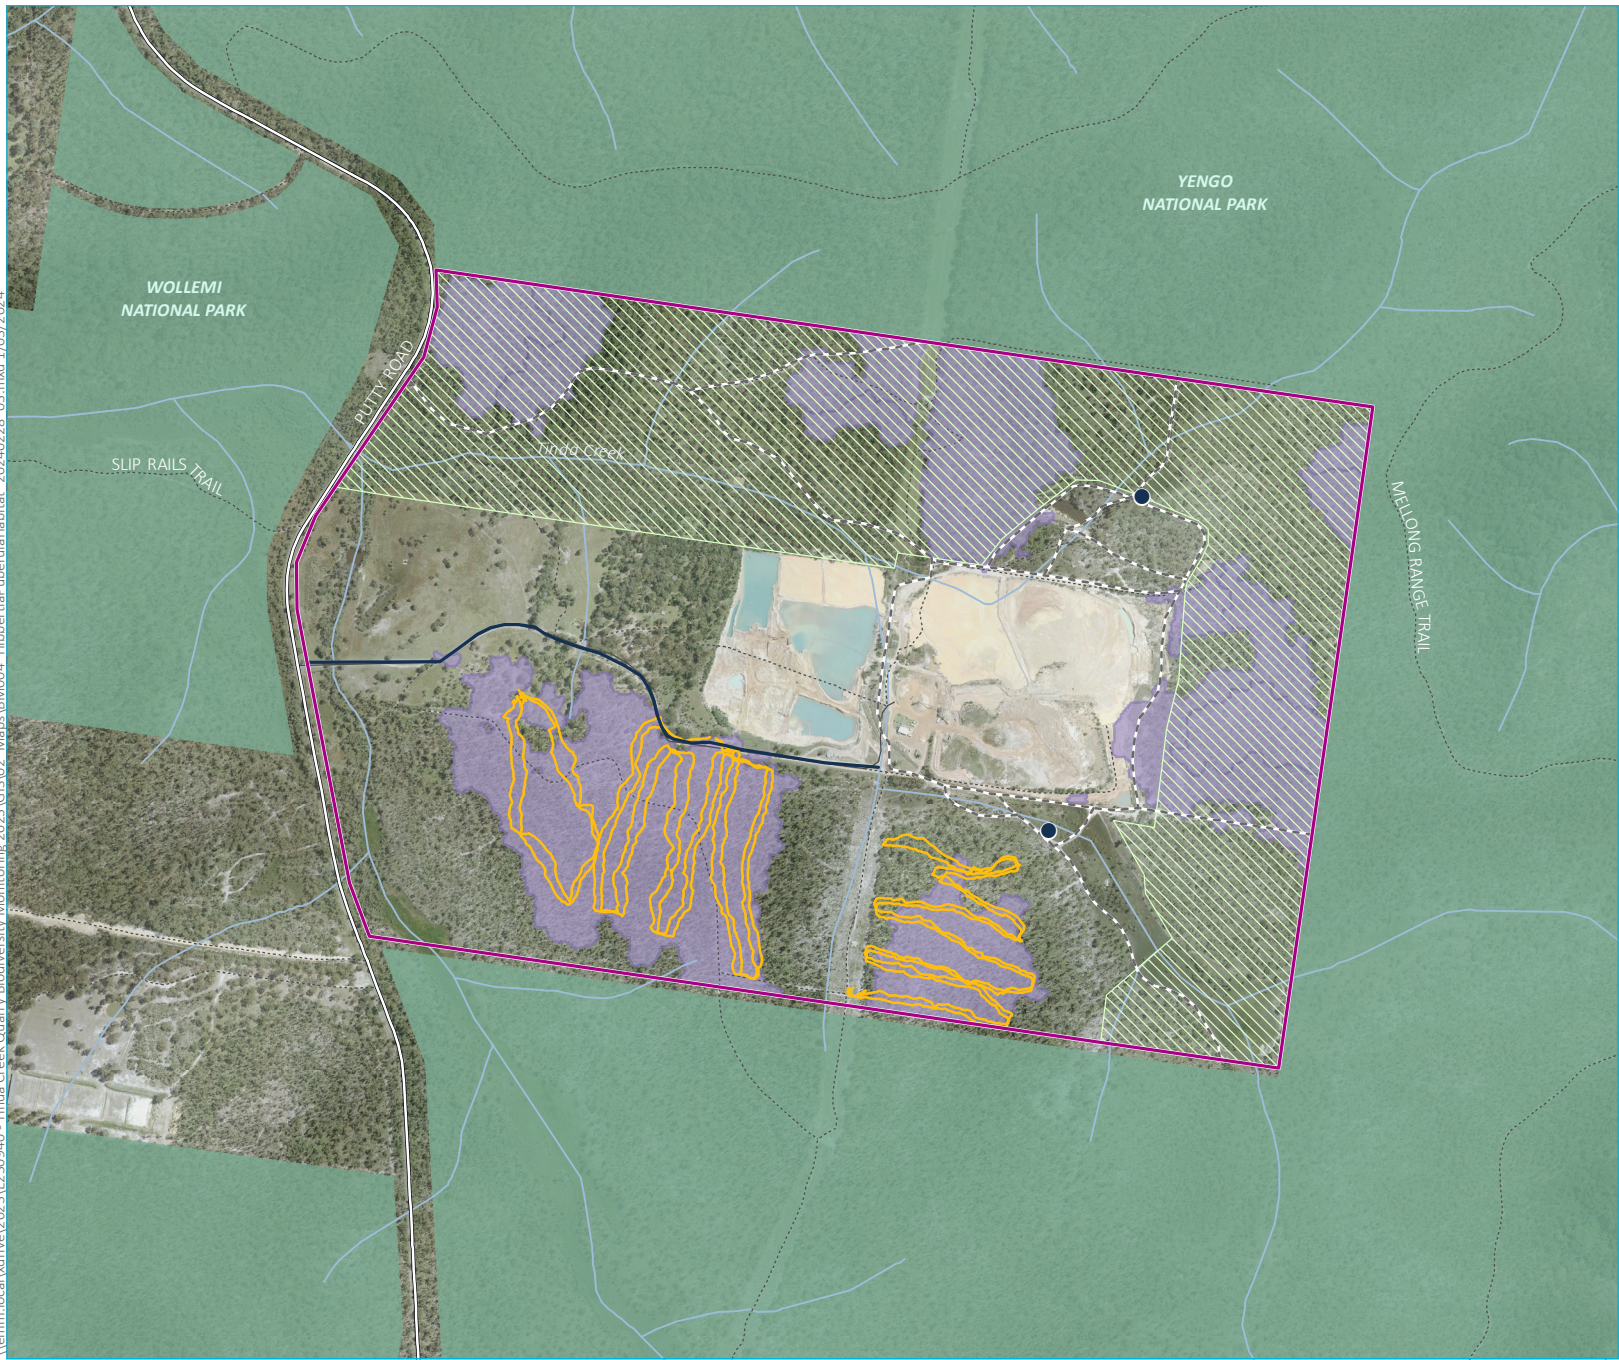
Tinda Creek Quarry
Biodiversity Monitoring Report 2023
Figure 3.1

Habitat assessment and surveys for *Hibbertia puberula* subsp. *extensa* were conducted in two patches of PCT 3622 Sydney Hinterland Yellow Bloodwood Woodland south of the active Quarry area on 16 December 2023 (Figure 3.1). These patches were approximately 9 ha and 20 ha in size and comprised dry sclerophyll woodland on sandy soil. Elevation in these patches ranged between 340 m and 380 m.

The canopy in these areas was dominated by Yellow Bloodwood (*Corymbia eximia*) and Narrow-leaved Apple (*Angophora bakeri*), while the mid-storey was dominated by *Leptospermum* (tea tree) and *Persoonia* (geebung) species. The ground layer was sparse and generally dominated by herbs and forbs. While other *Hibbertia* species, such as Hoary Guinea Flower (*Hibbertia obtusifolia*) were identified throughout these areas, *Hibbertia puberula* subsp. *extensa* was not observed.

Hibbertia puberula subsp. *extensa*
habitat assessment and
survey effort

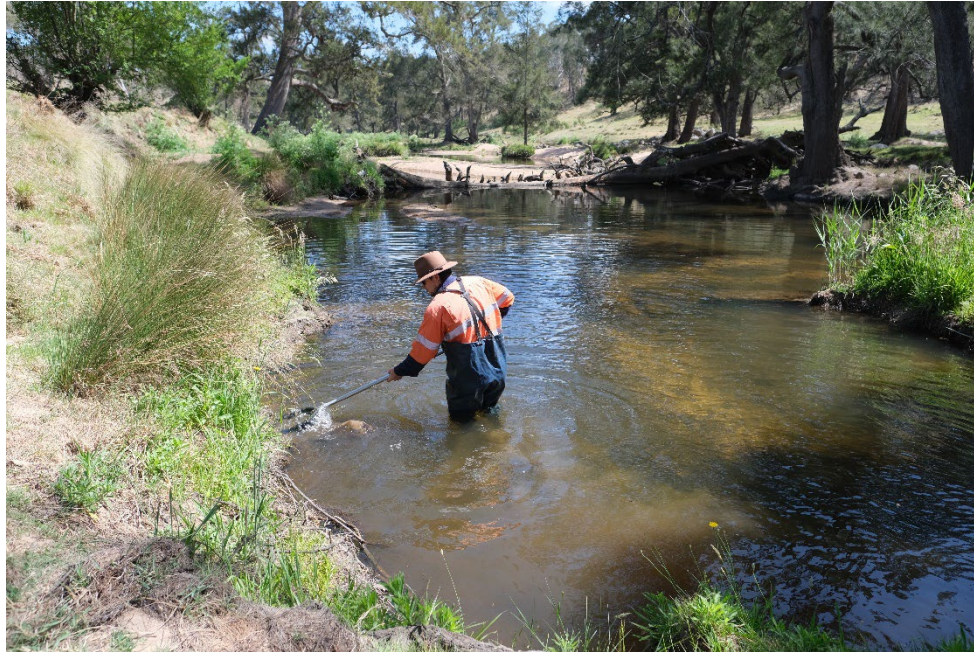
Plate 1: Sampling method

Samples of macroinvertebrates were collected from pool edges for a length of 10 metres, either as a continuous line or in disconnected segments. Sampling in segments was often undertaken to ensure the sampling of sub-habitats such as macrophyte beds, bank overhangs, submerged branches and root mats. Segmented sampling was also employed where pool length was short and it was logistically difficult to sample in a continuous line (e.g. in-stream logs). A 250 µm dip net was drawn through the water with short sweeps towards the bank to dislodge benthic fauna while scraping submerged rocks and debris, sides of the stream bank and the bed substrate (Plate 1). Further sweeps in the water column targeted the suspended fauna.

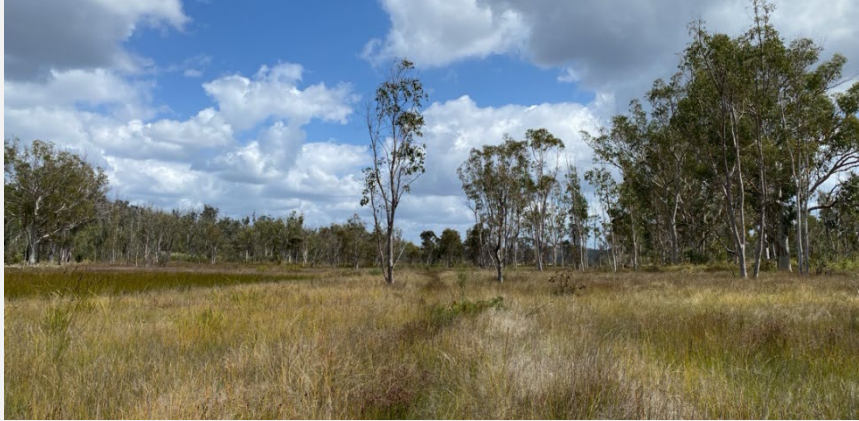
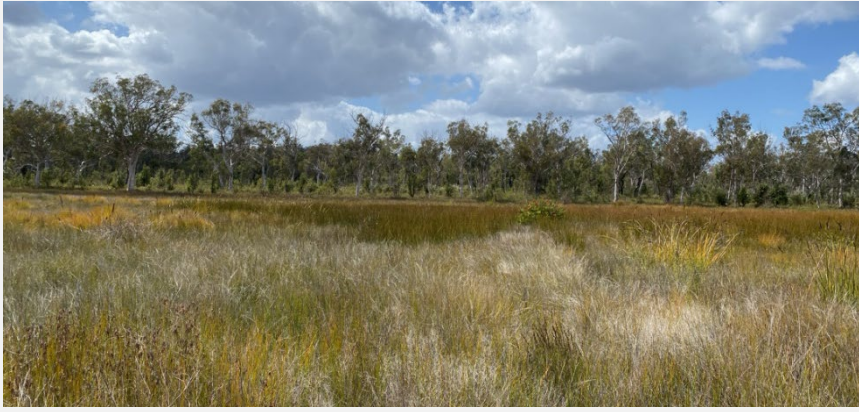
Criteria	Attribute	Site 1
Riparian	Vegetation	Canopy absent. Scattered Parramatta Red Gum (<i>Eucalyptus parramattensis</i>) regenerating within this location. Mid-story absent. Groundcover dominated by sedge, low shrub, herb and grasses including <i>Leptocarpus tenax</i> ; <i>Juncus</i> sp.; <i>Lepyrodia scariosa</i> ; <i>Schoenus brevifolius</i> ; <i>Entolasia stricta</i> ; <i>Gonocarpus micranthus</i> ; <i>Melaleuca thymifolia</i> ; <i>Micromyrtus ciliata</i> and <i>Dampiera stricta</i> .
	Stream shading	Low <5%.
	Exotic vegetation	-
Stream characteristics	Width (m)	<1 m.
	Substrate	Majority sand and silt.
	Flow/depth	Dry
	Macrophytes/algae	Macrophytes present

Criteria	Attribute	Site 1
	Water quality observations	Dry
Comments		Very shallow and generally narrow channel form (<1 m). Open sandy floodplain with the flow channel identified by the change in vegetation, indicating the more permanent presence of surface water or subsurface flow.
Plate 2: Site 1	Downstream

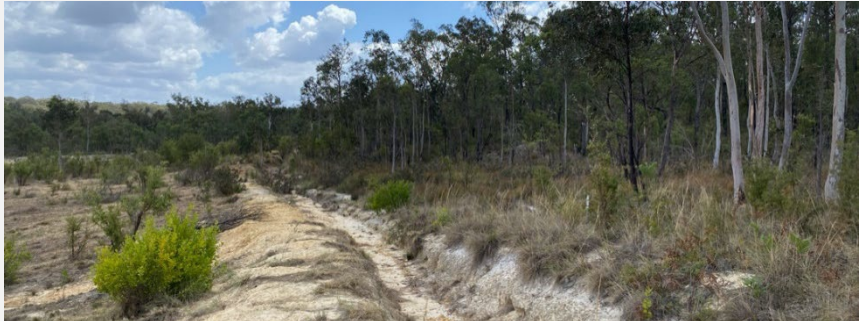
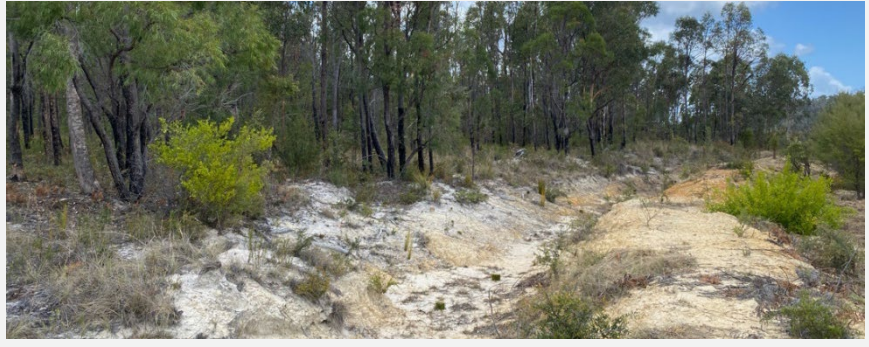
Criteria	Attribute	Site 3
Riparian	Vegetation	Canopy and mid-story absent. Groundcover dominated by <i>Chorizandra spaerocephala</i> .
	Stream shading	Low/none.
	Exotic vegetation	-
Stream characteristics	Width (m)	<2 m.
	Substrate	Sand 70%, silt 30%.
	Flow/depth	Dry
	Macrophytes/algae	Absent.
	Water quality observations	Dry
Comments		Very loose and unstable banks.
Plate 4: Site 3	Downstream

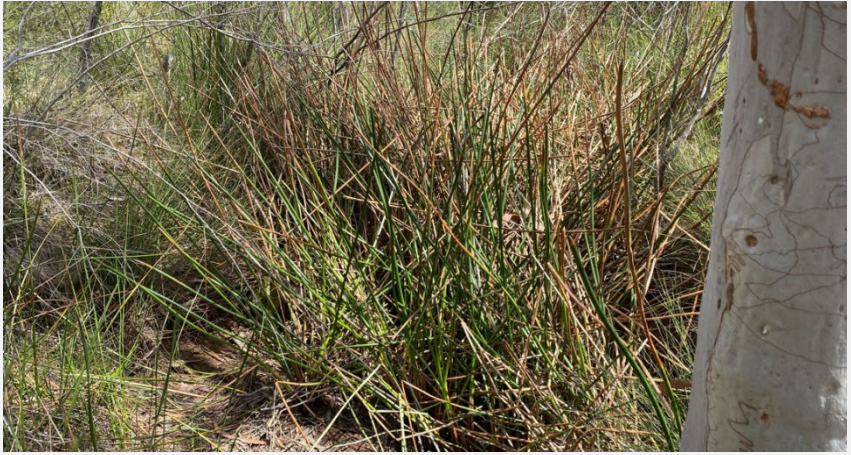
Criteria	Attribute	Site 4
Riparian	Vegetation	Canopy composed of <i>Eucalyptus haemastoma</i> (<5%). Mid-story dominated by small trees and tall shrubs. Ground cover was sparse with signs of slight post fire regrowth and dominated by <i>Chorizandra spaerocephala</i> .
	Stream shading	Low.
	Exotic vegetation	-
Stream characteristics	Width (m)	2 m.
	Substrate	80% silt, 20% sand.
	Flow/depth	Dry
	Macrophytes/algae	Macrophytes present
	Water quality observations	Dr
Comments	None.	
Plate 5: Site 4	Downstream

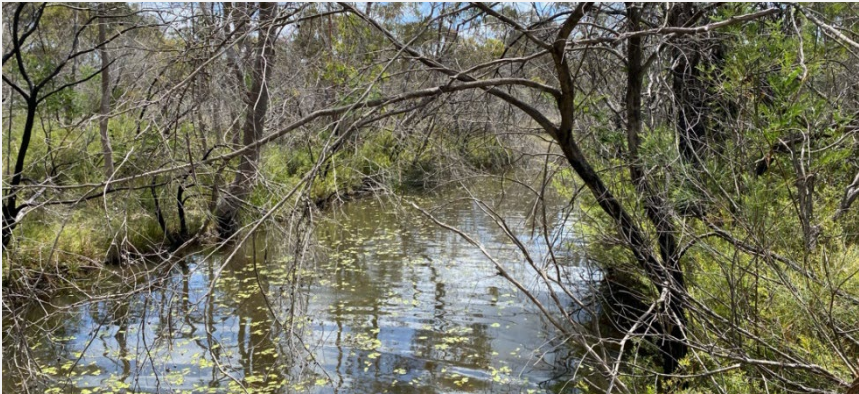
Criteria	Attribute	Site 5
Riparian	Vegetation	Canopy present and comprised of <i>Eucalyptus haemastoma</i> , Mid-story supporting dense cover of small trees and tall shrubs (<i>Acacia</i> spp. and <i>Cassurina</i> spp.). There were signs of regrowth of ground covering including regenerative Cat-tailed bulrush (<i>Typha</i> sp.) and Round headed bristle sedge (<i>Chorizandra spaerocephala</i>).
	Stream shading	Low-moderate.
	Exotic vegetation	-
Stream characteristics	Width (m)	6 m.
	Substrate	Silt 90%, sand 10%.
	Flow/depth	No flow/deep >1 m.
	Macrophytes/algae	Cat tail Bulrush (<i>Typha</i> sp.) and floating macrophyte <i>Potamogetan sulcus</i>
	Water quality observations	Water availability was relatively high; conditions were highly turbid.
Comments	Riparian and macrophyte vegetation present	
Plate 6: Site 5	Downstream

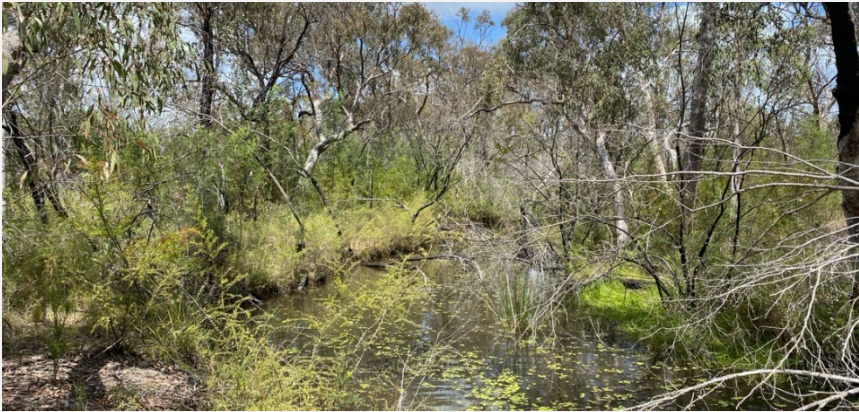
Criteria	Attribute	Site 6
Riparian	Vegetation	Forest Red Gum (<i>Eucalyptus tereticornis</i>), White Stringybark (<i>Eucalyptus globoidea</i>) dominated the canopy vegetation. The mid-storey was dominated by small trees and tall shrubs. The ground cover consisted of regenerating native grasses, herbs and ferns.
	Stream shading	Low/moderate.
	Exotic vegetation	-
Stream characteristics	Width (m)	4 m.
	Substrate	Sand 20%, silt 80%.
	Flow/depth	No flow/ >1 m deep.
	Macrophytes/algae	Large amount of biofilm present. Cat tail Bulrush (<i>Typha</i> sp.),
	Water quality observations	Water availability was relatively high; conditions were highly turbid.
Comments		-
Plate 7: Site 6	Downstream	 
	Upstream

The aquatic habitat at Site 6 (Plate 7) at the time of the spring 2023 monitoring surveys is detailed in Table 12.

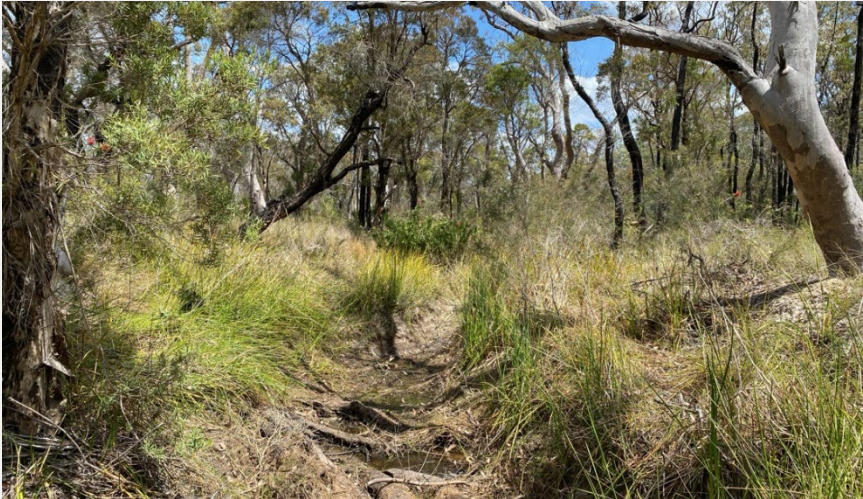
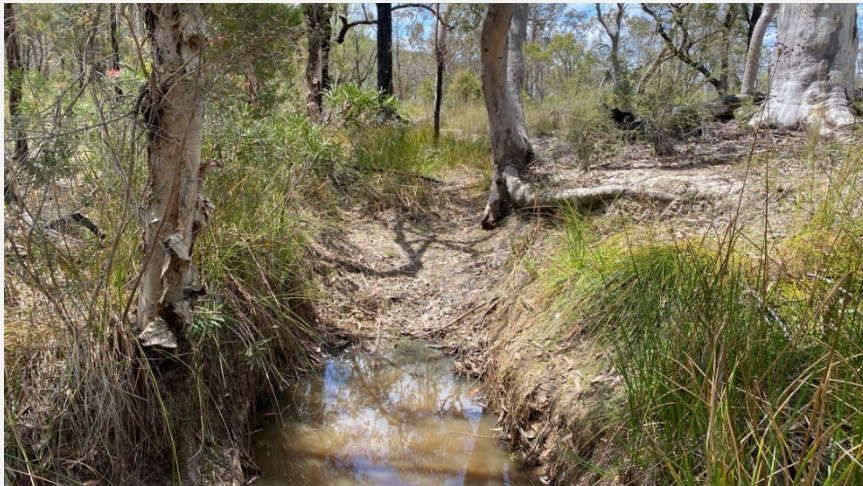
Criteria	Attribute	Site 8
Riparian	Vegetation	Canopy vegetation included Grey Gums (<i>Eucalyptus punctata</i>) and Scribbly Gums (<i>Eucalyptus haemastoma</i>). The mid-storey was heavily damaged due to bushfires. The ground cover consisted of by native grasses, herbs and ferns along with Eucalyptus and Casuarina regeneration post fires.
	Stream shading	Low/moderate.
	Exotic vegetation	-
Stream characteristics	Width (m)	<3 m.
	Substrate	Pebble 30%, sand 20%, silt 50%.
	Flow/depth	No flow.
	Macrophytes/algae	A green macro algae was present
	Water quality observations	Turbid, low flow conditions.
Comments		-
Plate 9:Site 8	Downstream

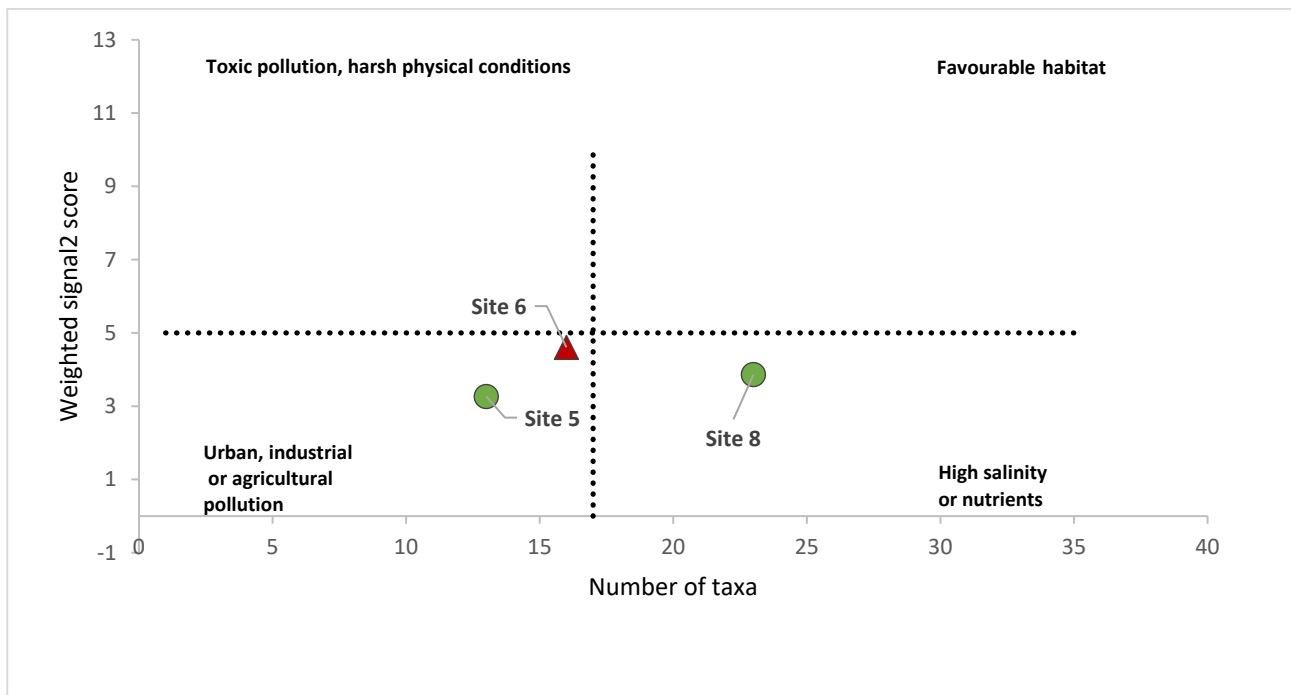
Figure 3: SIGNAL2 Bi-plot – Spring 2023

The low weighted SIGNAL2 scores recorded at all sites in spring 2024 indicate that the macroinvertebrate assemblage present in the streams is dominated by predominantly pollution-tolerant taxa (Table 16, Figure 3). The Biplot, indicates that no sites have favourable aquatic habitat, and all locations are exhibiting some form of pollution or natural stress. However, this appears typical for streams in the area as one reference site is clustered together with a test site in this quadrant. These results are generally indicative of harsh environmental conditions at reference Site 5 and test Site 6. Pollution-sensitive taxa recorded include Mayfly Leptophlebiidae (SIGNAL 8) observed at Sites 6 and 8, flies Dixidae (SIGNAL 7) at site 6 and mites Acarina (SIGNAL 6) at all sites.

Note: reference sites represented as green circles, while test sites represented as red triangles.
